03/06/2024

Arborist Report

Client: Live Oak Associates - Attention: Katrina Krakow

Site: 50 Los Gatos-Saratoga Rd, Los Gatos CA

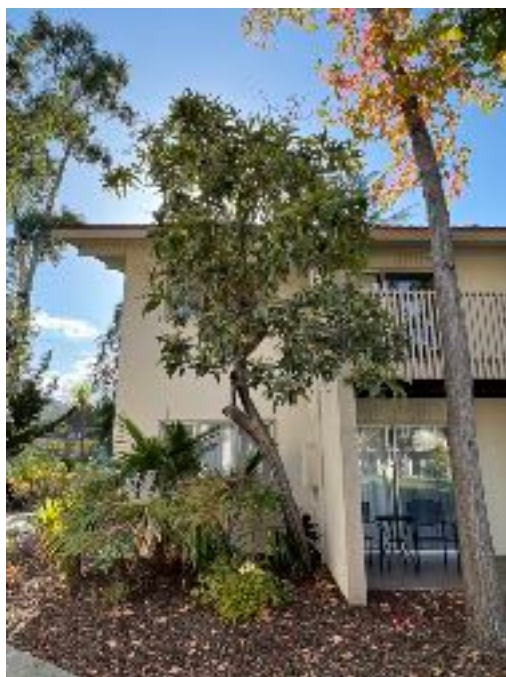
Tag 4989: Decay noted in both of the two main uprights. Deadwood is a parent in the upper canopy.

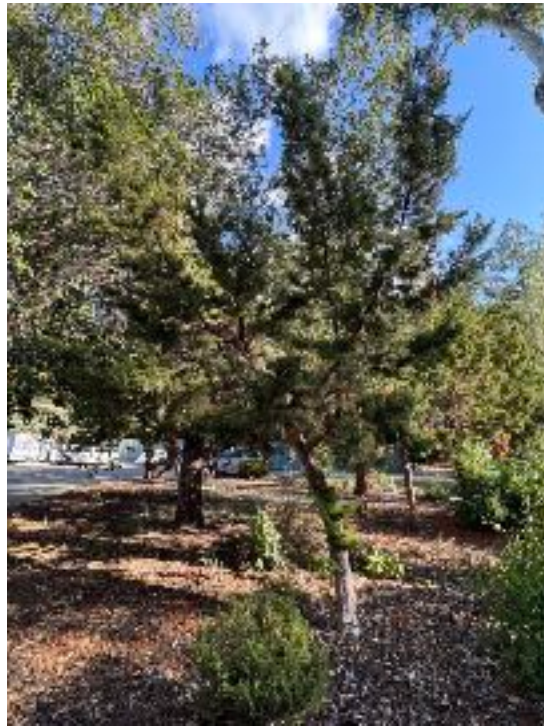
Tag 4990: Trunk of the tree has a significant lean to the northeast.

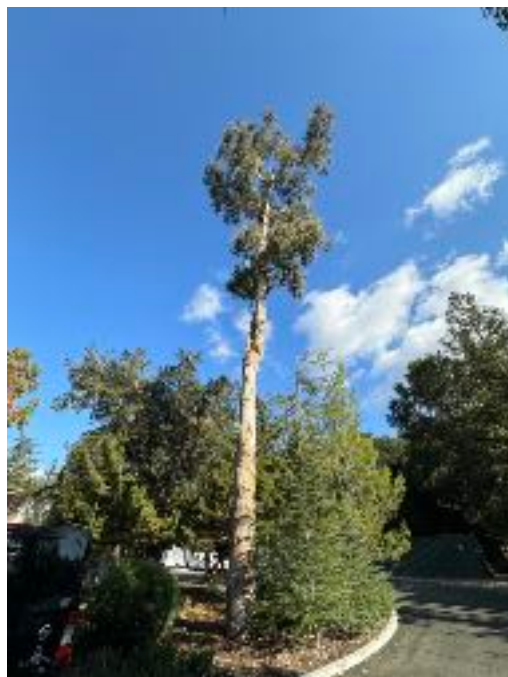
Tag 4991: Poor attachment at first main crotch.
Tree has already lost a major upright just adjacent to first main crotch.

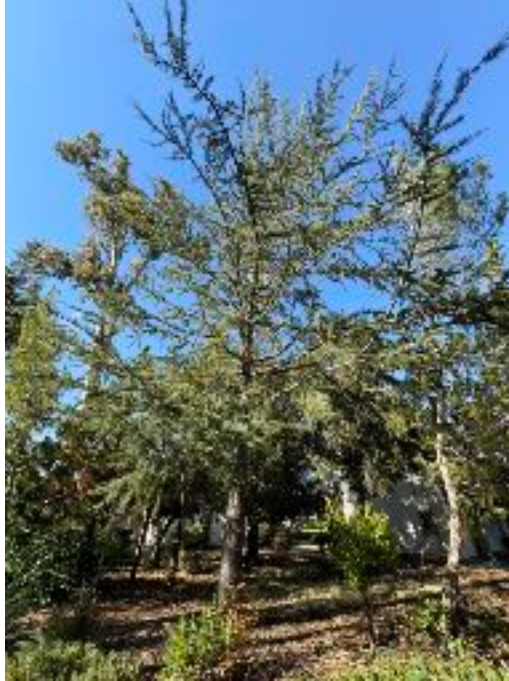
Tag 4992: Significant dieback at the top of the canopy.
Sparse foliage throughout the canopy.

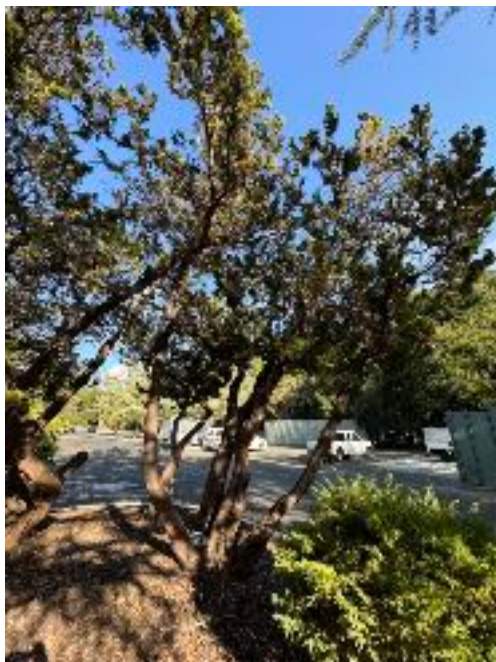
Tag 4993: Sparse foliage in the canopy is noted.
Minor die back observed in the canopy.
Neighboring Monterey cypress canopy is conjoining with canopy of this
Monterey cypress.

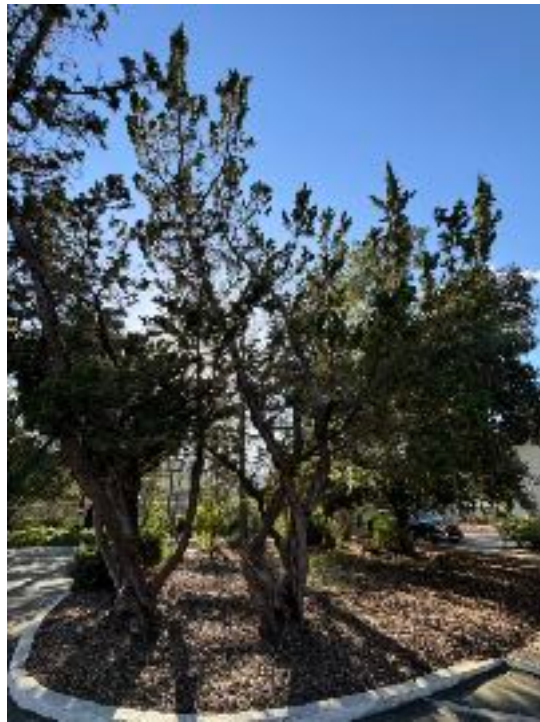
Tag 4994: Upper canopy is beginning to conjoin with the neighboring Monterey cypress canopy.

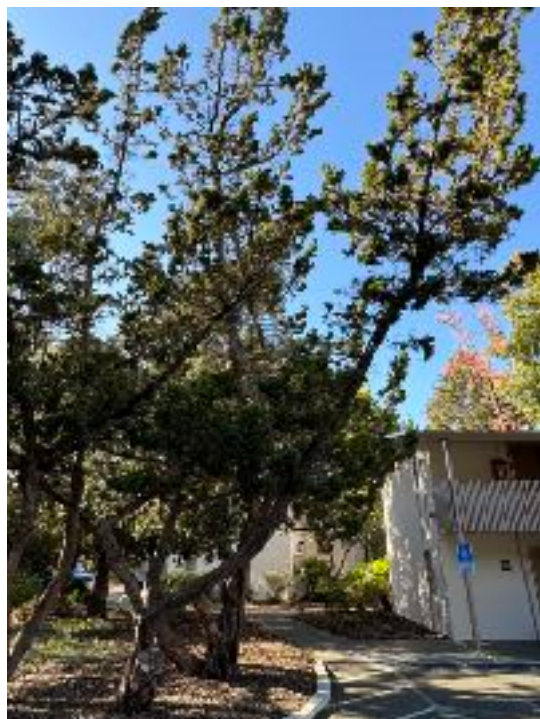
Tag 4995: Canopy conjoining with neighboring Monterey cypress trees.

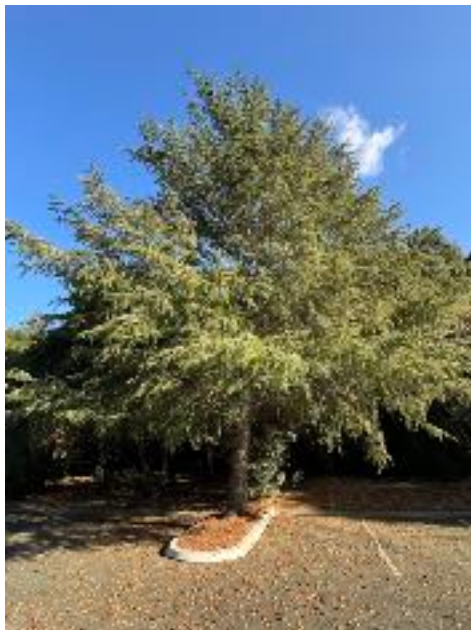
Tag 4997: Canopy skirt is approximately 6 1/2 feet above grade, minor dieback noted and lower canopy.

Tag 4998: Canopy skirt is approximately 6 feet above grade at certain points.

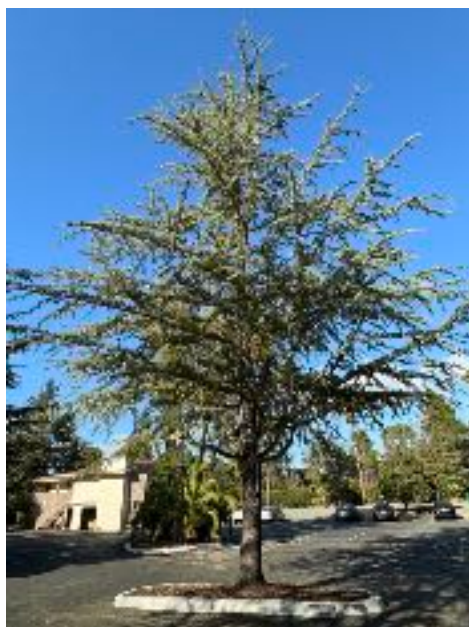
Tag 4999: Crossing limbs noted in canopy.

Minor dieback apparent throughout canopy.

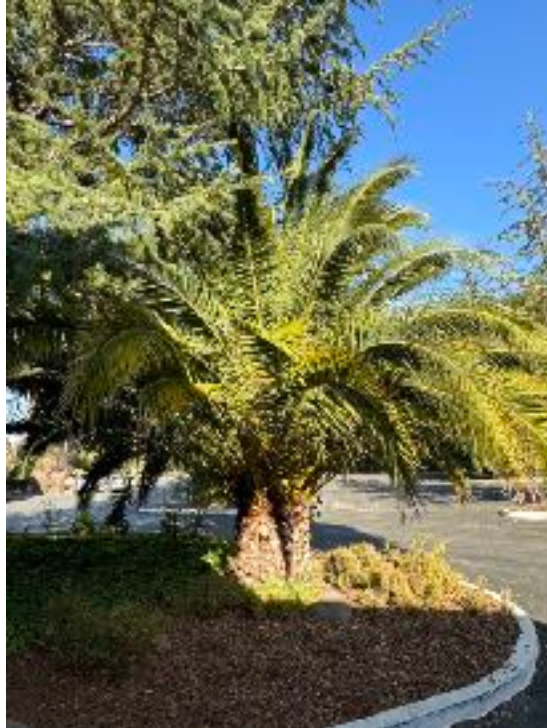
Tag 5000: Canopy is growing up into the canopy of the neighboring deodar cedar.

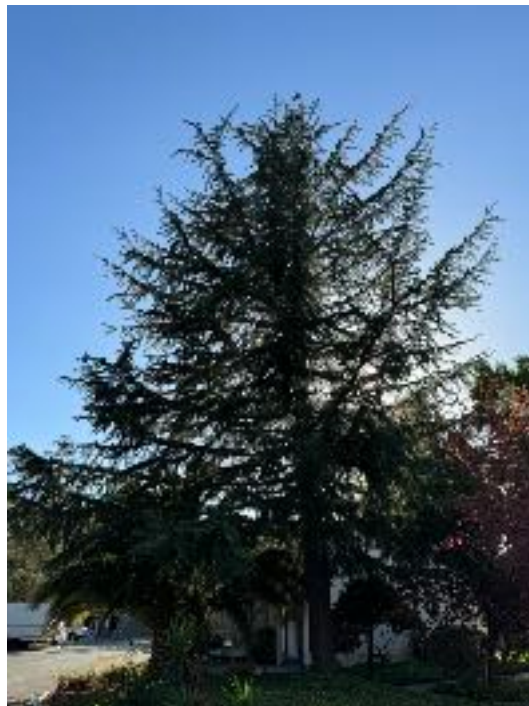
Tag 5001: No notable observations.

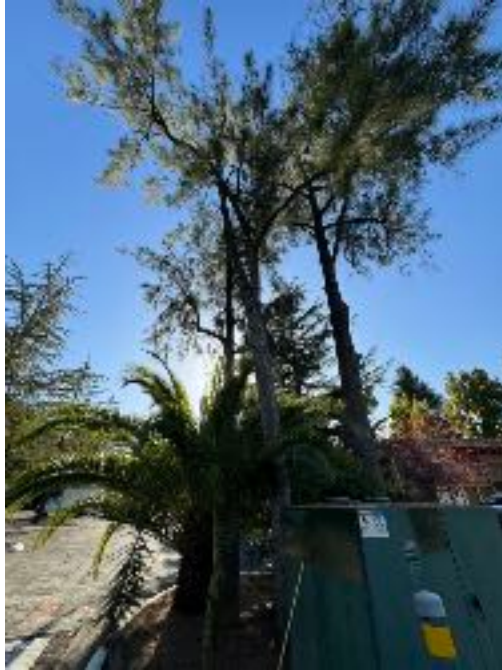
Tag 5004: Moderate die back noted throughout canopy from drought stress.

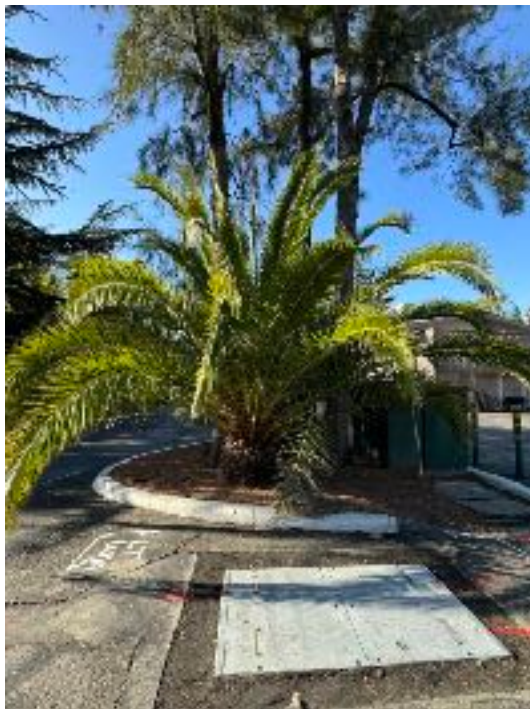
Tag 5005: Palm fronds are growing around the neighboring pine tree.

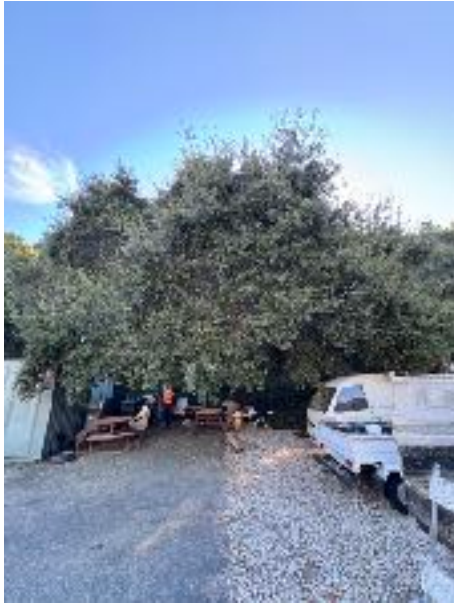
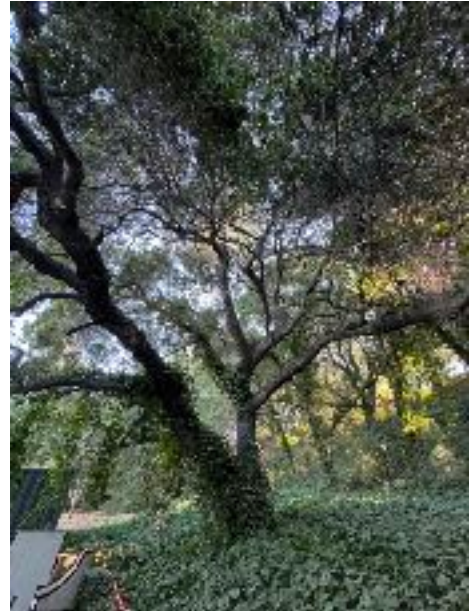
Tag 5006: Canopy skirt is approximately 5ft above grade level at multiple points.

Significant Ivy growing up the main stem and main uprights.

Moderate deadwood noted in canopy.

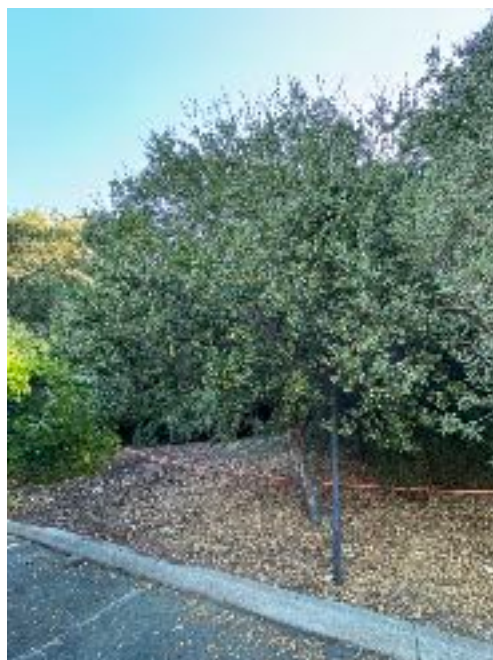
Tag 5009: Canopy is enveloping adjacent lamp.
Minor deadwood noted in canopy.

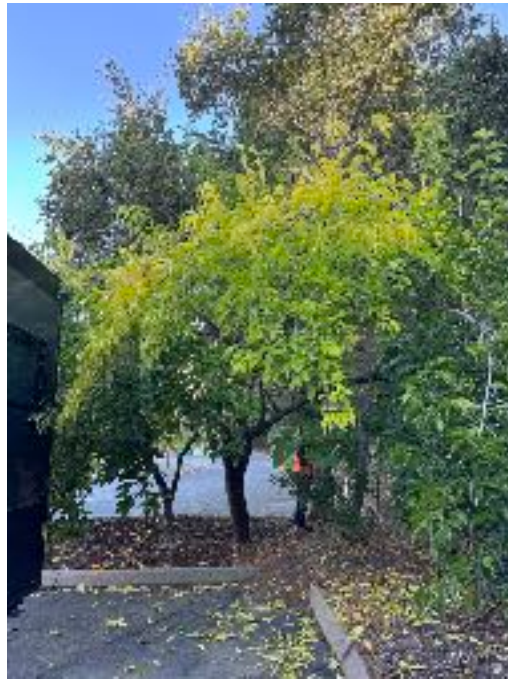
Tag 5010: Fungal fruiting bodies noted on trunk and co-dominant upright.

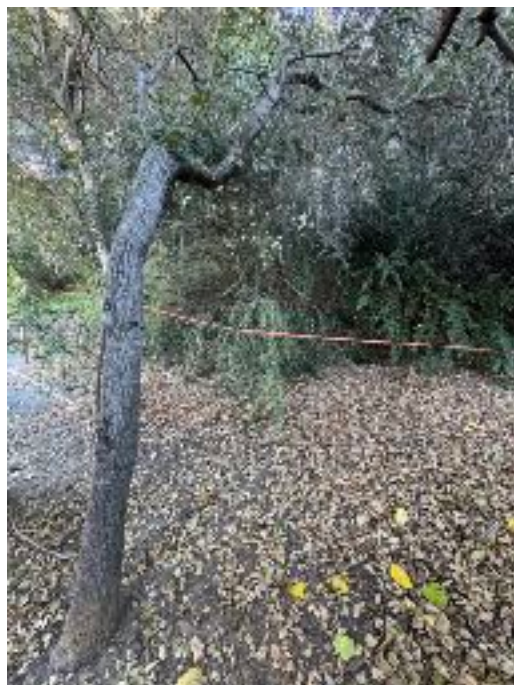
Tag 5011: The canopy of this tree is growing entirely towards the eastern direction due to competition for light with neighboring oak trees.

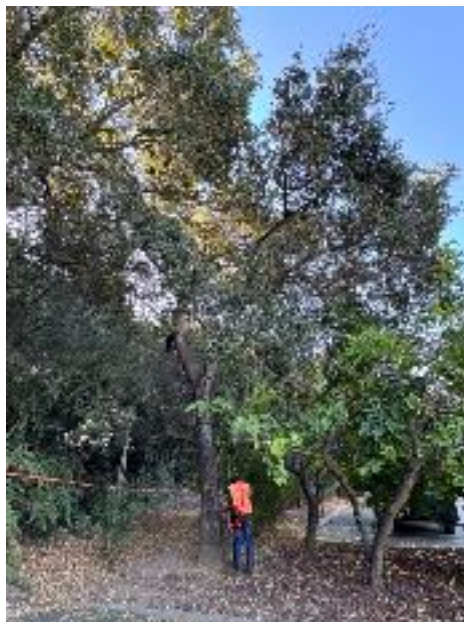
Tag 5012: Volunteer from another species growing at the base that could affect the trees structural integrity.
Canopy has grown towards the south due to competition with neighboring oak tree.

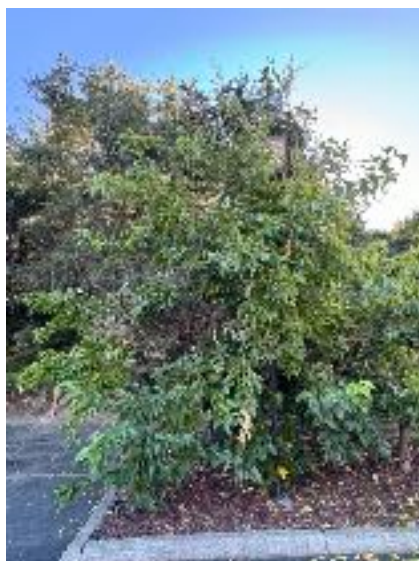
Tag 5013: Significant decay on co-dominant upright.
Multiple broken limbs in the upper canopy.
Canopy contains multiple overlapping limbs.
Canopy skirt is nearly touching the ground in multiple locations.
Canopy is obscuring adjacent lamppost.

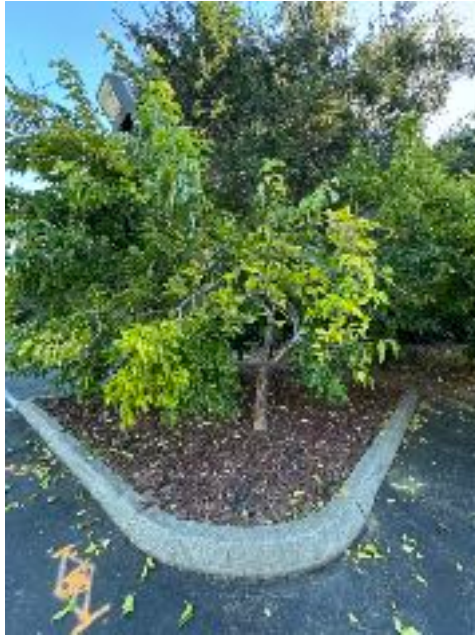
Tag 5014: Significant decay on trunk and up both codominant uprights.
Canopy contains overlapping limbs.
Canopy skirt is approximately 3 feet above grade.

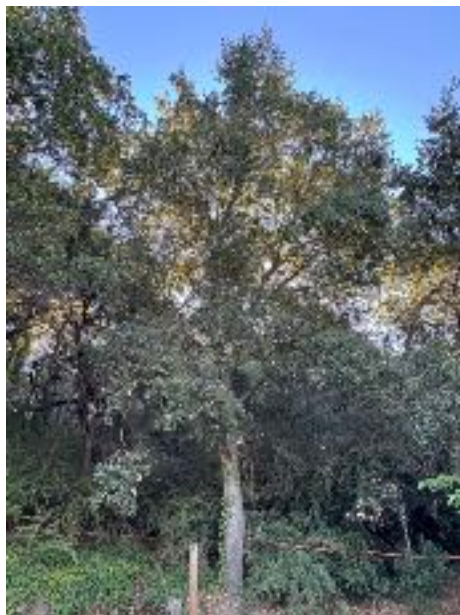
Tag 5015: Root system can be considered integral to the hillside grade retention
Ivy growing up the trunk.

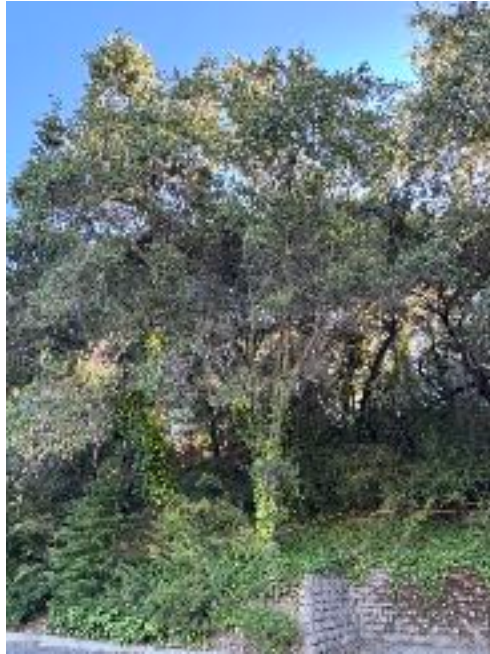
Tag 5016: Root system can be considered integral to the hillside grade retention

Ivy growing up the trunk.

Minor deadwood noted in canopy.

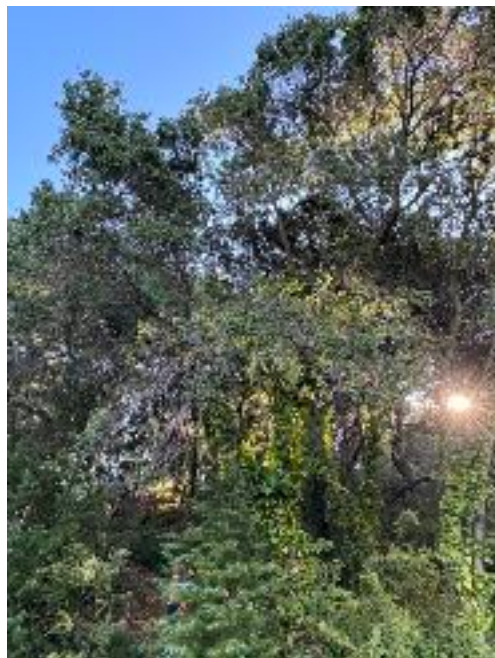
Tag 5017: Significant Ivy growing up the trunk of the tree and both main uprights.

Moderate deadwood noted in the canopy.

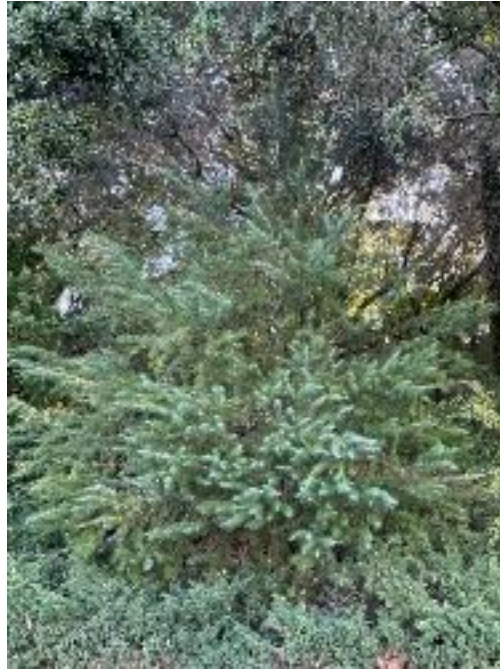
Tag 5018: Foliage is growing predominantly on the western side due to the availability of light.

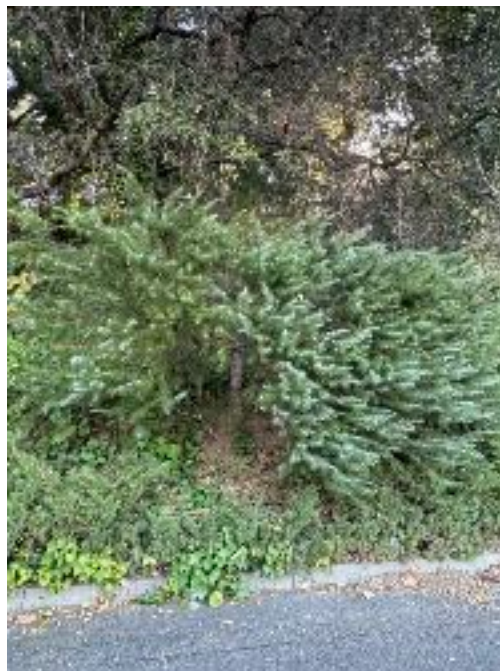
Tag 5019: Dense canopy with over-lapping limbs.

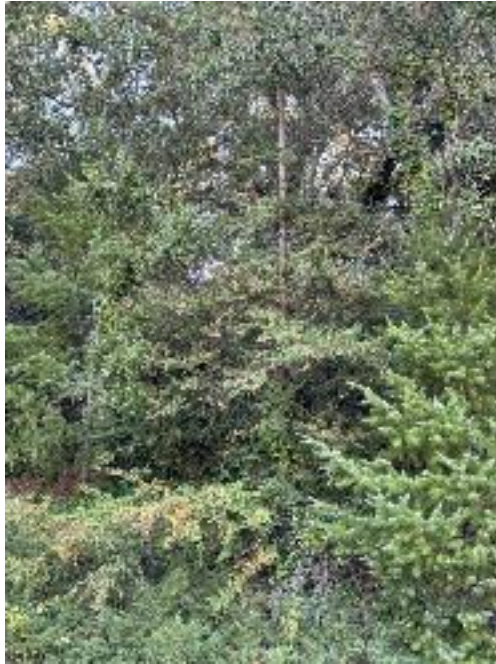
Tag 5020: Ivy growing up trunk.
Canopy is significantly obstructed by surrounding trees.

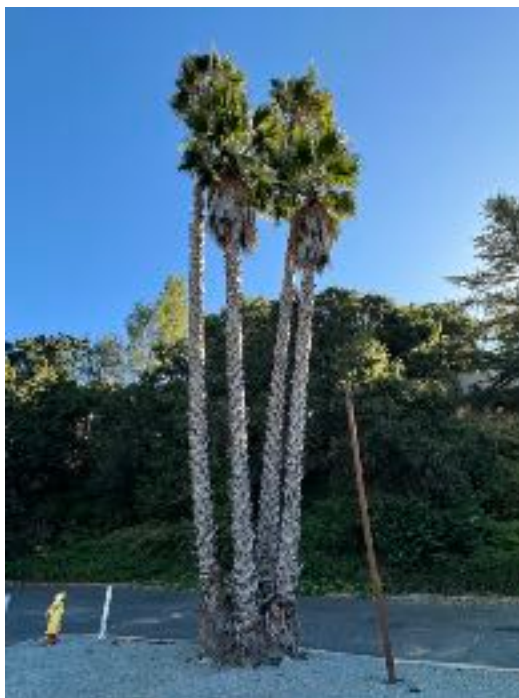
Tag 5021: Multiple trunks conjoined at the base, sharing a root system.
Root system is damaging the surrounding asphalt.

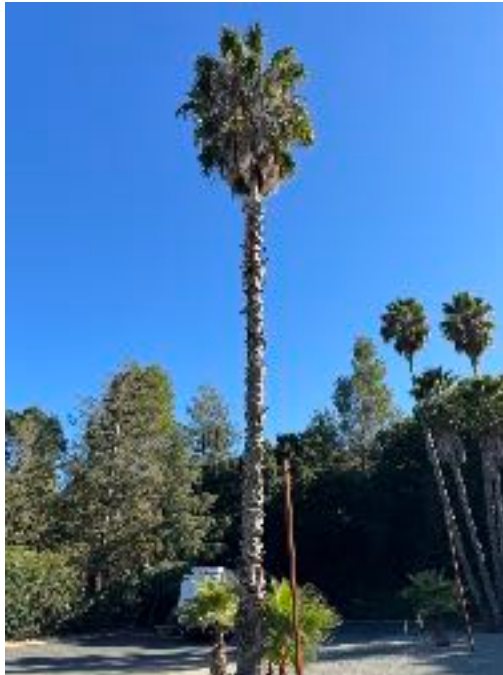
Tag 5022: Multiple volunteers growing from base of the trunk.

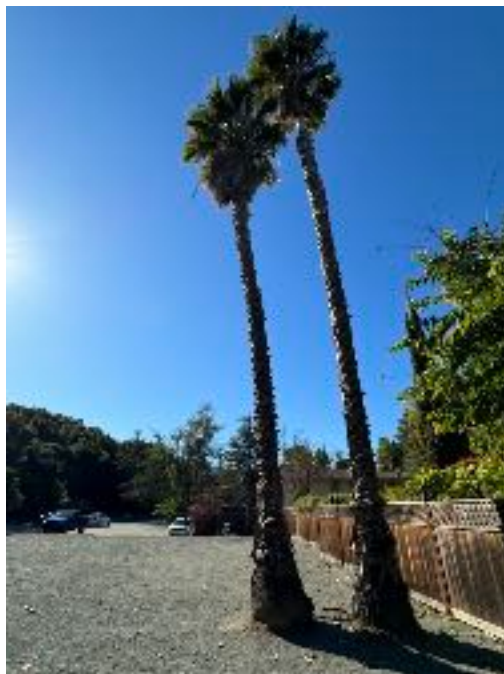
Tag 5023: Growing in close proximity to neighboring Mexican fan palm.

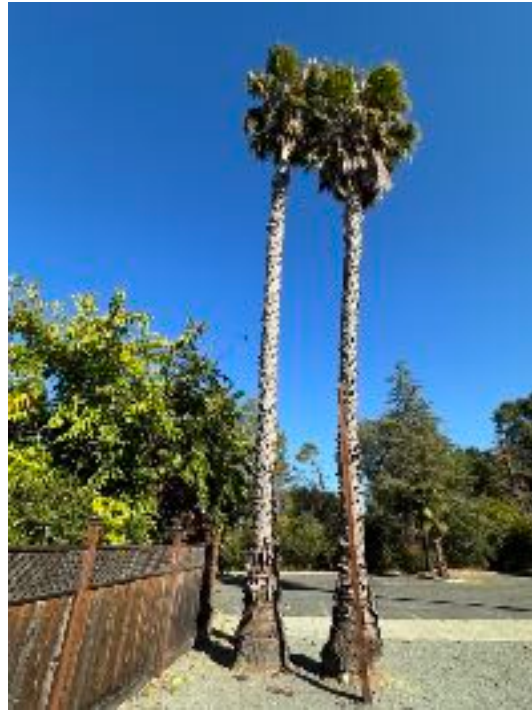
Tag 5024: Growing in close proximity to neighboring Mexican fan palm.

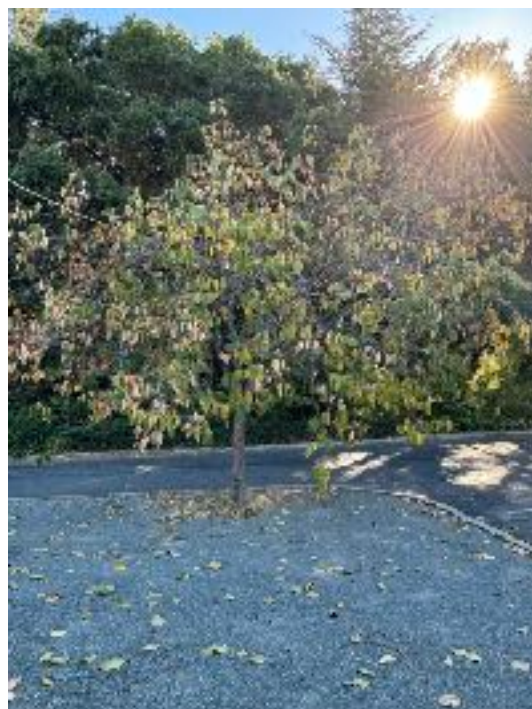
Tag 5025: Canopy skirt is approximately 3.5ft above grade at multiple points.

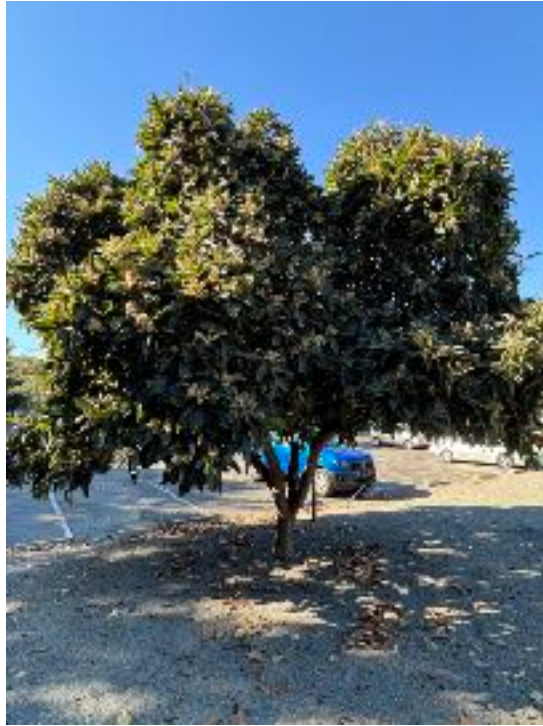
Tag 5026: Canopy overhangs adjacent parking spaces.

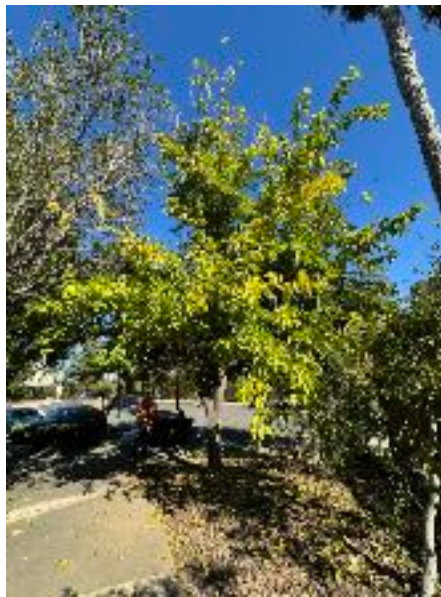
Tag 5030: Decay noted in the upper canopy.
Signs of cankering at the base of the trunk.
Mechanical damage on trunk.
Crossing limbs in canopy.

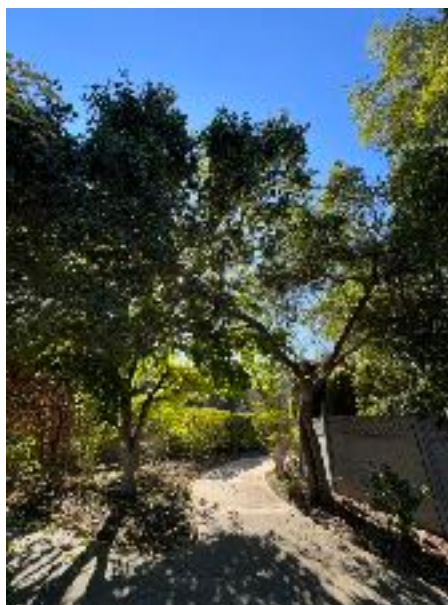
Tag 5031: Upper canopy colliding into hedge.
Limb hanging over walkway that could pose danger to pedestrians on path
Included bark noted at base of trunks.

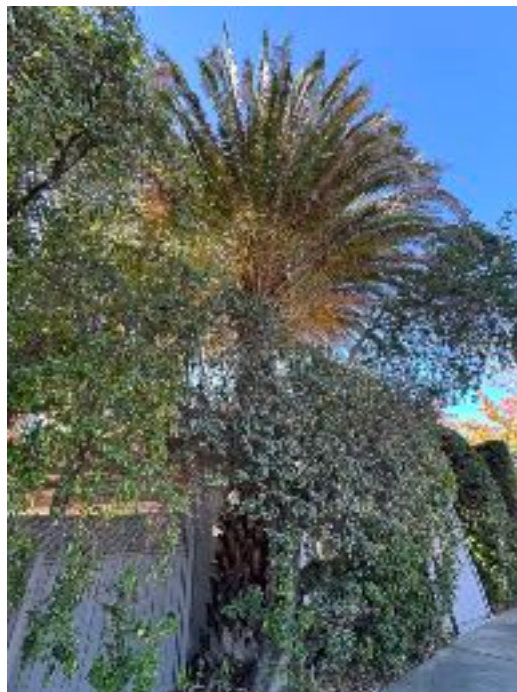
Tag 5033: Trunk is colliding with roof of the adjacent structure.

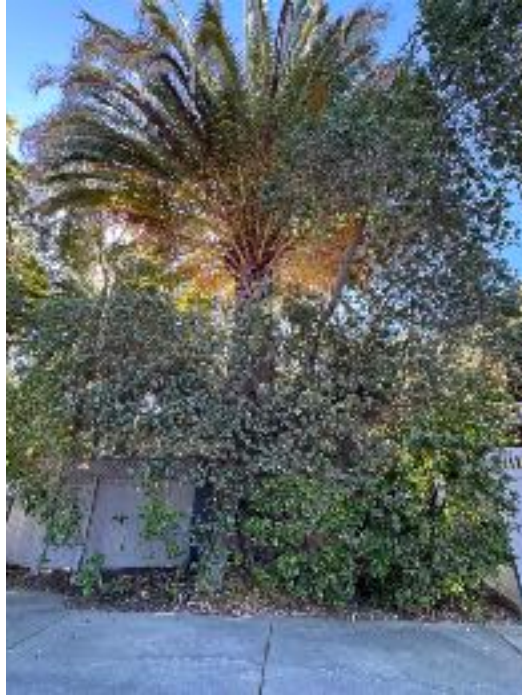
Tag 5034: Tree has been heavily pruned into a hedge structure, with only one upright extending over 15 feet tall.

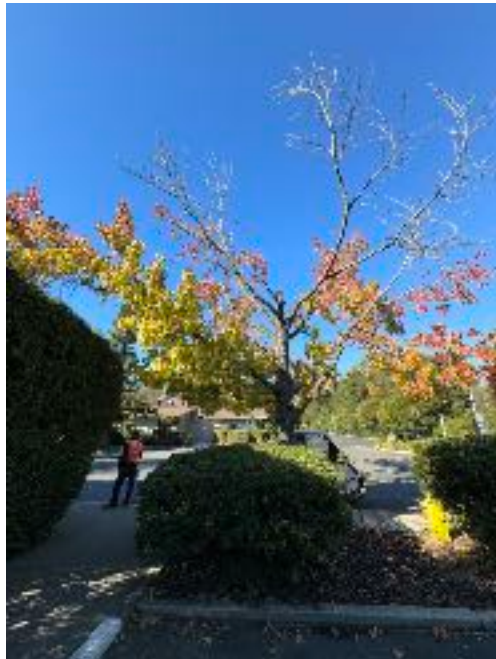
Tag 5035: Tree has been topped, significant deadwood in the canopy. Poor structure of canopy.

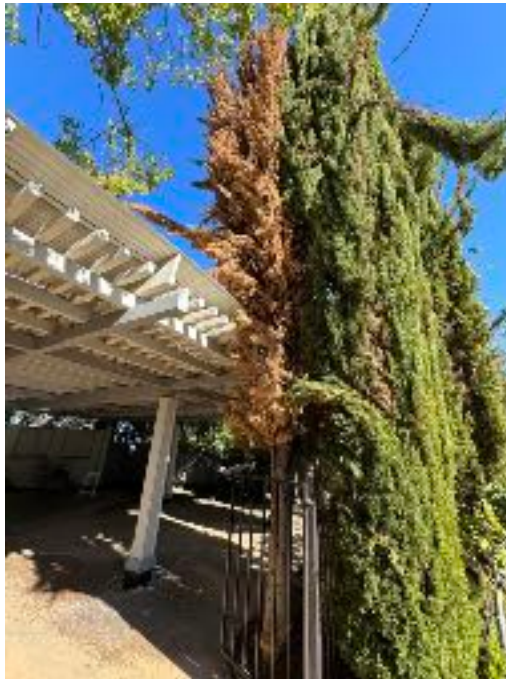
Tag 5037: Canopy growing in contact with roof of adjacent structure. Dead

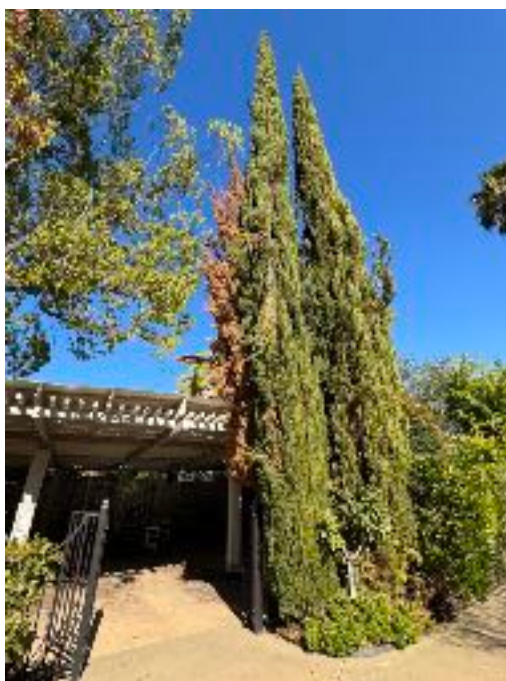
Tag 5038: No notable observations.

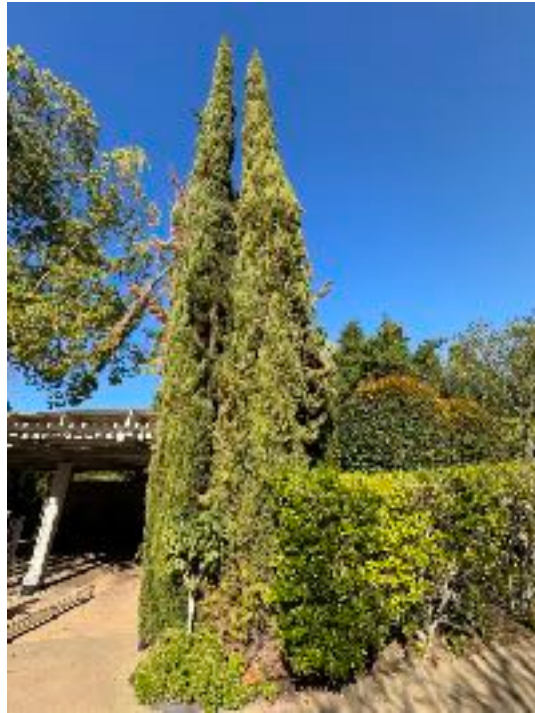
Tag 5039: No notable observations.

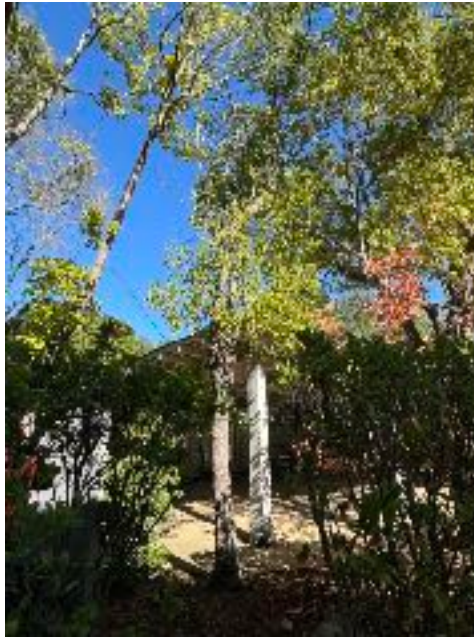
Tag 5041: Wires around limb are girdling the tree.
Genevie branches are extending over roof of adjacent structure.
Minor die back noted in canopy.

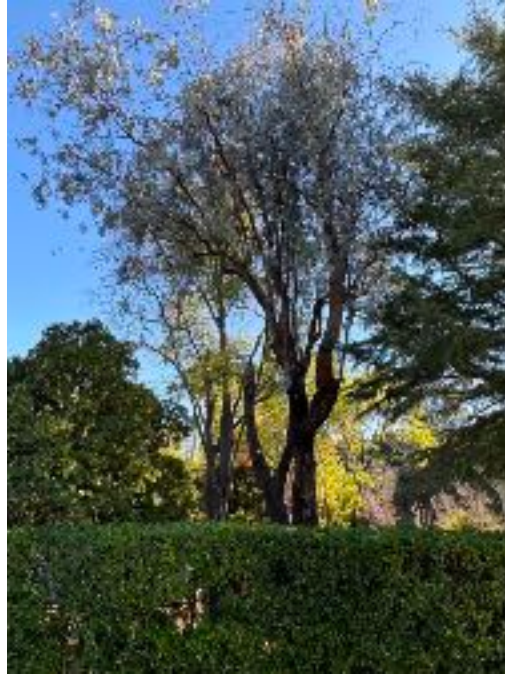
Tag 5045: Significant decay at the base of the trunk.
Poor structural integrity and has potential for failure.

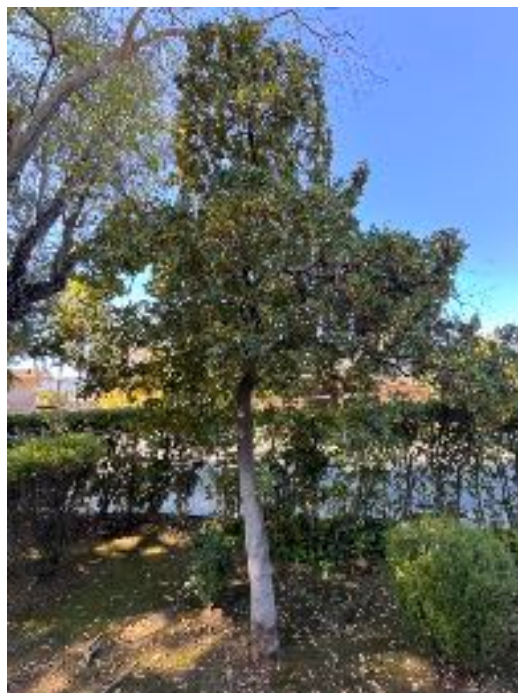
Tag 5046: Dead branch apparent in canopy.

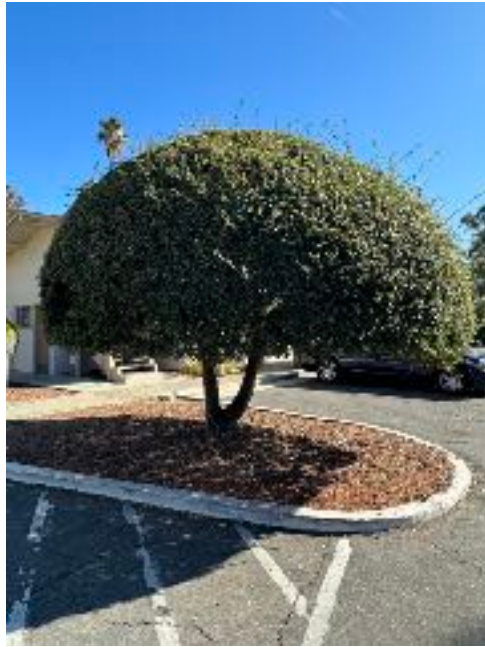
Tag 5047: No notable observations.

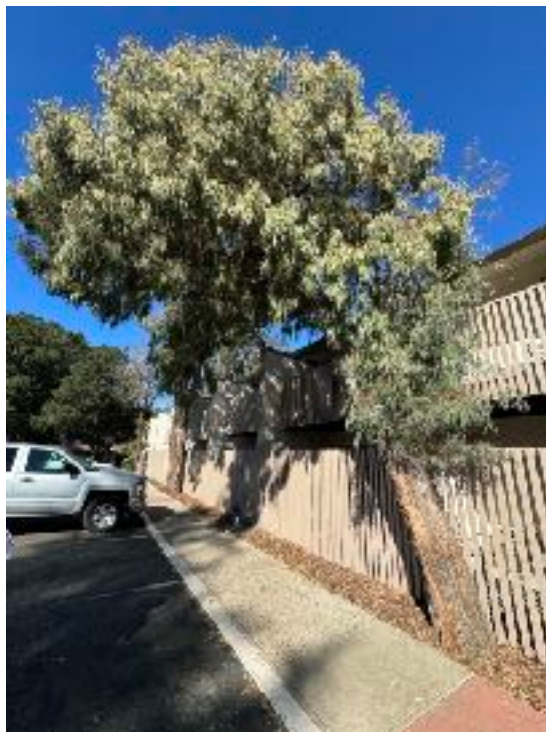
Tag 5048: Canopy has a significant lean to the southwest.

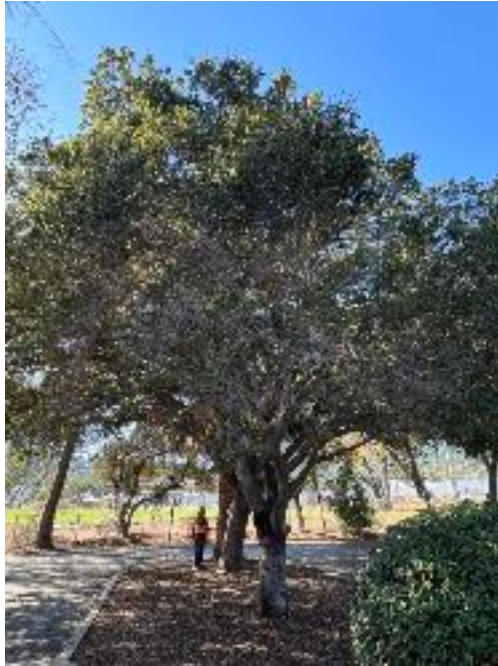
Tag 5051: Significant amount of dead limbs and decay noted in upper canopy.

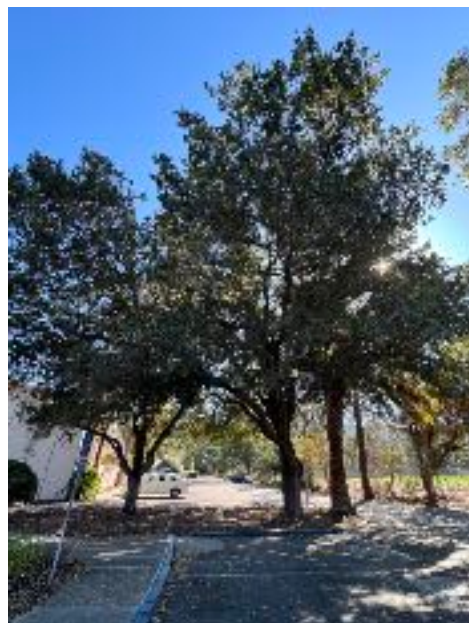
Tag 5052: Canopy has fused with adjacent canary island date palm. Moderate deadwood in upper canopy.

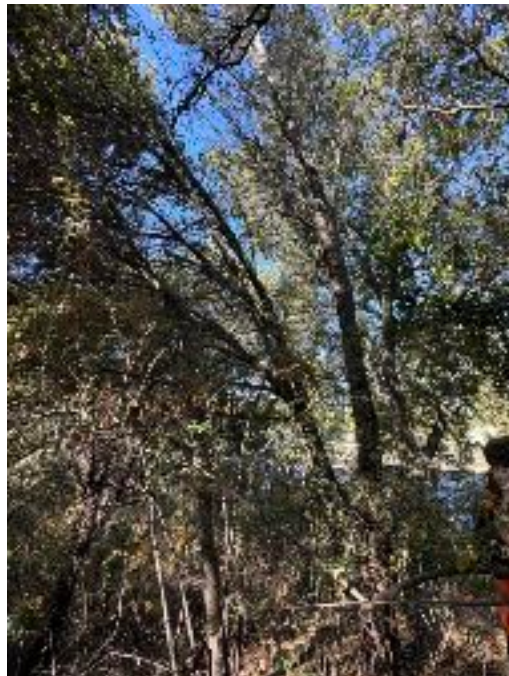
Tag 5056: Birds nest in canopy.
Minor deadwood noted in upper canopy.

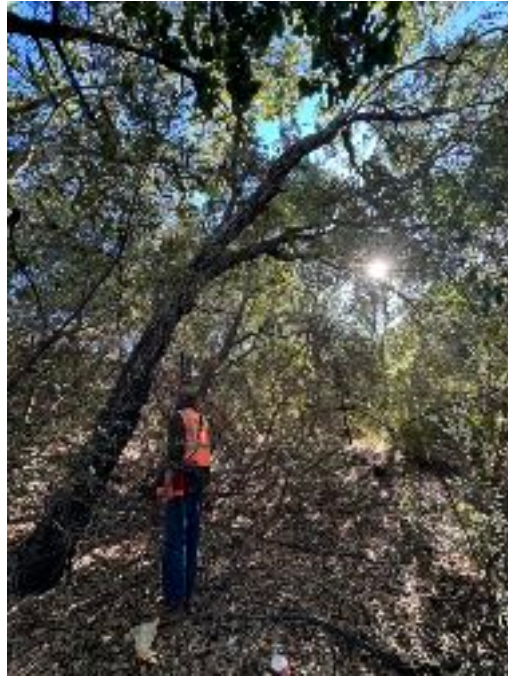
Tag 5057: Canopy is leaning towards the south west due to competition with neighboring oak trees for light.

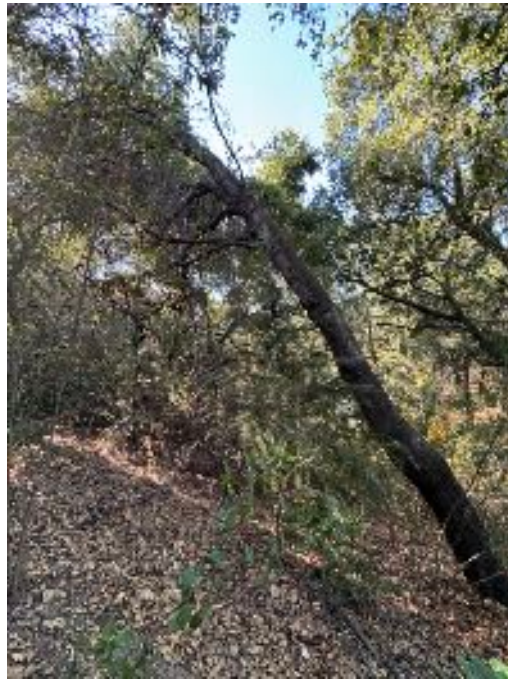
Tag 5059: Medium limb is conjoined with power pole, moderate deadwood in upper canopy, wound on main stem has evidence of decay

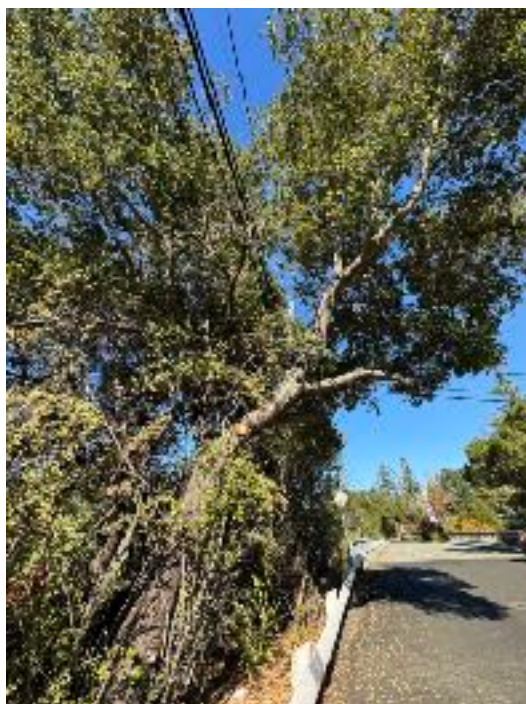
Tag 5060: Canopy is growing amongst the adjacent powerlines.

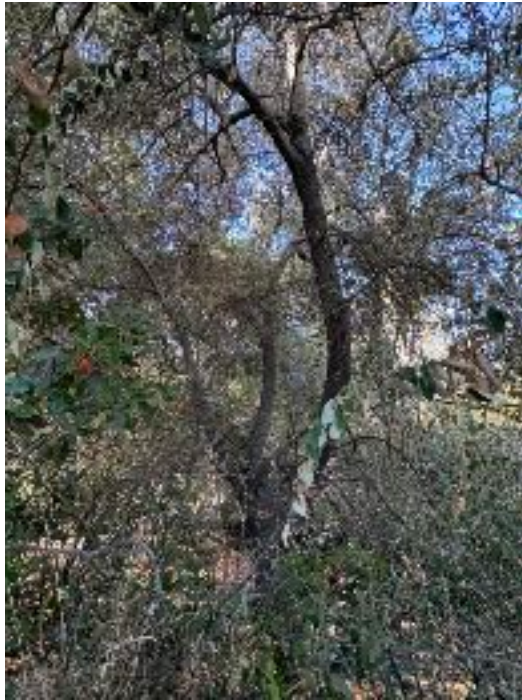
Tag 5061: Multiple dead limbs from itself and other trees have fallen into the canopy.

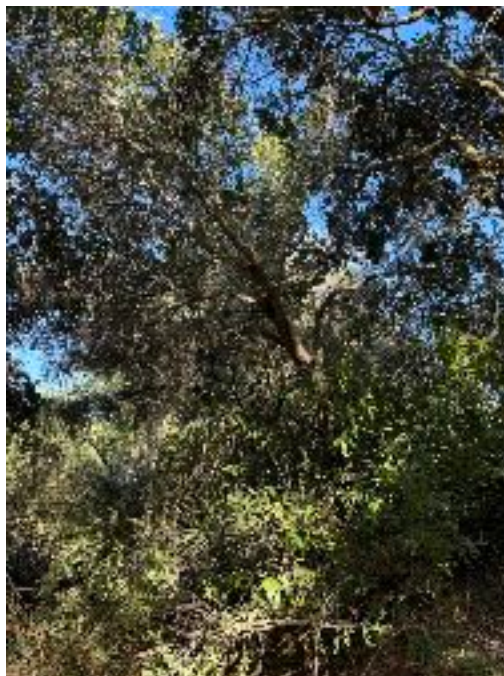
Tag 5062: Moderate die back and deadwood in lower canopy.

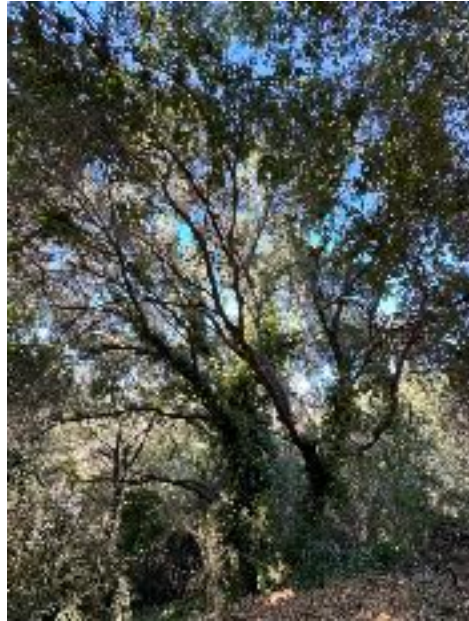
Tag 5063: Ivy Growing up main stem and main uprights, deadwood observed throughout canopy.

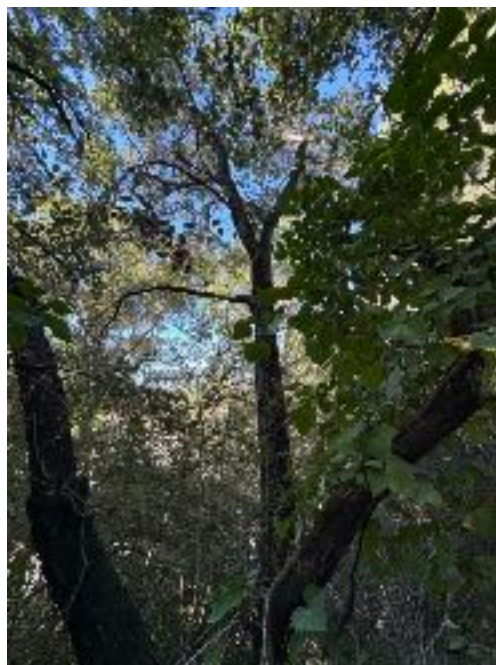
Tag 5064: Moderate deadwood throughout canopy.

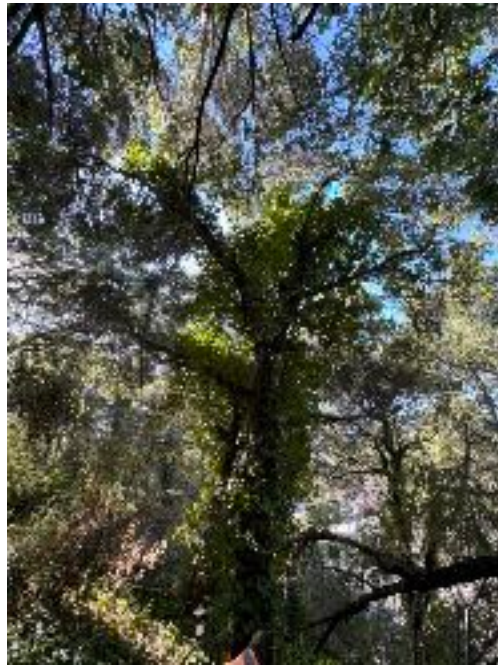
Tag 5065: Significant Ivy growing up main stem and into canopy.

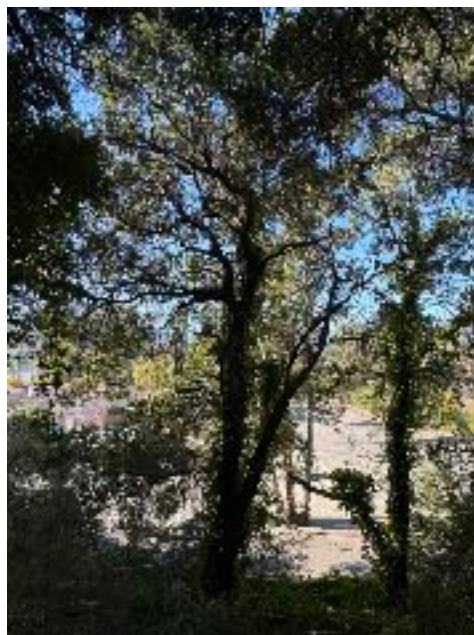
Tag 5066: Ivy growing up the main stem and both uprights up into canopy, moderate deadwood noted throughout canopy.

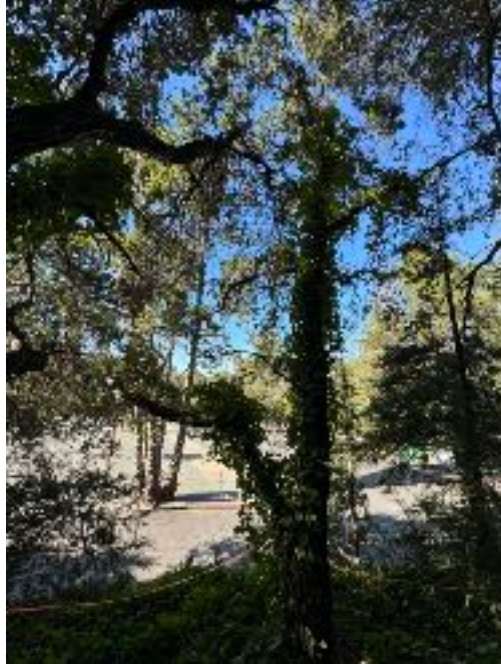
Tag 5067: Ivy is growing up main stem, and both uprights all the way up to the upper canopy.
Minor deadwood noted throughout canopy.

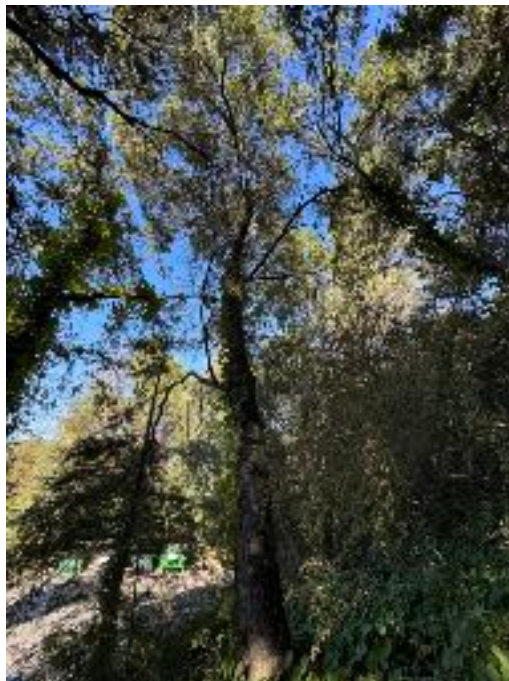
Tag 5068: Ivy growing up main stem.
Moderate deadwood noted throughout canopy.

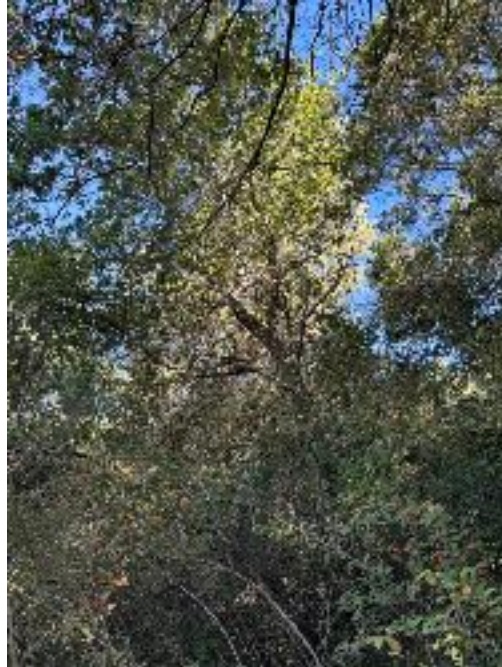
Tag 5069: Minor deadwood in lower canopy.

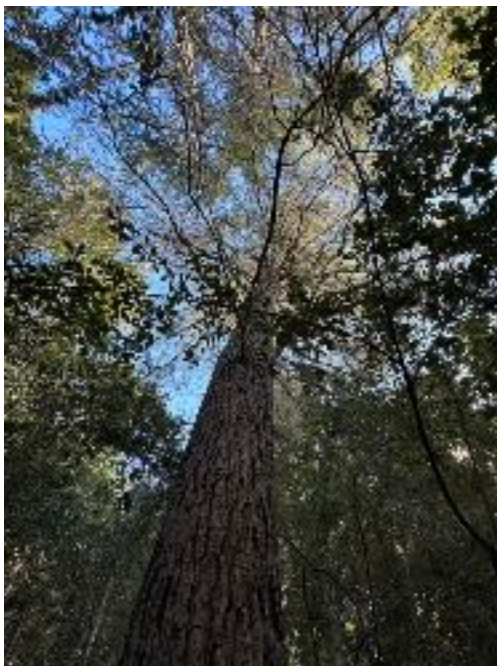
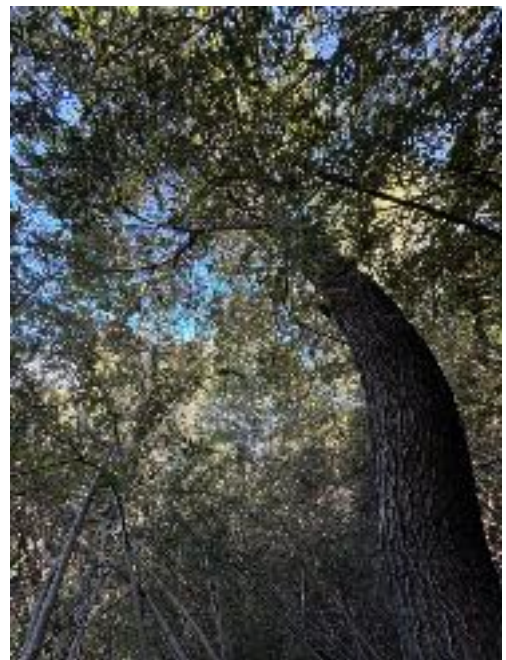
Tag 5070: Moderate deadwood in the canopy.

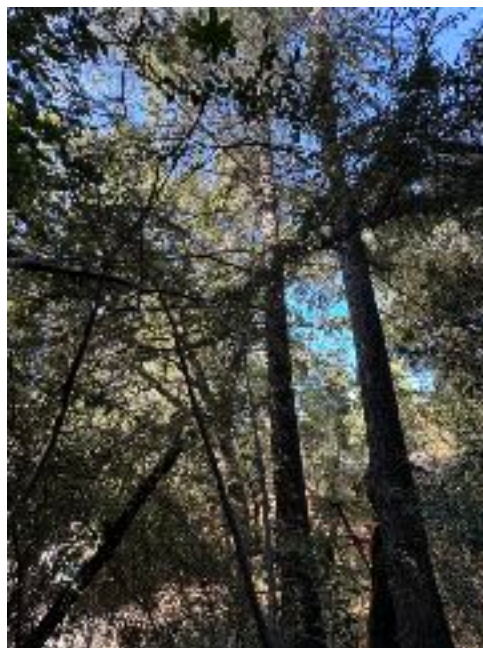
Tag 5072: Moderate deadwood noted throughout canopy.
