03/06/2024

Arborist Report

Client: Live Oak Associates - Attention: Katrina Krakow

Site: 50 Los Gatos-Saratoga Rd, Los Gatos CA

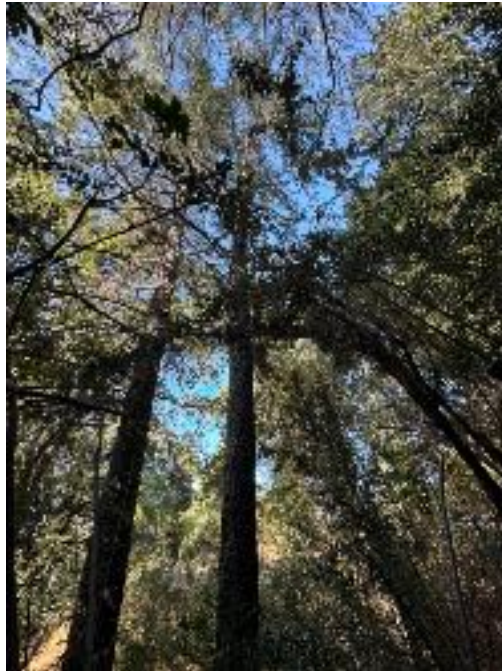
Tag 5073: Moderate deadwood noted throughout canopy.

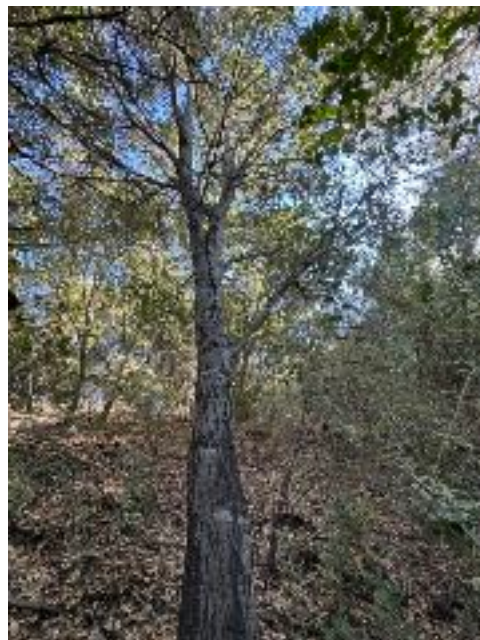
Tag 5074: Moderate deadwood noted throughout canopy

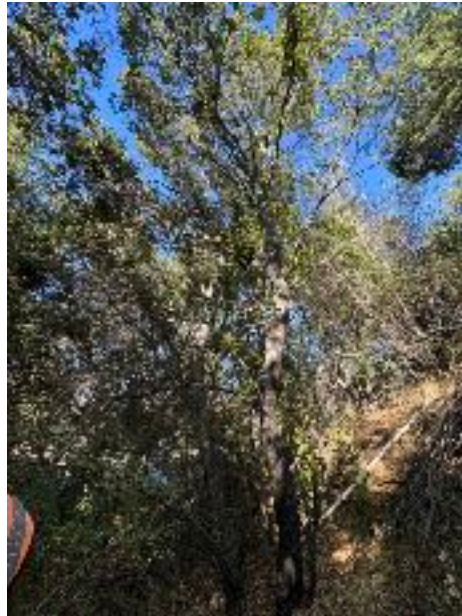
Tag 5075: Moderate deadwood noted throughout canopy

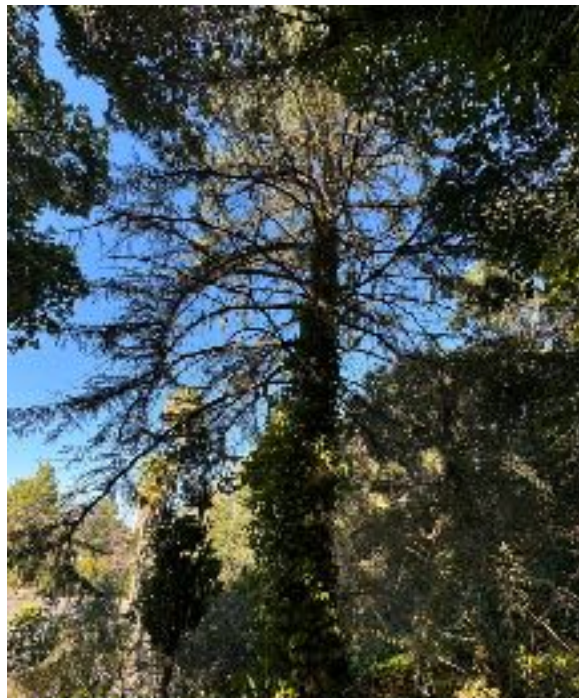
Tag 5076: Ivy growing up main stem to middle of the canopy. Moderate deadwood throughout canopy.

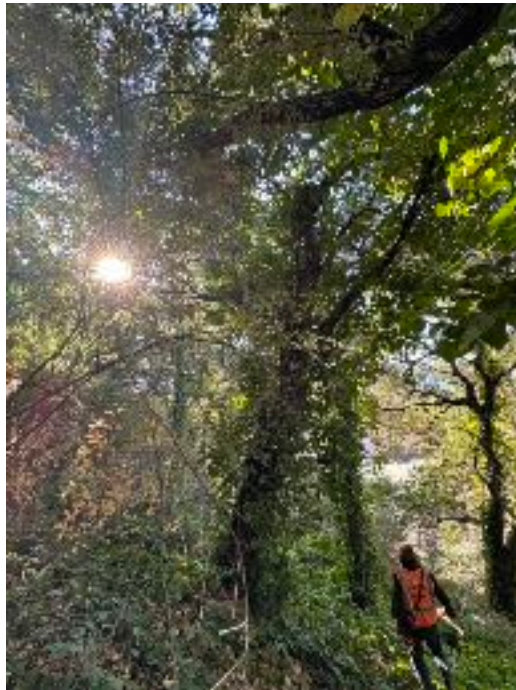
Tag 5077: Ivy growing up main stem and main uprights all the way to upper canopy.

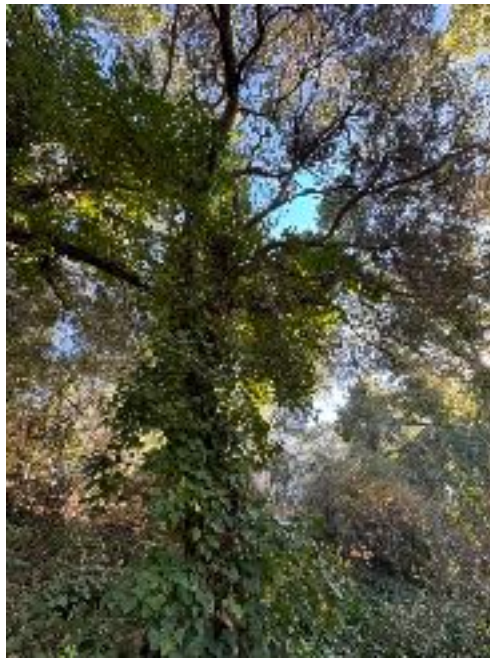
Tag 5079: Ivy growing up the main stem.
Moderate deadwood noted throughout canopy.

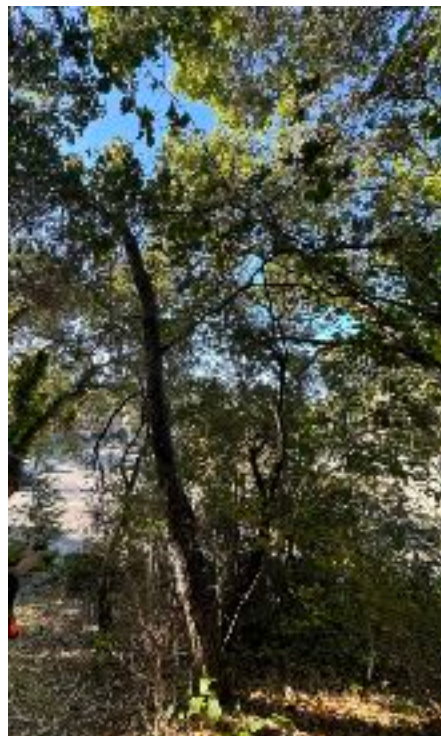
Tag 5080: Tree has a significant lean to the Westwood direction due to competition for light with neighboring oak trees.

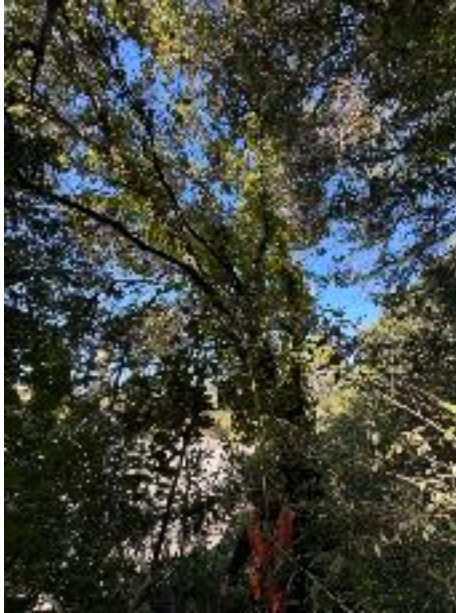
Tag 5081: Ivy growing up main stem, and main uprights to upper portion of the canopy.

Moderate deadwood noted throughout canopy.

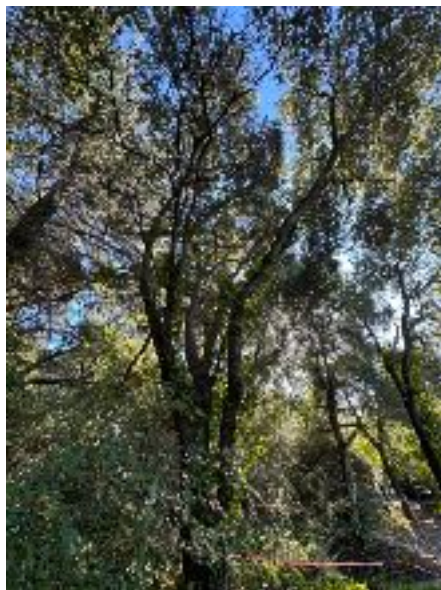
Tag 5082: Ivy growing up main Stan, and main uprights, deadwood noted throughout the canopy.

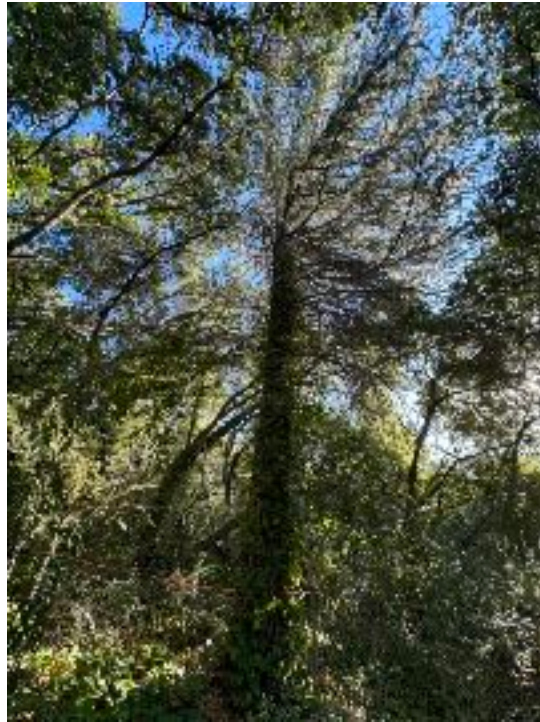
Tag 5083: Very significant deadwood throughout canopy.
Ivy growing up main stem to approximately 25-30 feet up the canopy.

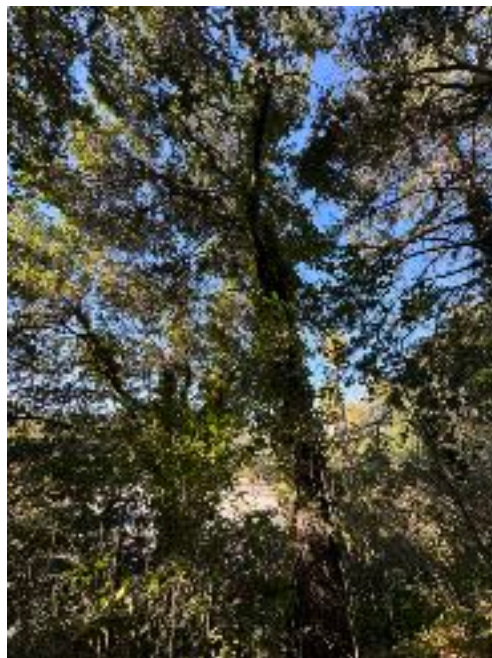
Tag 5084: Moderate deadwood throughout canopy.
Significant lean to the west due to competition for light.

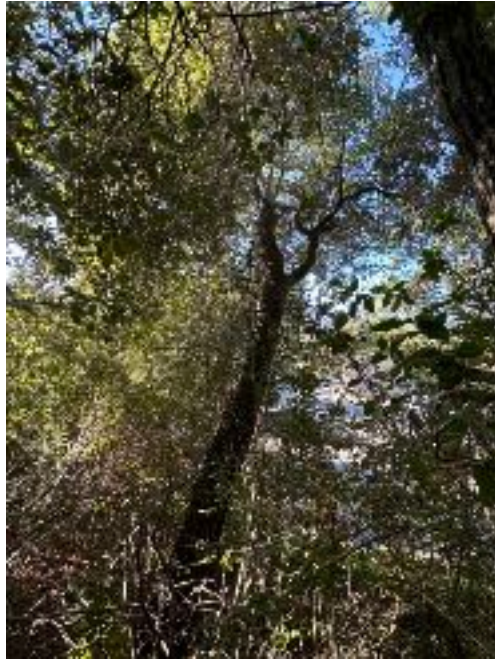
Tag 5085: Tree has a significant lean to the west due to competition with neighboring oak trees for light.

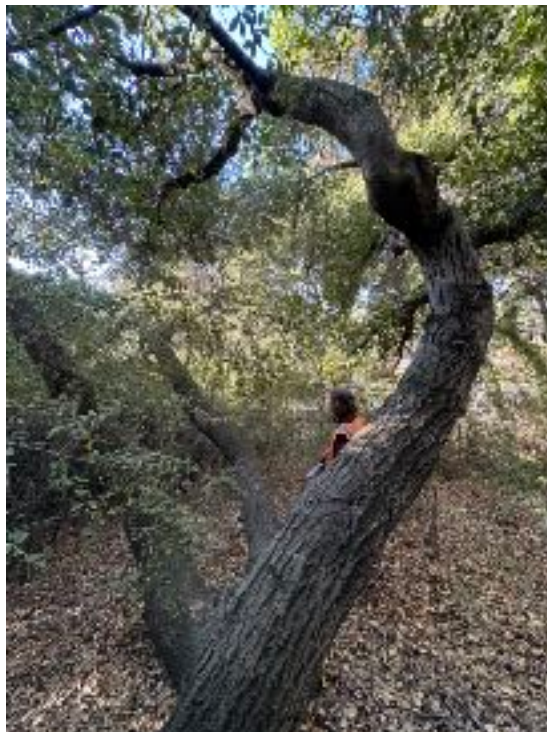
Tag 5086: Co-dominant uprights of the tree have a major lateral lean to the west.

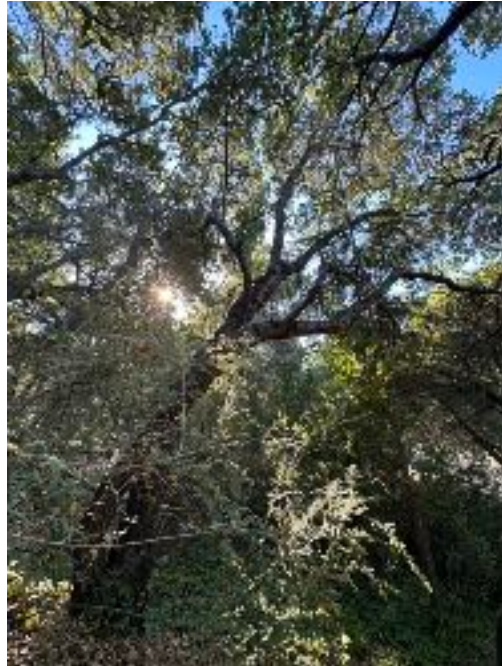
Tag 5087: Moderate deadwood canopy.

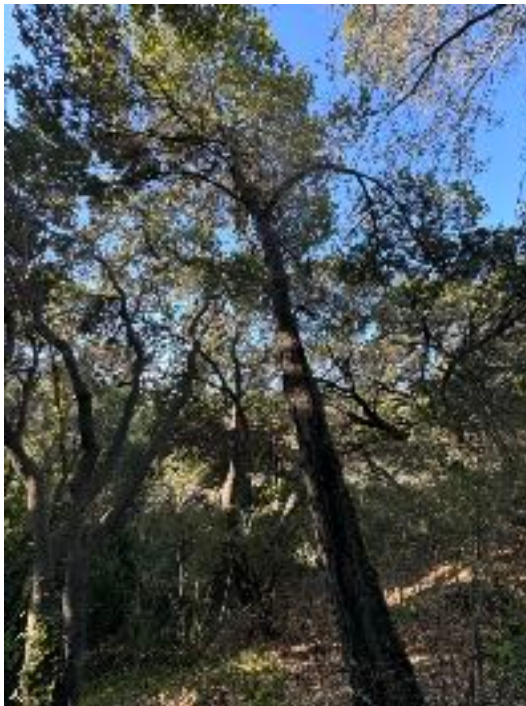
Tag 5088: No notable observations.

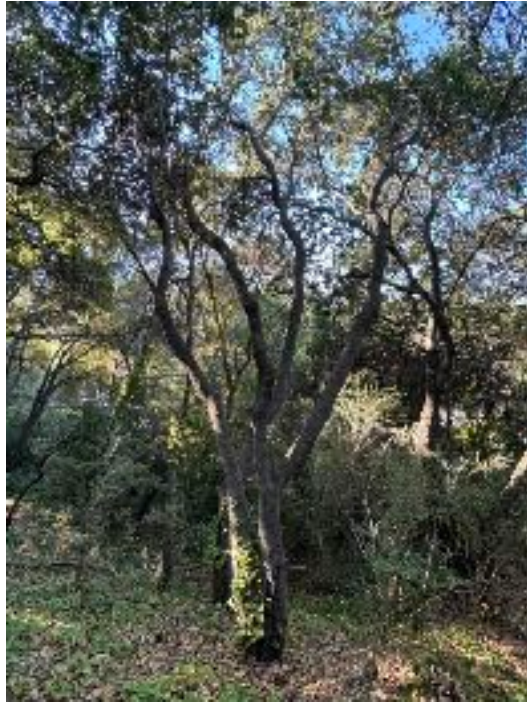
Tag 5089: Slight Ivy growing up main stem.
Moderate deadwood throughout canopy.

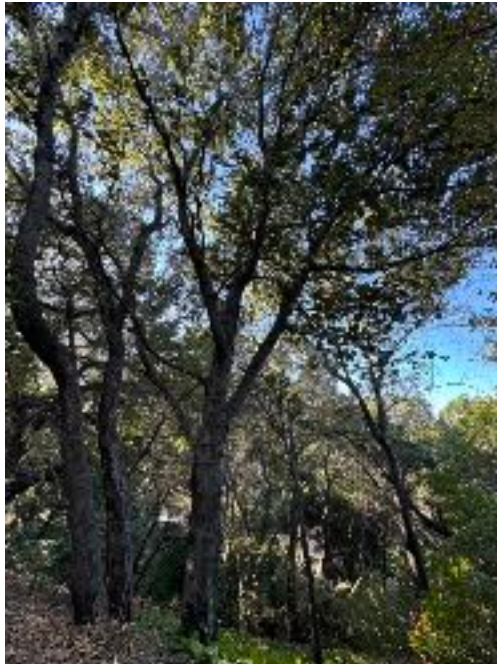
Tag 5091: Slight deadwood noted throughout canopy.

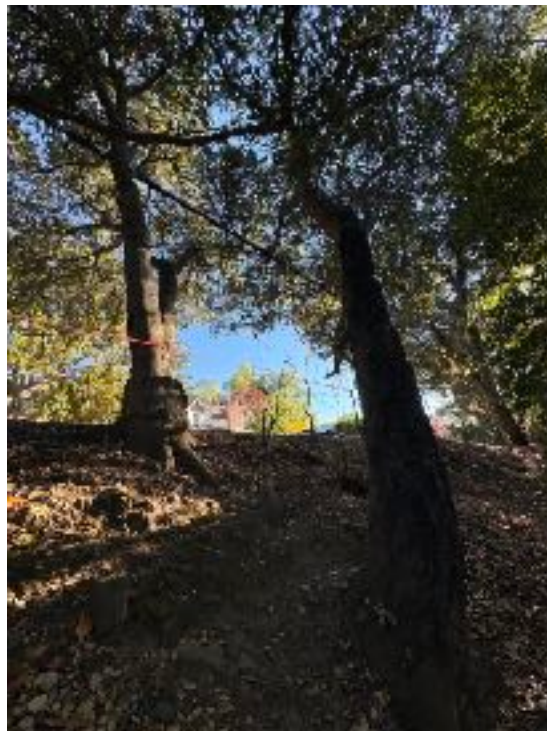
Tag 5096: Branches extending over the power cables and over the street.

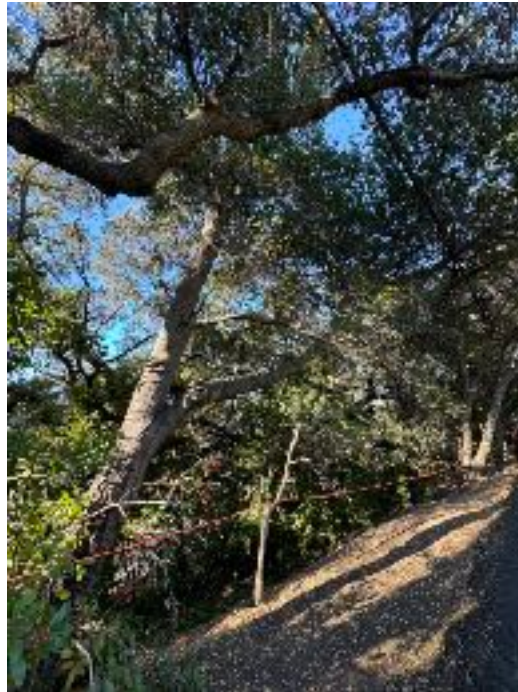
Tag 5097: Branches extending over the power cables and over the street.

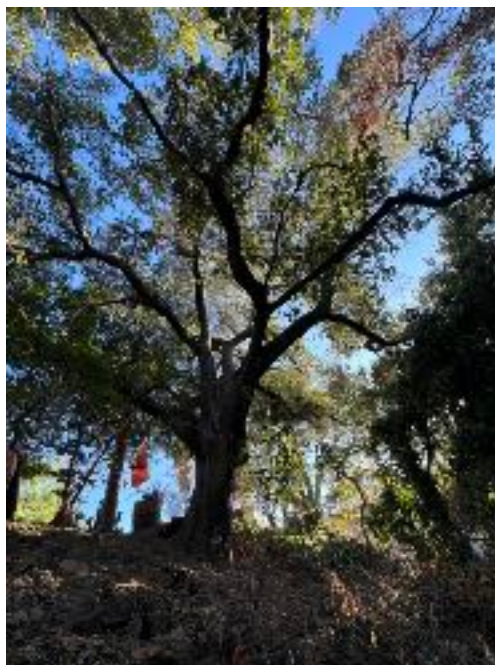
Tag 5098: Branches extending over the power cables and over the street.

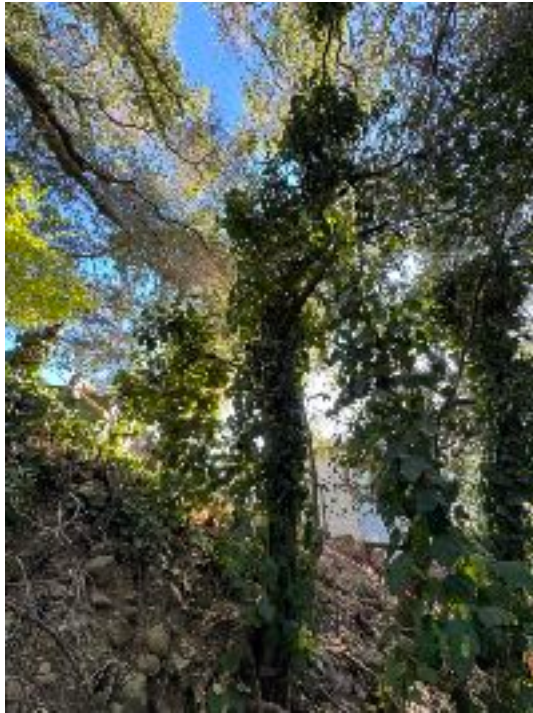
Tag 5099: Ivy growing on trunk throughout canopy.

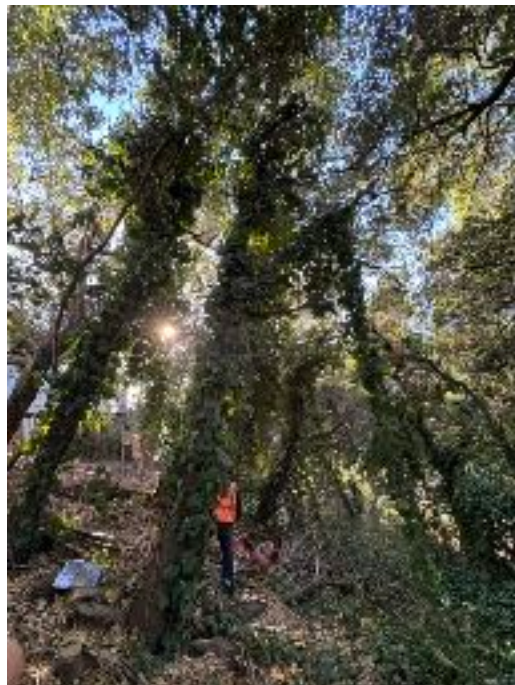
Tag 5100: Ivy growing on trunk throughout canopy.

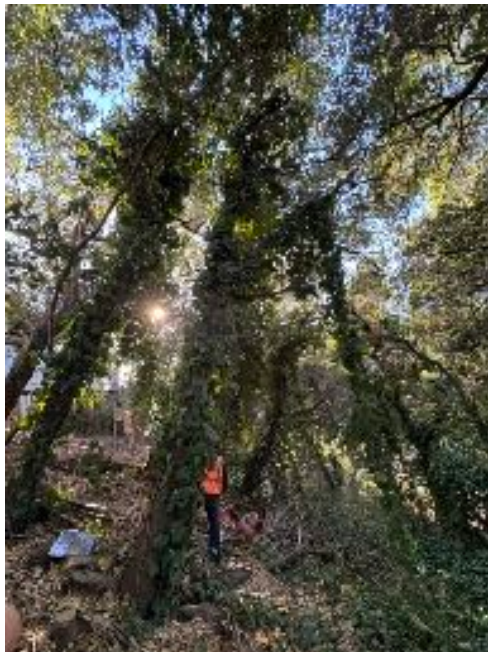
Tag 5101: Ivy growing on trunk throughout canopy.

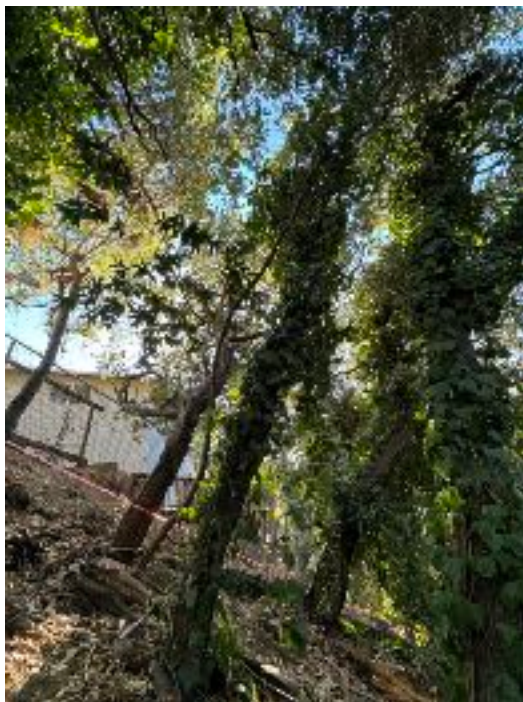
Tag 5102: Ivy growing on trunk throughout canopy.
Significant deadwood throughout canopy.

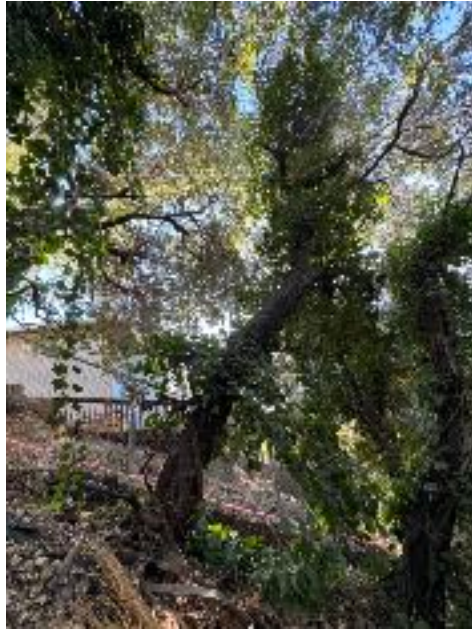
Tag 5103: Ivy growing on trunk throughout canopy.
Significant deadwood throughout canopy.

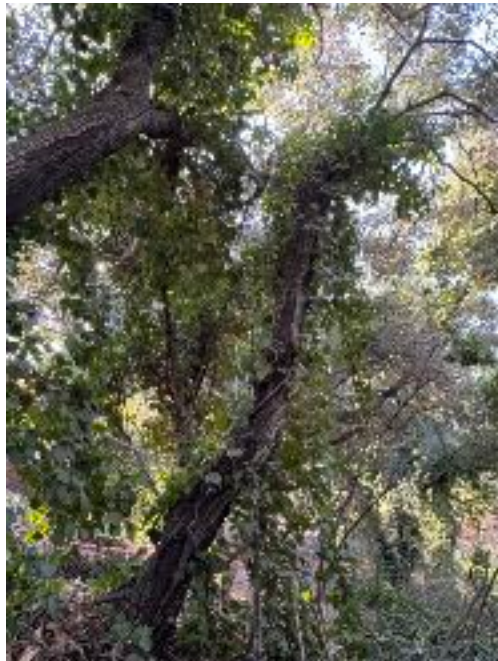
Tag 5104: Ivy growing on trunk throughout canopy.
Significant deadwood throughout canopy.

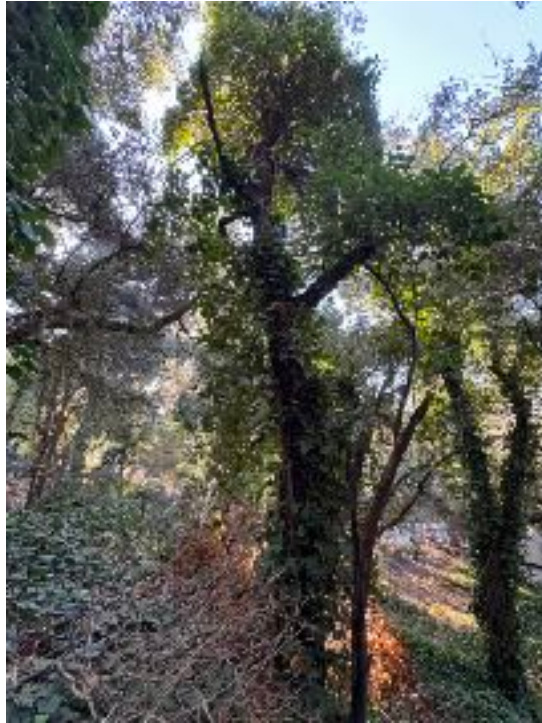
Tag 5105: Ivy is growing up trunk throughout branches and canopy.

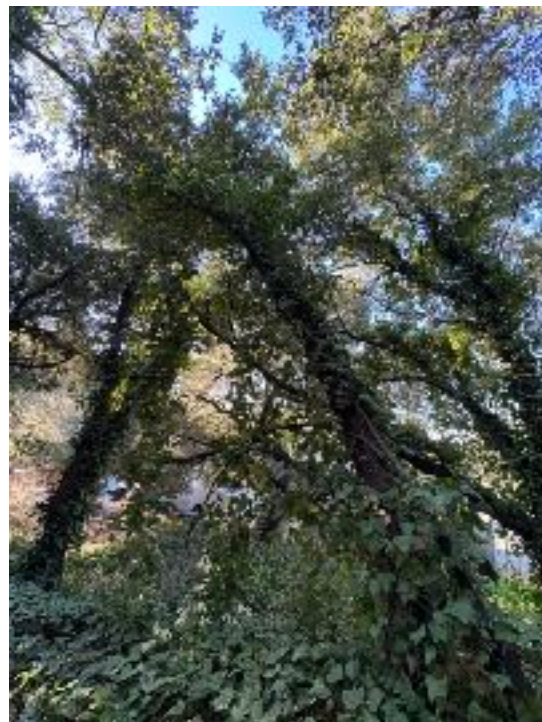
Tag 5106: Ivy is growing up trunk throughout branches and canopy. Tree has a significant westward lean.

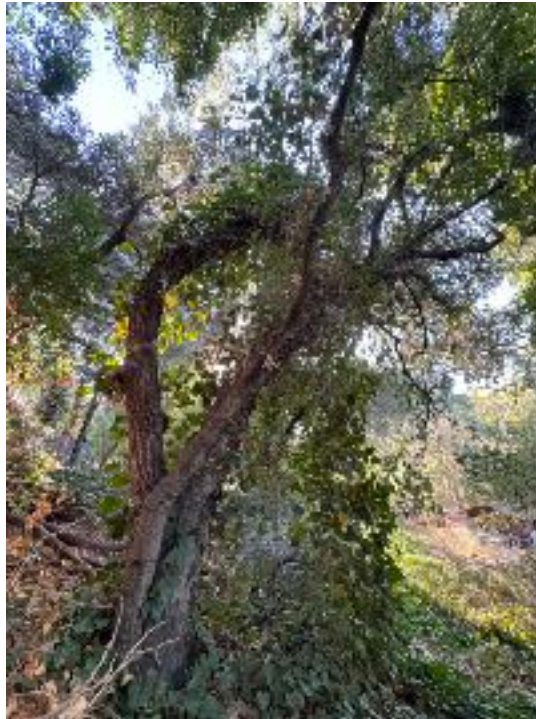
Tag 5107: Ivy is growing up trunk throughout branches and canopy. Tree has a significant westward lean.

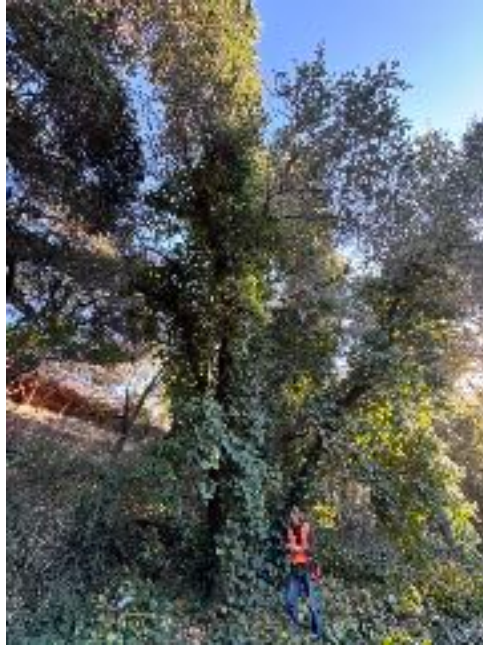
Tag 5109: Ivy is growing up trunk throughout branches and canopy. Moderate deadwood noted throughout canopy.

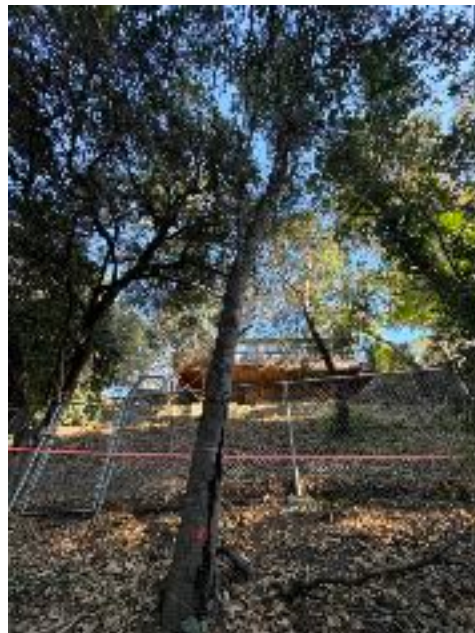
Tag 5110: Old vines from removed Ivy exist in upper canopy.

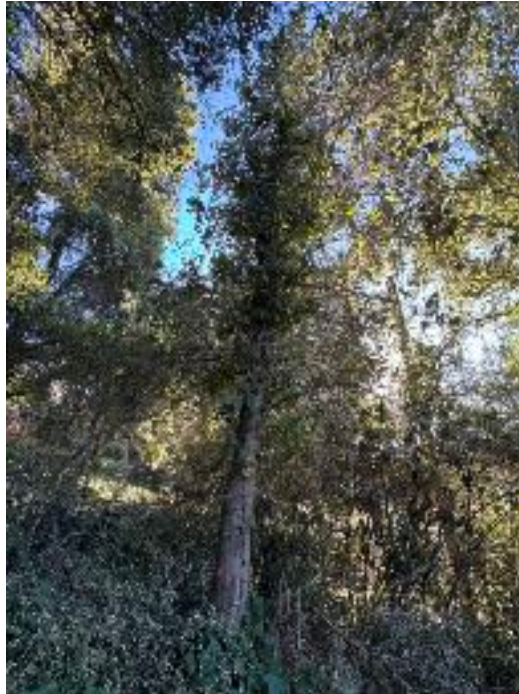
Tag 5111: Ivy growing up main stem to the upper canopy.

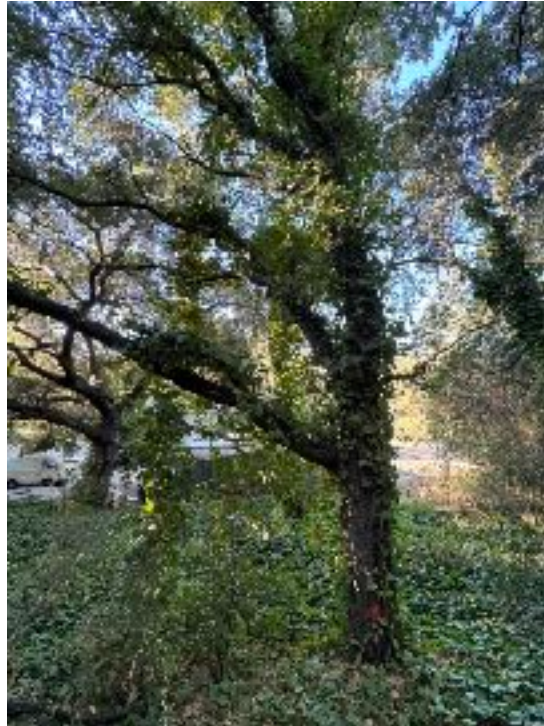
Tag 5113: Ivy growing up main-stem and throughout canopy.

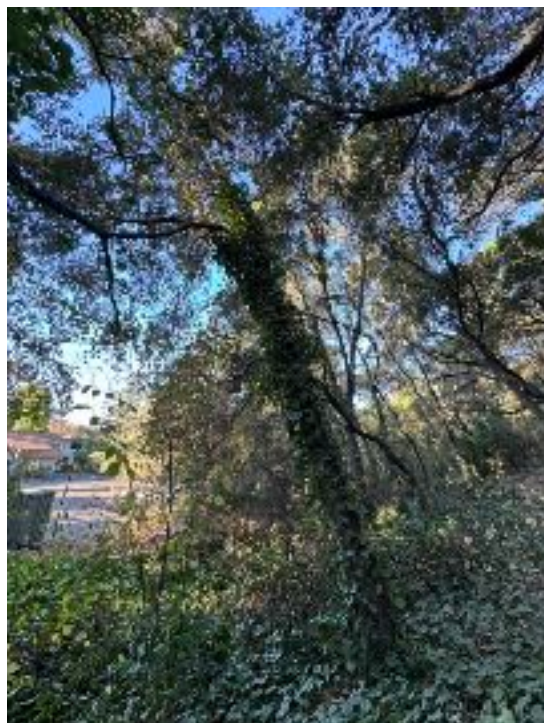
Tag 5114: Ivy growing up main-stem and throughout canopy.

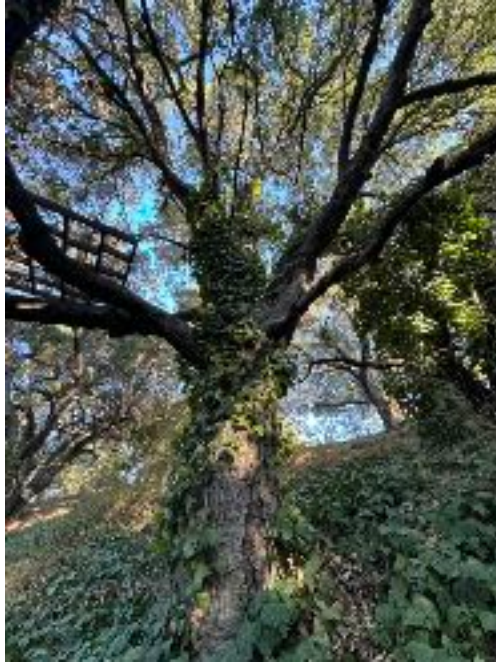
Tag 5115: Ivy growing up main stem and throughout canopy.
Significant deadwood throughout canopy.
Partially constructed tree house.

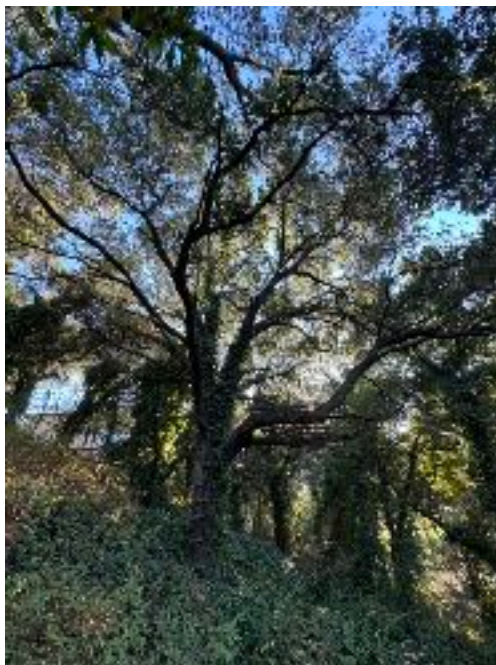
Tag 5116: Minor deadwood in canopy.

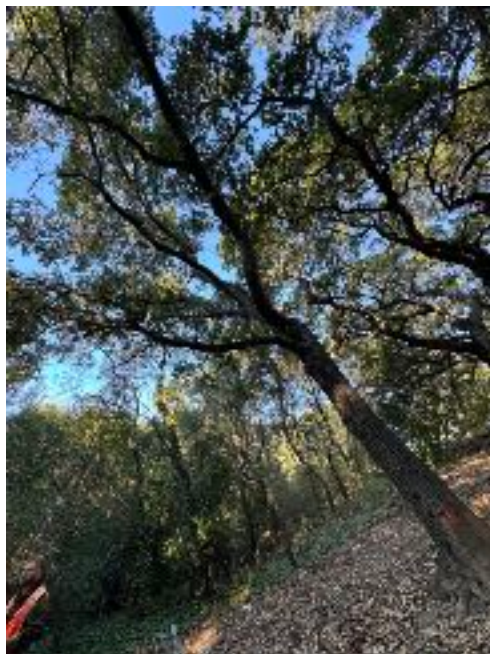
Tag 5118: Significant deadwood throughout canopy, tree has a Westward lean.

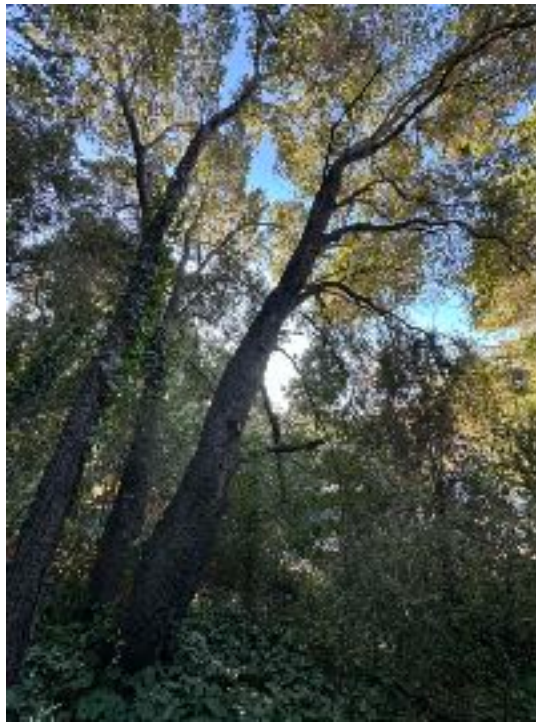
Tag 5121: Tree has a westward lean.

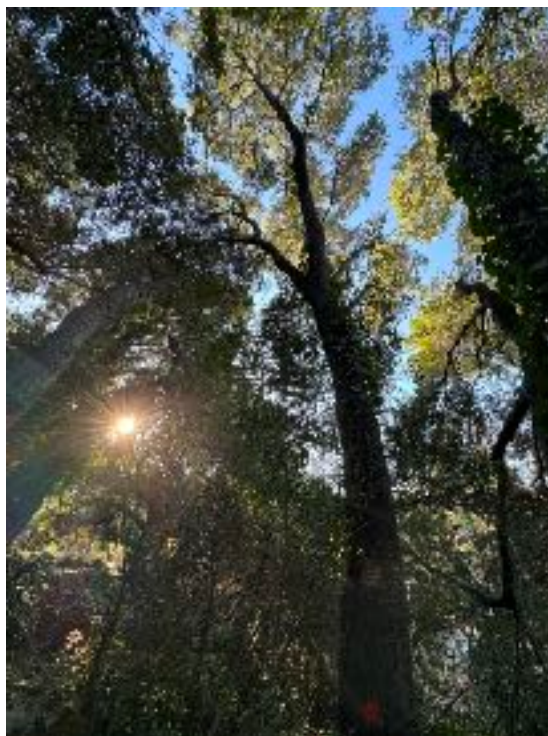
Tag 5122: Ivy growing up main stem.
Tree has a significant westward lean.

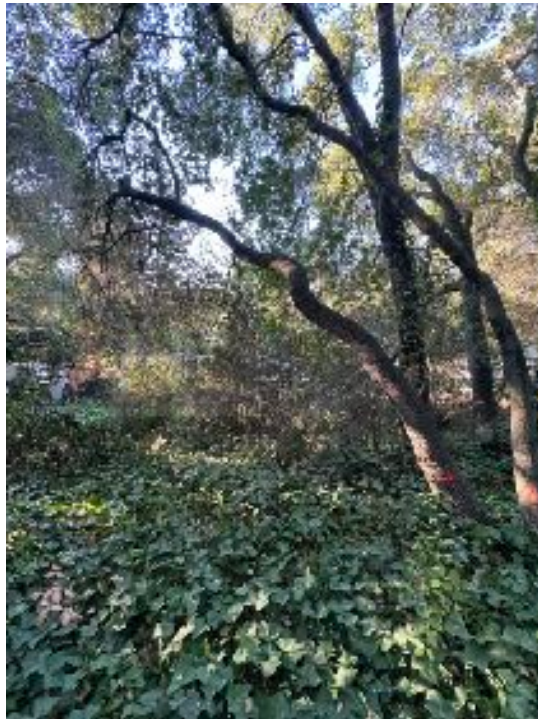
Tag 5123: Ivy is growing up the main stem of the tree, moderate deadwood.

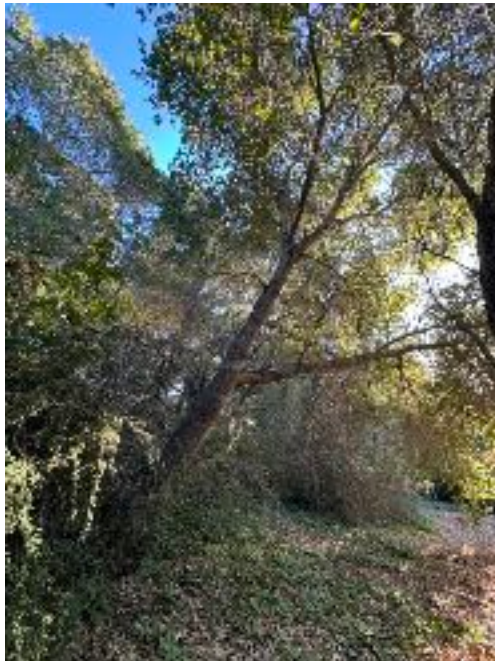
Tag 5125: Moderate deadwood noted throughout canopy.
Tree has a significant Westward lean.

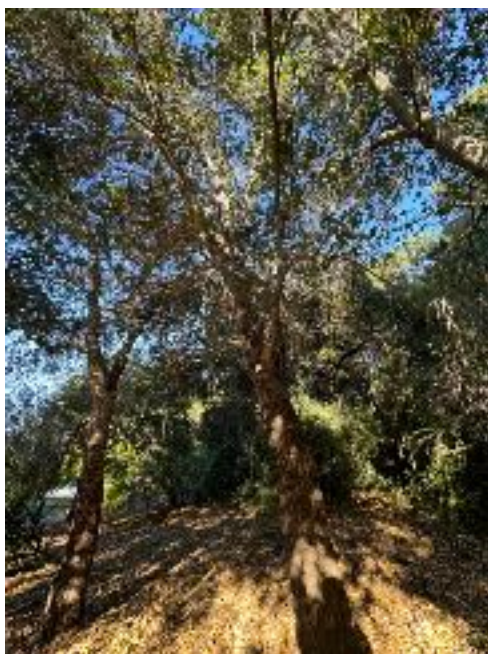
Tag 5126: Moderate deadwood noted throughout canopy.

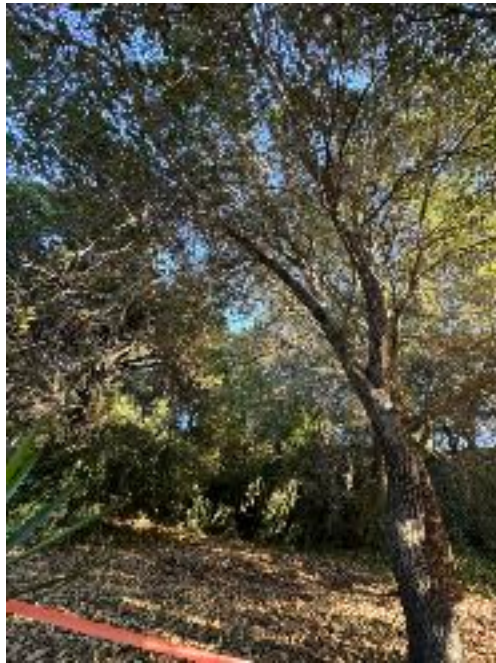
Tag 5127: Tree has a significant Northwest lean.

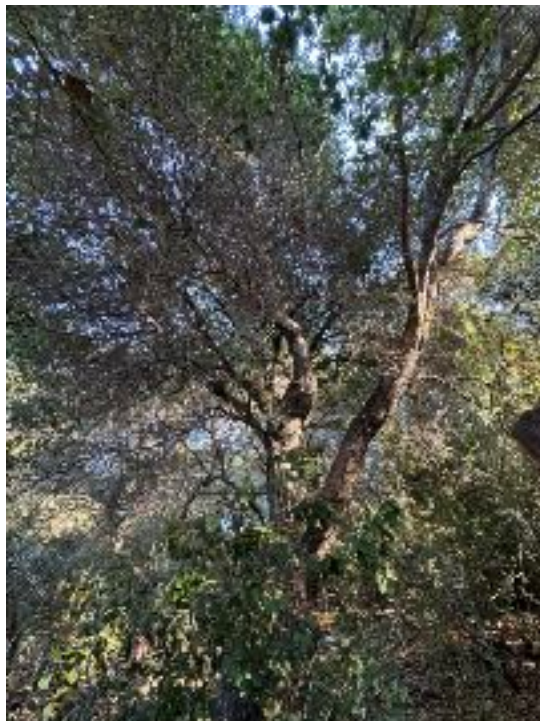
Tag 5128: Moderate deadwood throughout canopy.

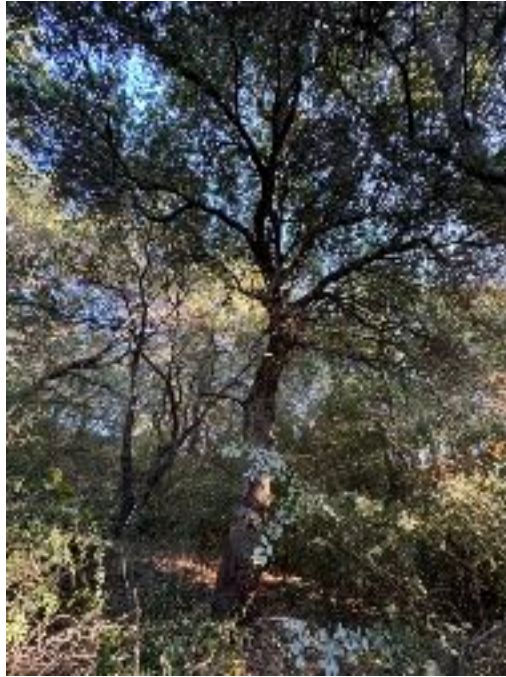
Tag 5129: Moderate deadwood throughout canopy.

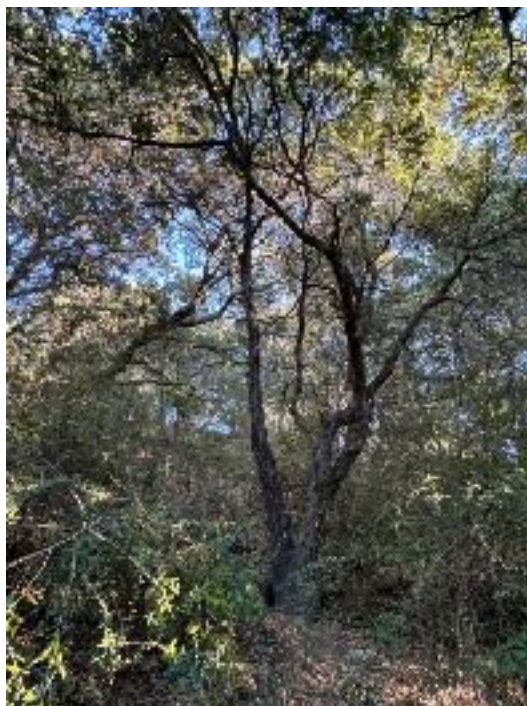
Tag 5130: Moderate deadwood throughout canopy.

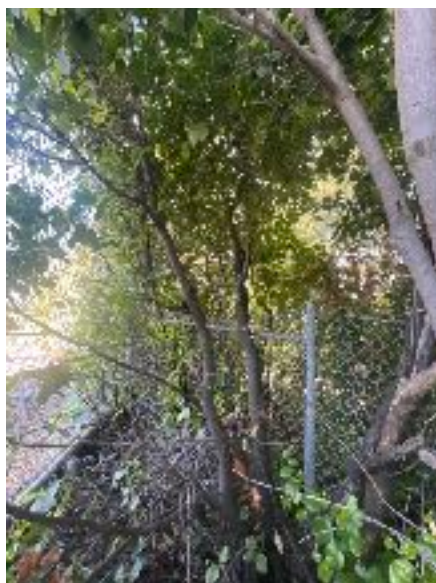
Tag 5417

This tree has a northern lean, the original main stem of this tree died, resulting in multiple epicormic shoots growing from the root flare that currently comprise the main uprights.

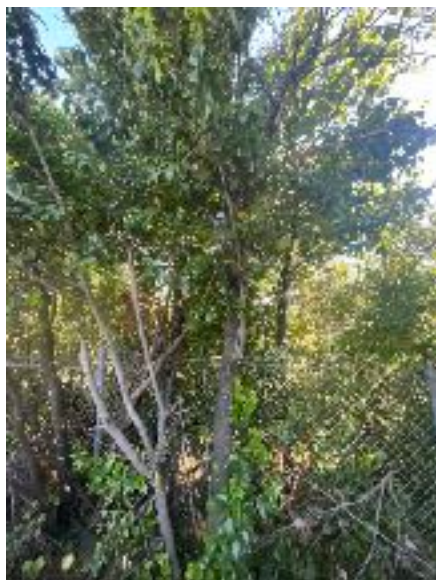
Tag 5418

This tree is growing along the perimeter chain-link fence. This tree has moderate die back in the canopy.

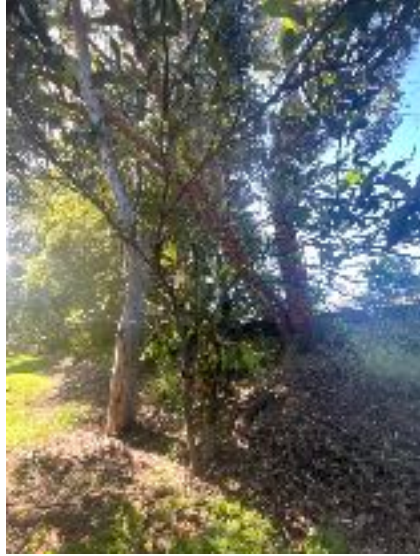
Tag 5419

Foliage from large neighboring eucalyptus trees are growing over the canopy. This tree has significant die back noted in the canopy due to lack of sunlight.

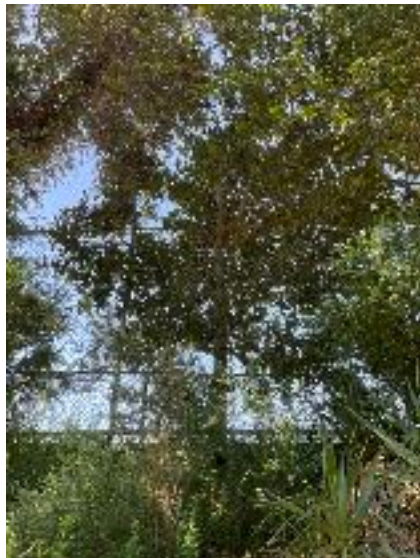
Tag 5420

The canopy of this tree is matted against the chain-link fence.

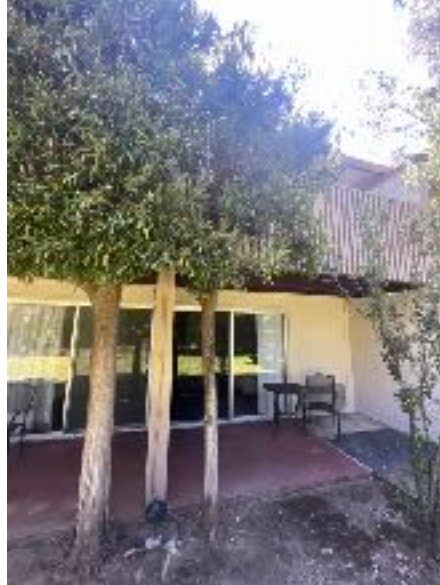
Tag 5421

Canopy of this tree is growing into the balcony of the property structure.

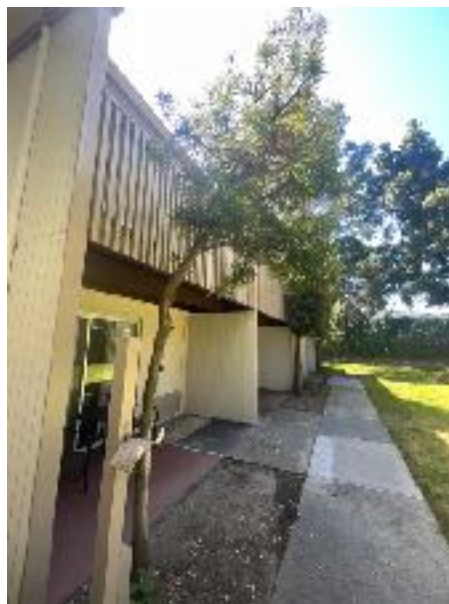
Tag 5422

This tree's canopy is growing with a significant northern lean, due to pruning of branches growing towards the structure to the south.

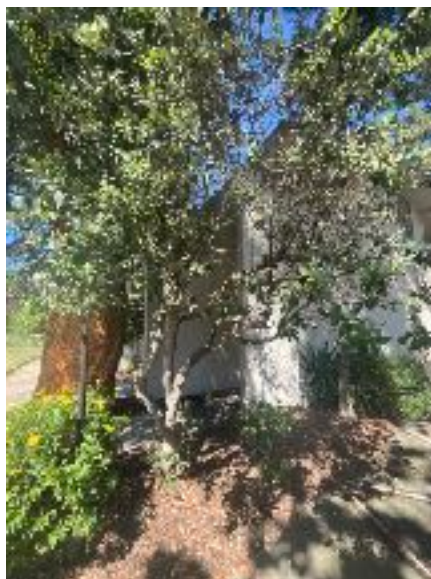
Tag 5424

Tree has a large canker in the main stem. Significant die back noted in the canopy. Minor decay. Cavities noted throughout the uprights.

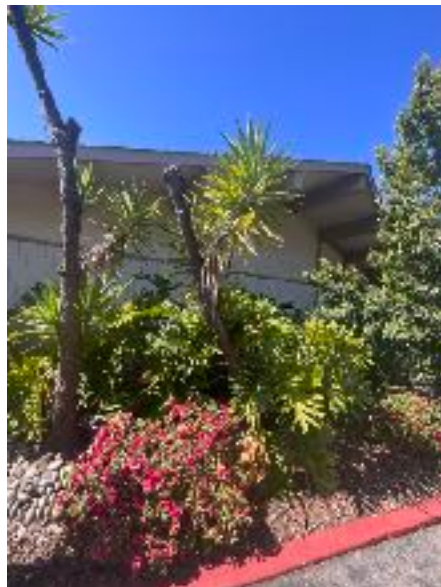
Tag 5426

This tree has significant decay cavities, is in very poor condition.

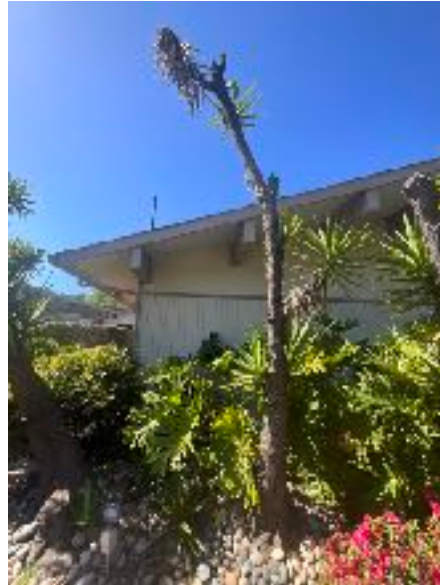
Tag 5427

This tree has significant decay cavities, is in very poor condition.

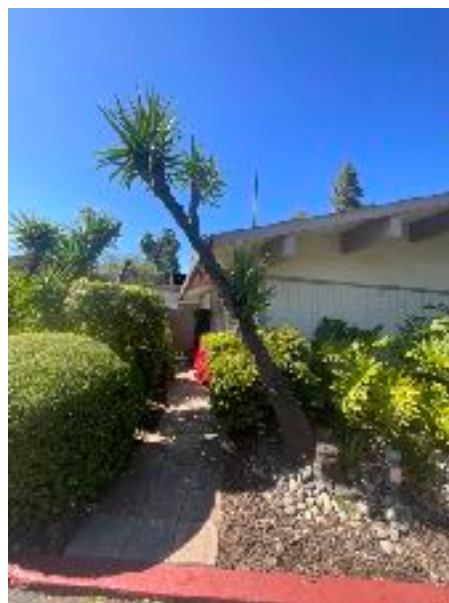
Tag 5428

This tree has a significant southern lien, and is in very poor condition.

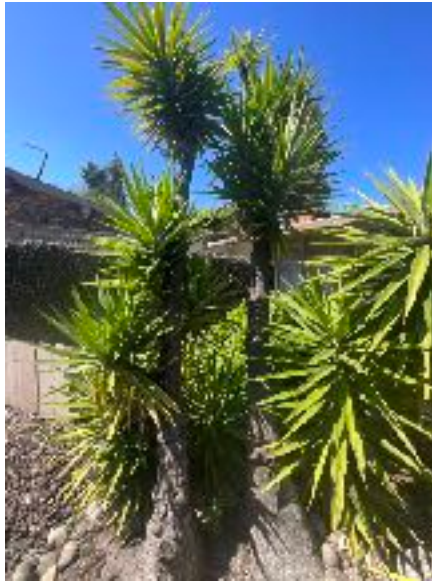
Tag 5429

There are two main uprights growing from the root flare. Significant decay on the main stems.

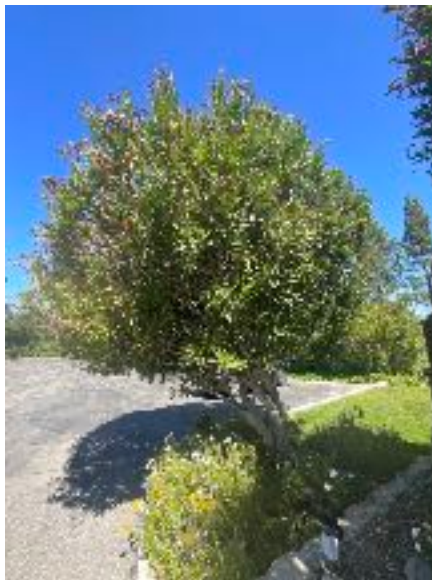
Tag 5430

Included bark between multiple uprights.

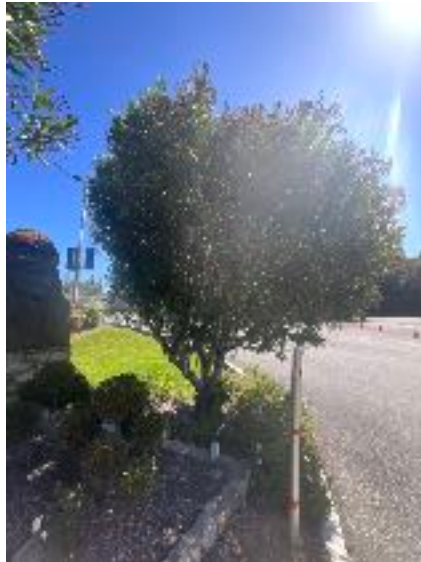
Tag 5431

Included bark between multiple uprights

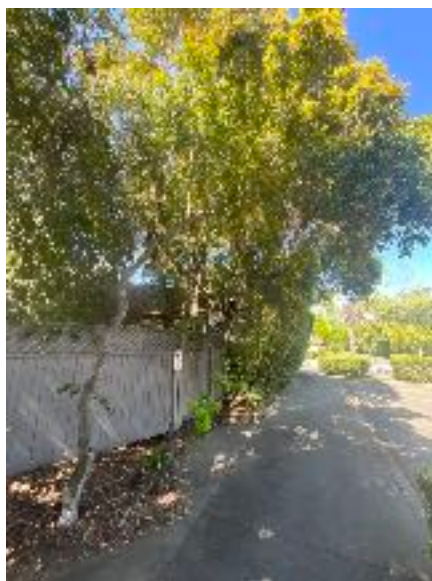
Tag 5432

This tree has a significant eastern lean due to the canopy being shaded by neighboring trees.

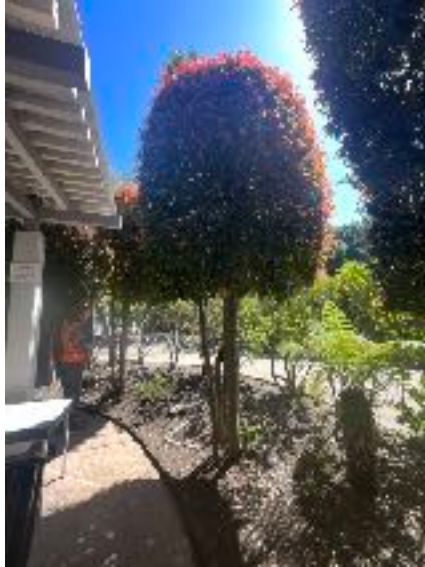
Tag 5433

This tree has multiple uprights growing from the roof flare. This tree has included bark between two of the main uprights.

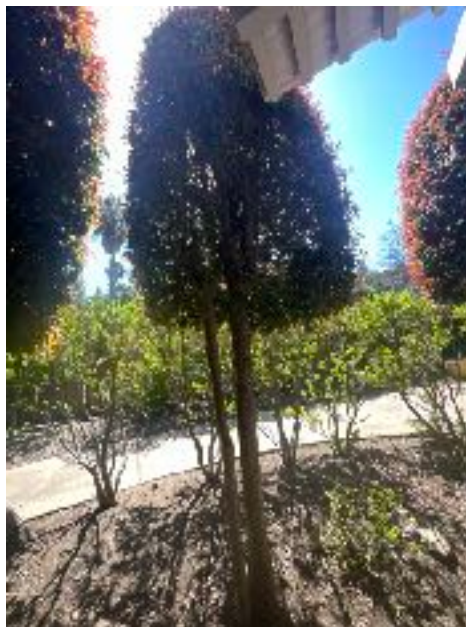
Tag 5434

The canopy of this tree is growing into the neighboring gazebo. This tree has two main uprights growing from the roof flare.

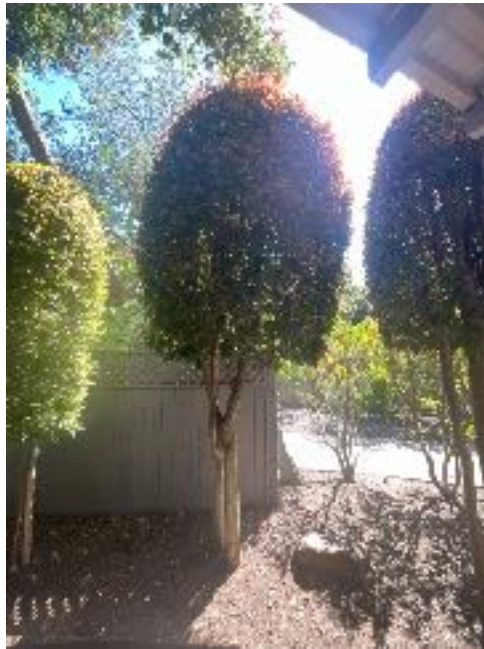
Tag 5435

This tree has two main uprights growing from the root flare.

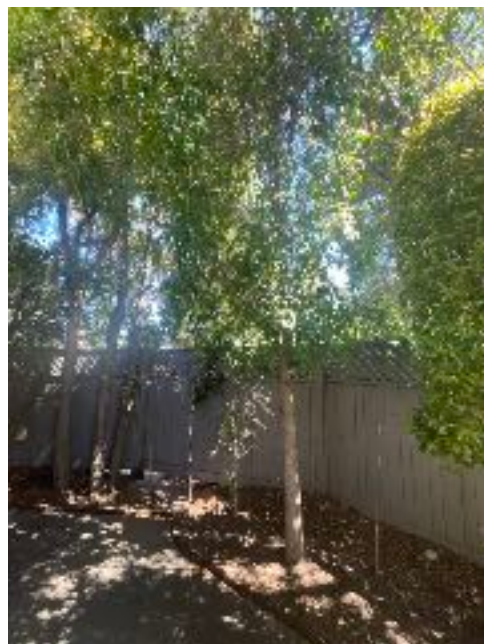
Tag 5436

This tree is in poor health with a very sparse canopy. The limited foliage is due to having a lack of sunlight from neighboring trees over-shadowing the canopy.

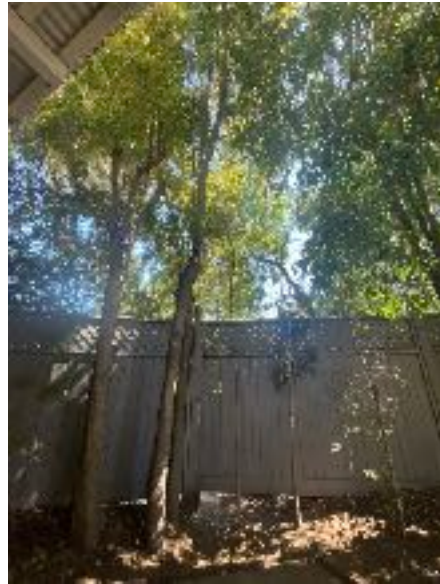
Tag 5437

This tree has two main uprights growing from the root flare. This tree has multiple minor decay cavities noted on the main uprights.

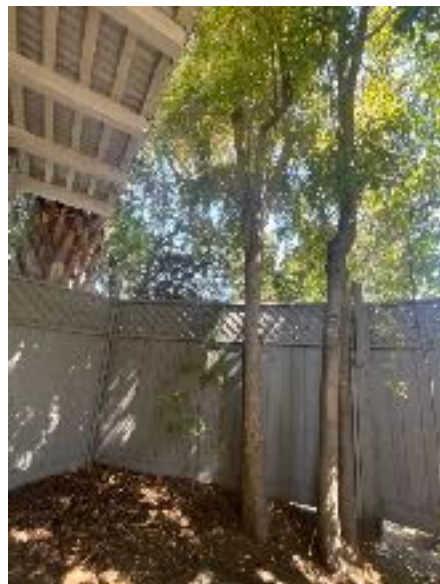
Tag 5438

This tree has included bark at the first main crotch. This tree's canopy is growing into the neighboring gazebo.

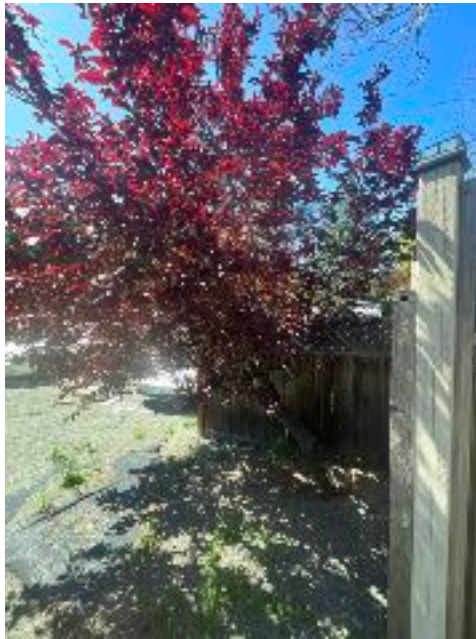
Tag 5439

This tree has significant rot/decay cavity on the main stem, approximately 1 foot above grade. This tree has a significant southern lean.
