03/06/2024

Arborist Report

Client: Live Oak Associates - Attention: Katrina Krakow

Site: 50 Los Gatos-Saratoga Rd, Los Gatos CA

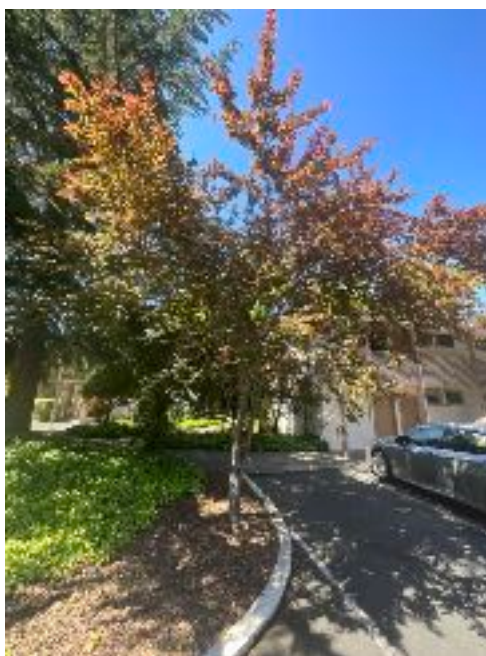
Tag 5440

This tree has included bark between the two main uprights.

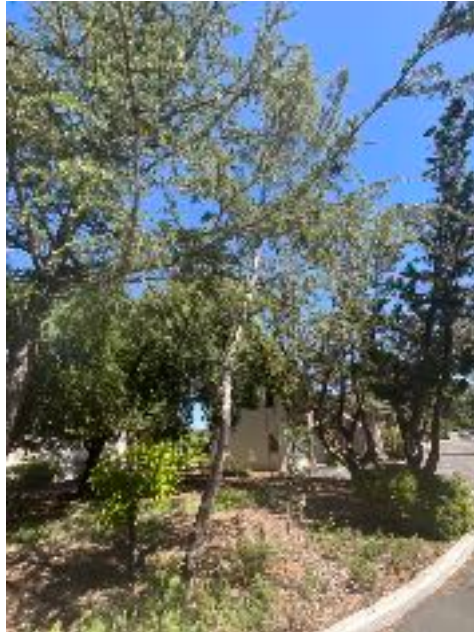
Tag 5441

This tree has a significant lean to the south, due to competition with neighboring trees.

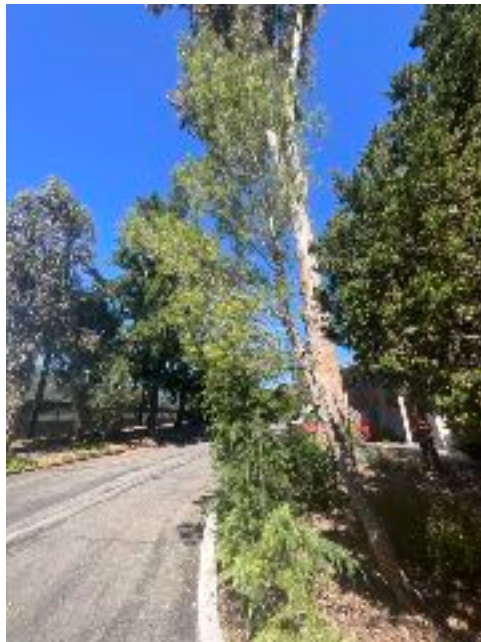
Tag 5442

This tree has a lean to the west due to competition with neighboring Hollywood juniper tree.

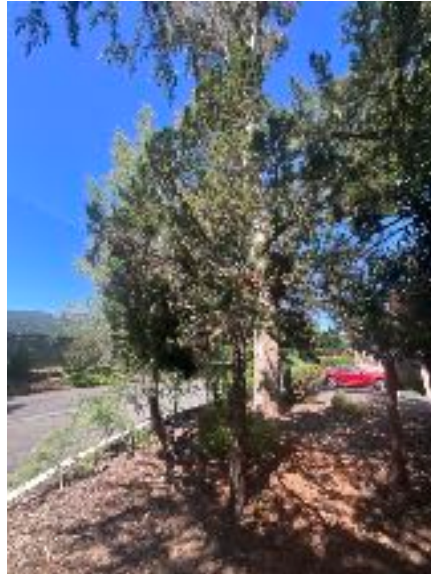
Tag 5443

Moderate die back in the canopy. Majority of the foliage is on the southern side due to competition for light.

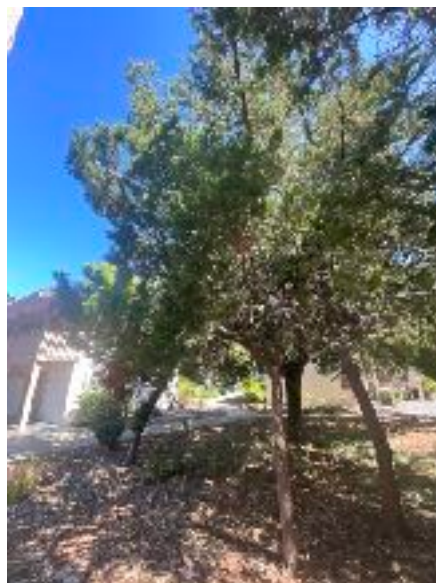
Tag 5444

Moderate die back in the canopy. Majority of the foliage on the north-western side due to competition for light.

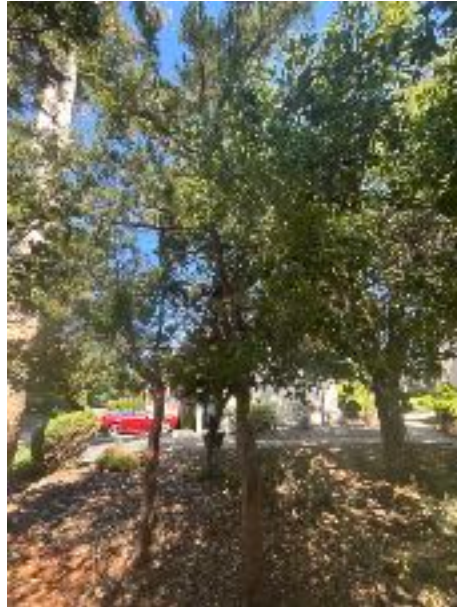
Tag 5445

Sparse canopy due to competition for light.

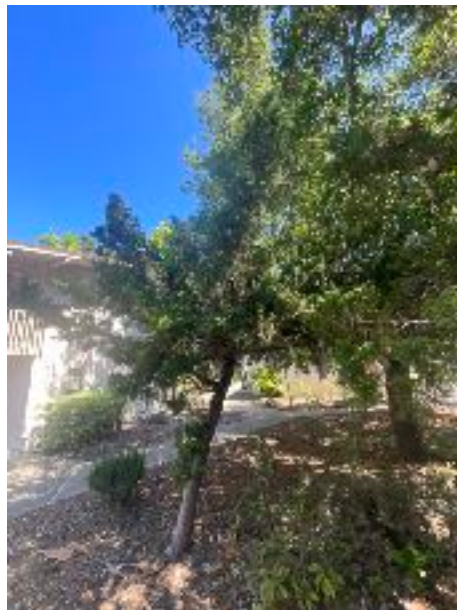
Tag 5446

This tree has a significant eastern lean.

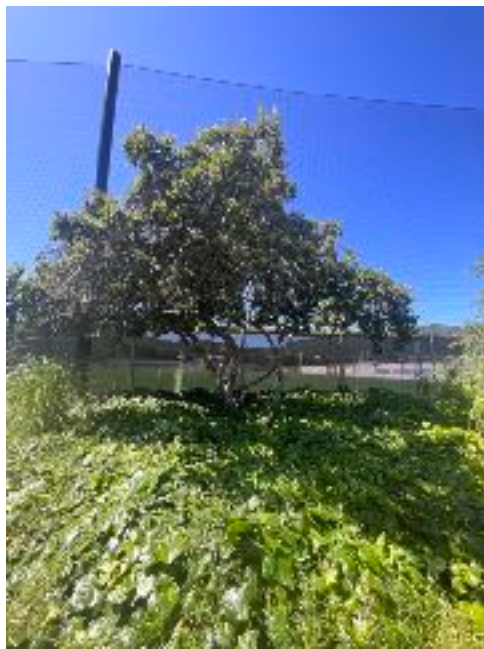
Tag 5447

This tree has significant die back in the canopy. This tree has multiple uprights growing from the root flare. There are crisscrossing and fused limbs noted in the canopy.

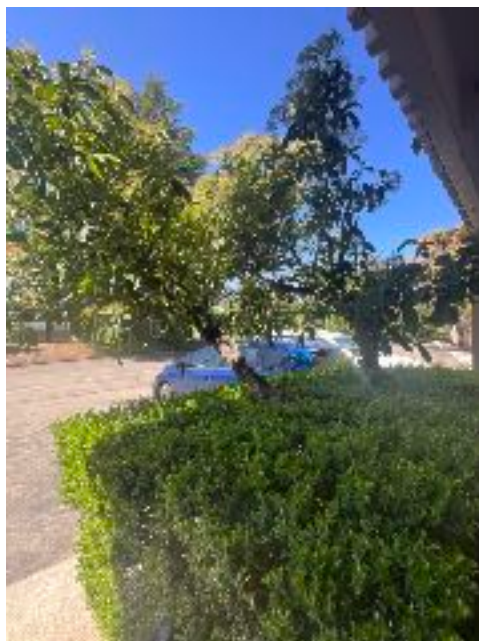
Tag 5448

This tree is growing up through a bush. The tree has a significant western lean. Major decay cavity noted along the main stem.

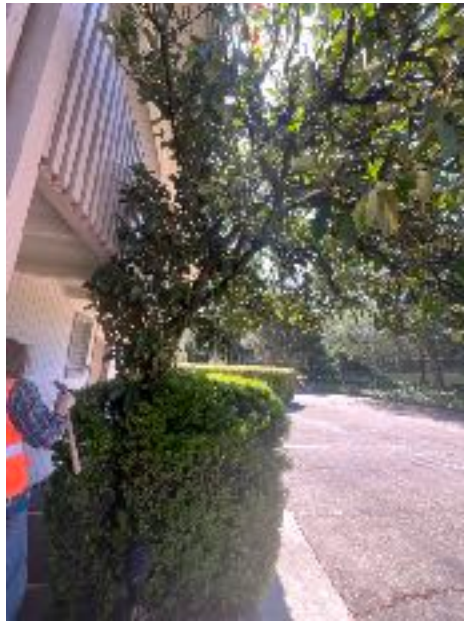
Tag 5449

This tree is growing into the deck of the adjacent property, and up through a landscape bush.

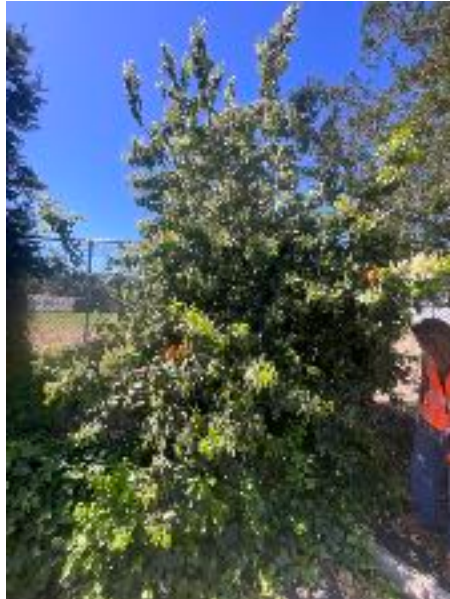
Tag 5451

Canopy of this tree is growing into neighboring chain-link fence. Canopy skirt of this tree is touching the ground.

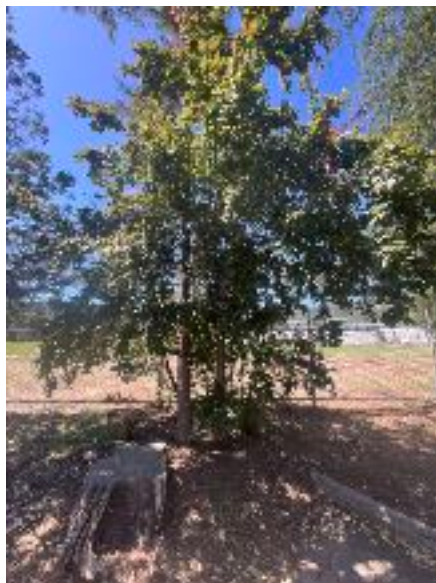
Tag 5452

Canopy of this tree is growing into the neighboring stone pine. Multiple epicormic shoots are growing from the root flare.

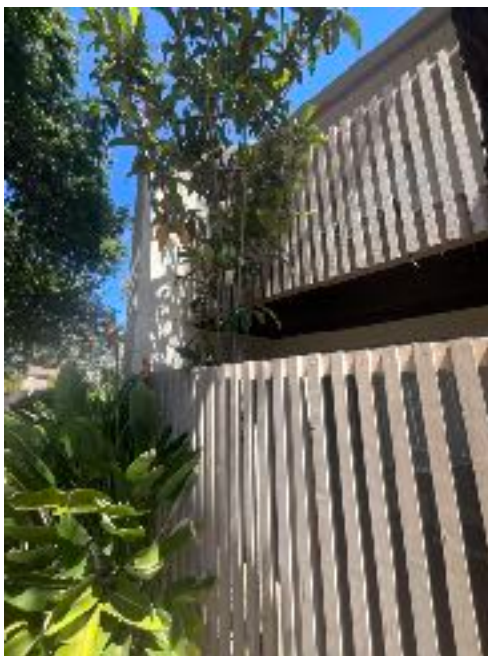
Tag 5453

There is a significant decay cavity approximately 7 feet above grade, along the main stem, with fungal fruiting bodies.

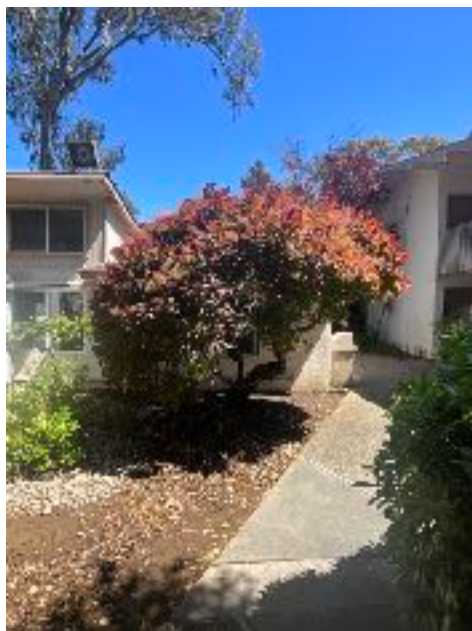
Tag 5454

This tree has a significant lean to the west side, due to competition with the neighboring building for light.

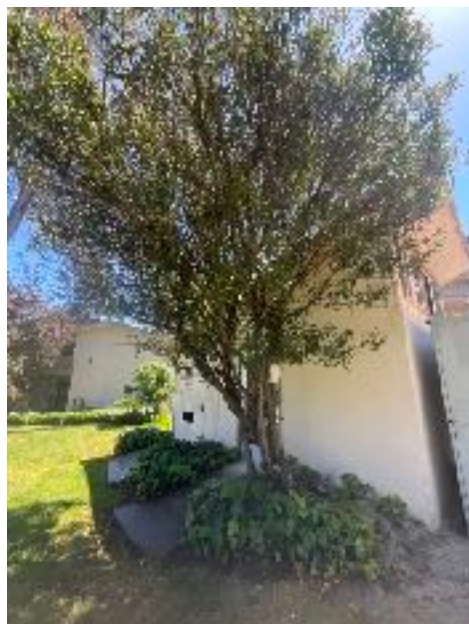
Tag 5455

This tree has included bark between the major uprights. This tree has significant die back in the upper canopy.

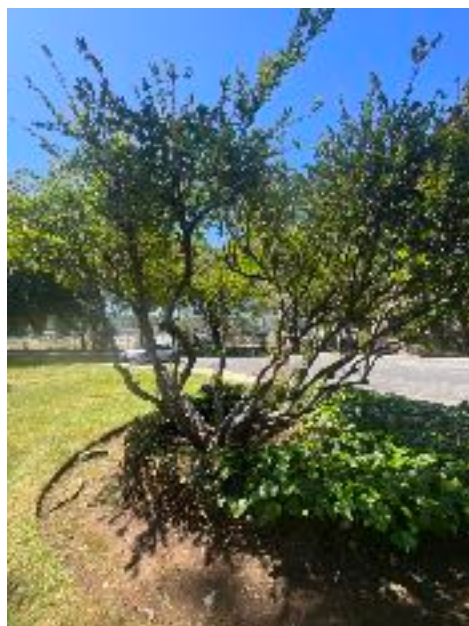
Tag 5456

This tree has approximately seven uprights, growing from the root flare. Included bark noted in between many of the uprights.

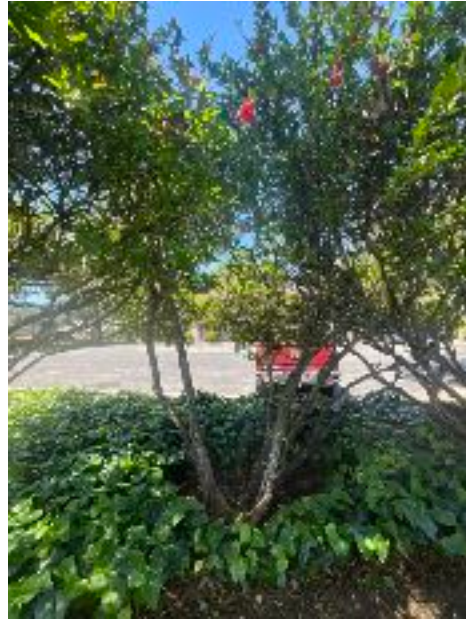
Tag 5457

This tree has included bark between the uprights. Significant decay noted at the base of the major uprights, approximately 1 foot above grade.

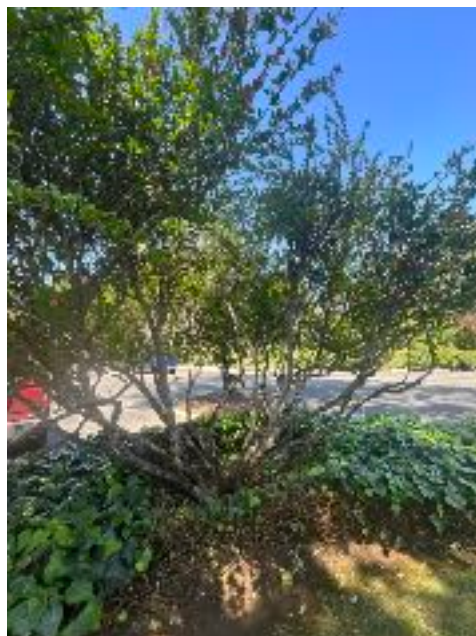
Tag 5458

This tree has significant decay on many of the uprights at approximately 1 to 2 feet above grade. This tree has included bark between the major uprights.

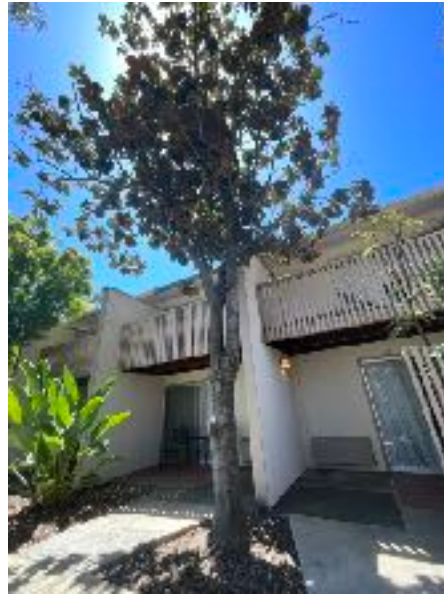
Tag 5459

Moderate die back noted in the canopy.

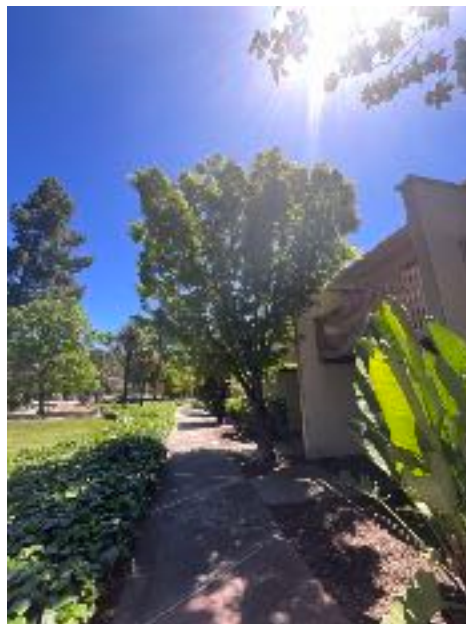
Tag 5460

Moderate decay cavities noted on many of the branches in the upper canopy.

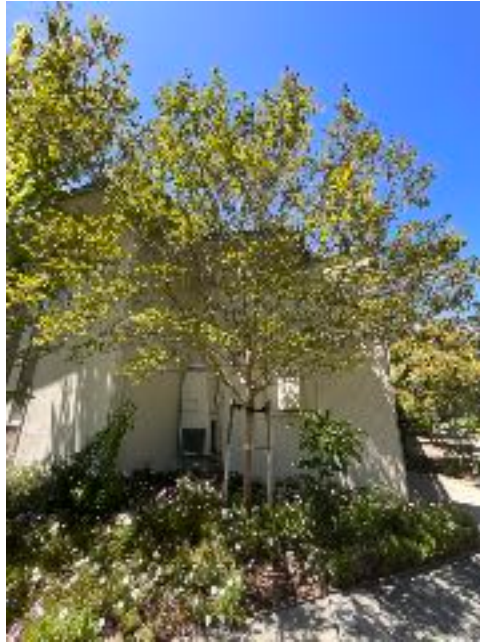
Tag 5461

Minor die noted in the canopy.

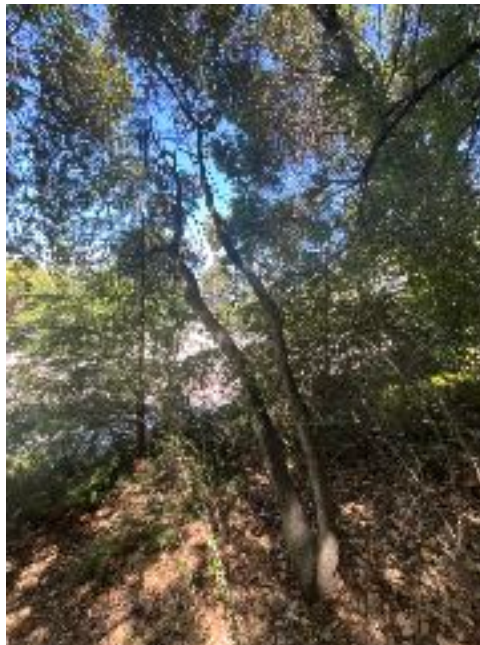
Tag 5462

This tree is in very poor condition.

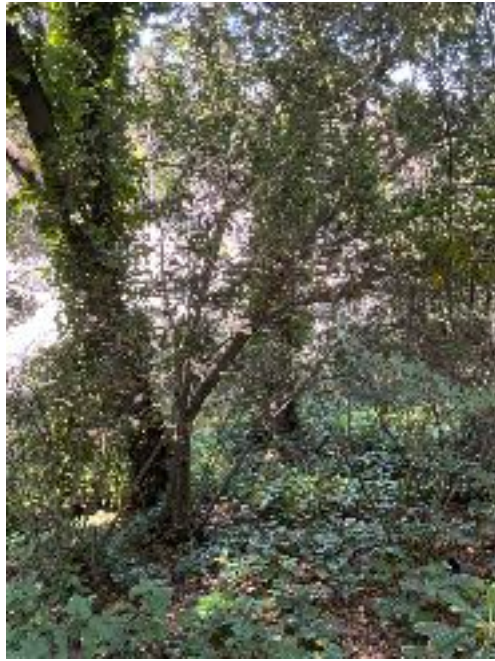
Tag 5463

This coast live oak tree is growing at a significant eastern lean due to competition with neighboring coast live oak.

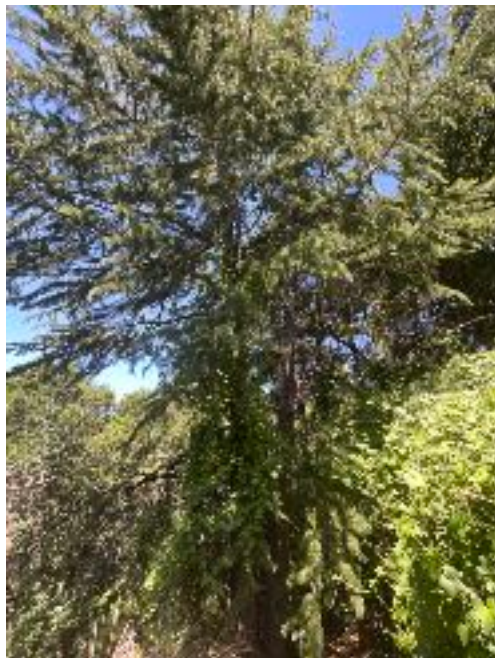
Tag 5464

This tree has two main uprights, growing from the root flare with included bark at the base of the trunks.

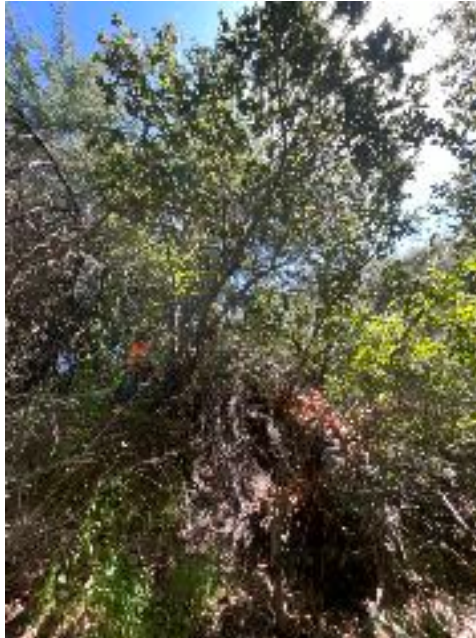
Tag 5465

Canopy of this tree has a northern lean. Minor deadwood noted in the canopy.

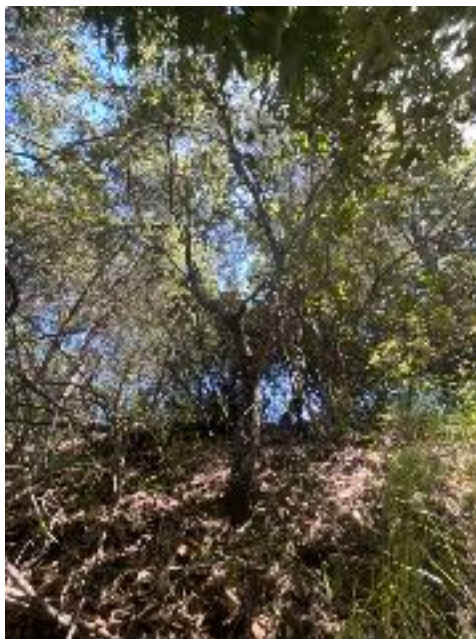
Tag 5466

This tree has two main uprights at approximately 10 feet above grade with included bark. Moderate die back noted in the canopy.

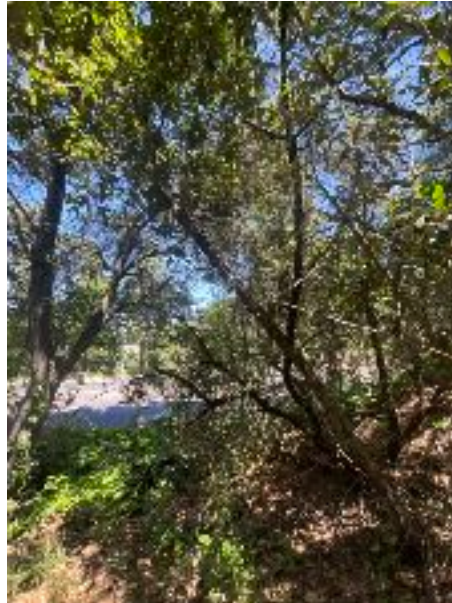
Tag 5467

This tree has a significant northern lean. Fungal damage noted in the canopy.

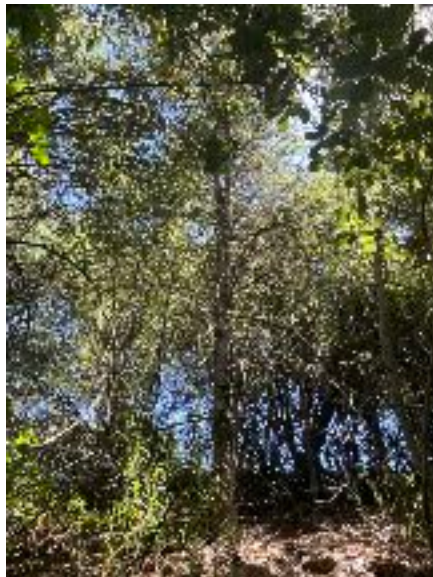
Tag 5470

This tree is two co-dominant uprights at approximately 15 feet above grade with included bark between them.

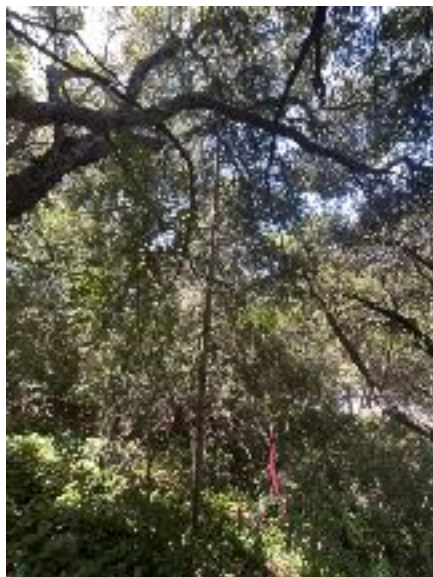
Tag 5471

This tree has one upright growing through the canopy of neighboring large oak tree.

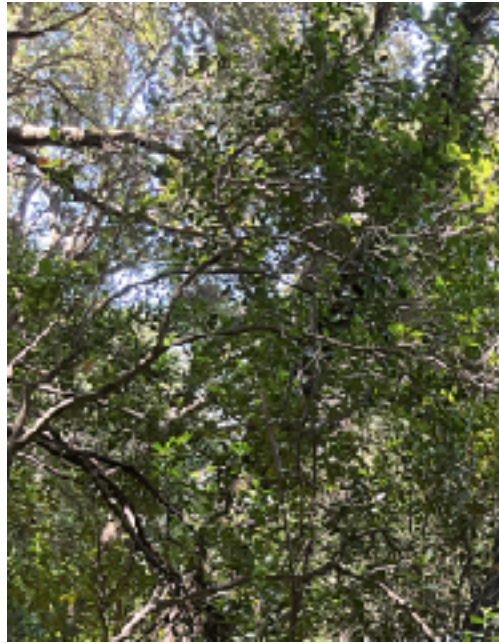
Tag 5472

Ivy is growing up the trunk, and is girdling this tree. Significant die back in the upper canopy.

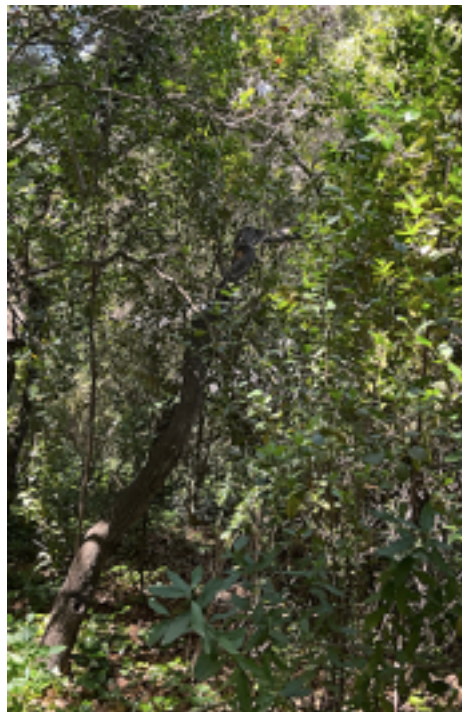
Tag 5473

Canopy of this tree is growing in a completely northern direction, and is very sparse due to competition for light.

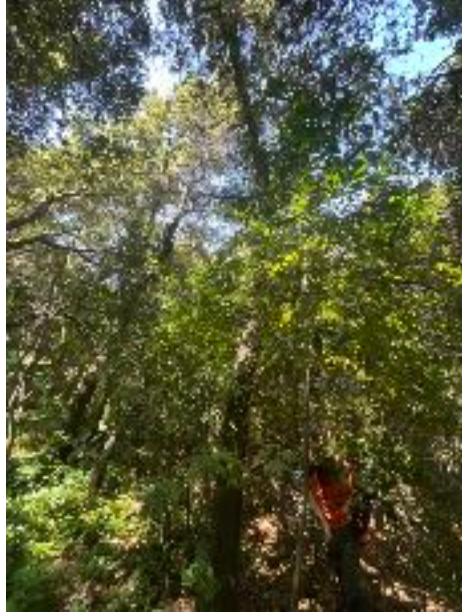
Tag 5474

Moderate die back noted in the canopy. This tree has a very sparse canopy.

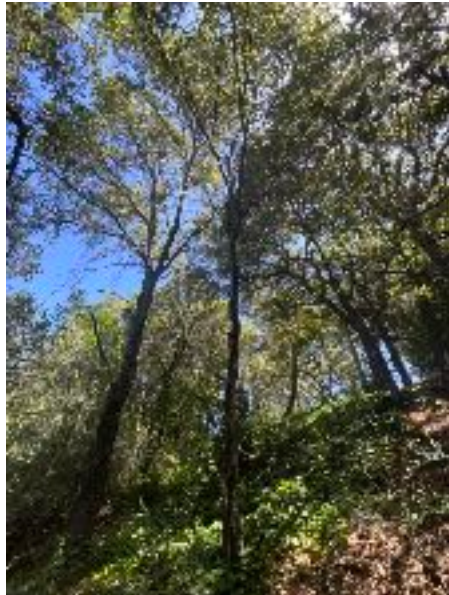
Tag 5475

This tree is growing under the neighboring canopies of the oak trees.

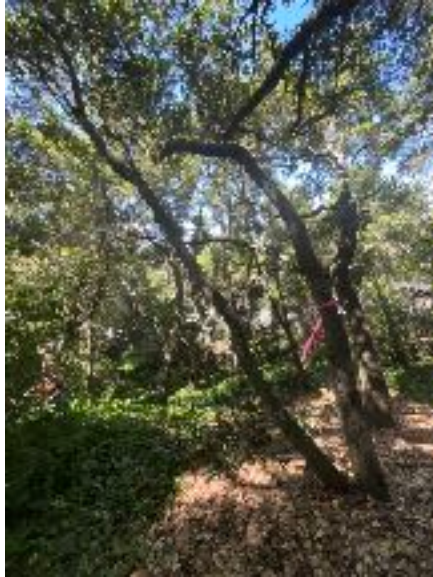
Tag 5476

The canopy of this tree is growing in a north-western direction. This tree has a very sparse canopy, and poor structure.

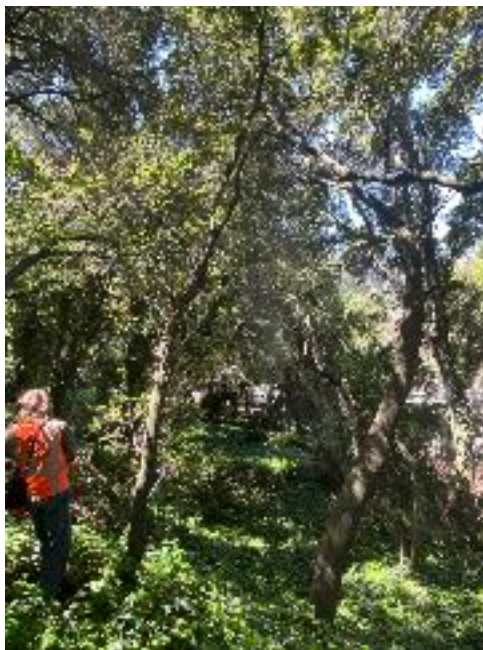
Tag 5477

This tree has fungal damage noted in the foliage of the canopy, the tree has a very sparse canopy.

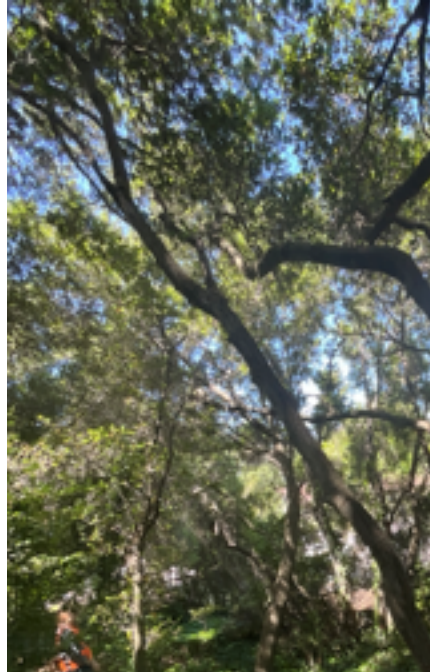
Tag 5478

This tree is growing in an entirely northern direction due to competition for light.

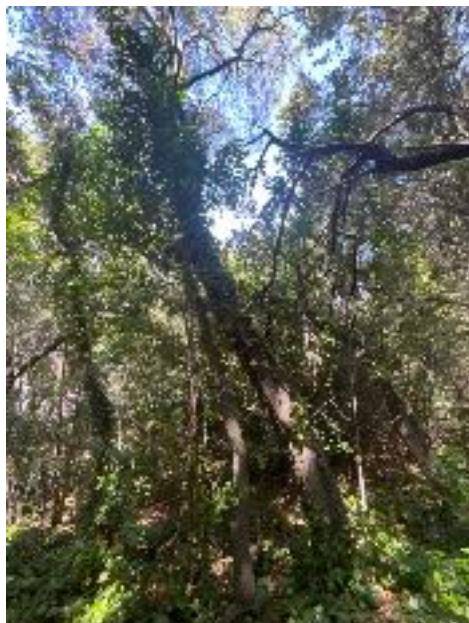
Tag 5479

This tree's canopy is growing an entirely northern direction. Ivy is growing up the trunk and girdling the tree.

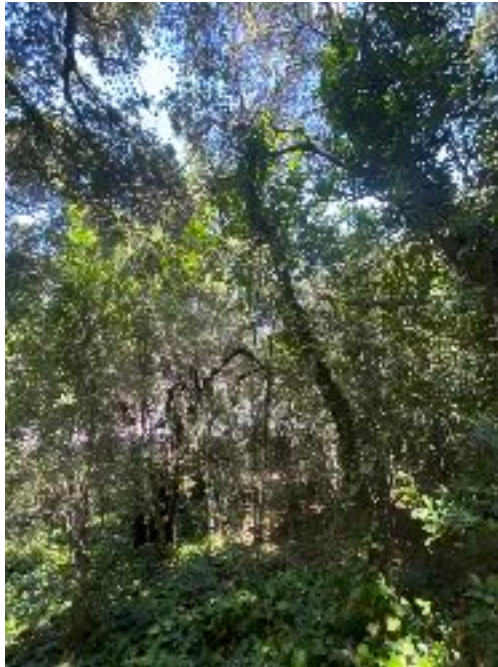
Tag 5480

The canopy of this tree is growing in an entirely western direction. Foliage is very sparse on this tree.

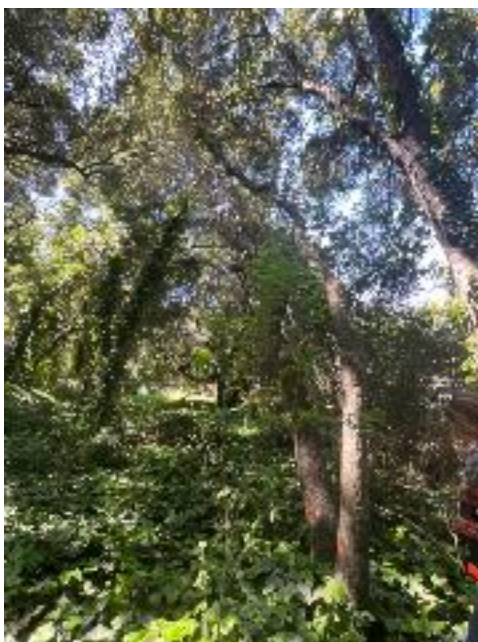
Tag 5481

This Live Oak is growing in a westward direction with a sparse canopy. This tree has a dead tree leaning into the canopy with Ivy growing up the dead tree.

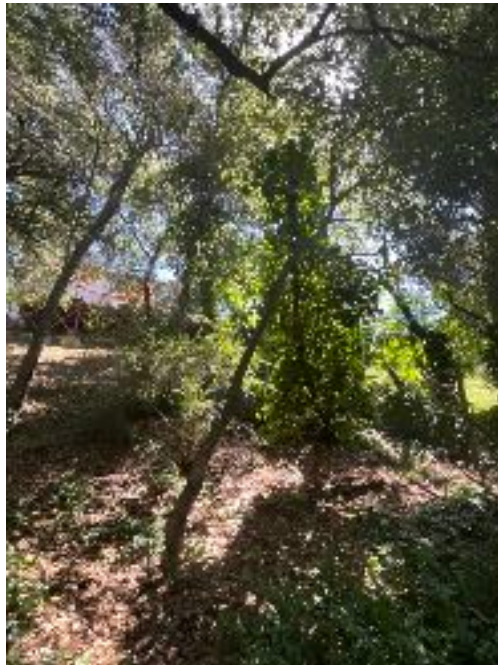
Tag 5482

Canopy of this tree is growing in a northern direction. Moderate deadwood noted in the upper canopy.

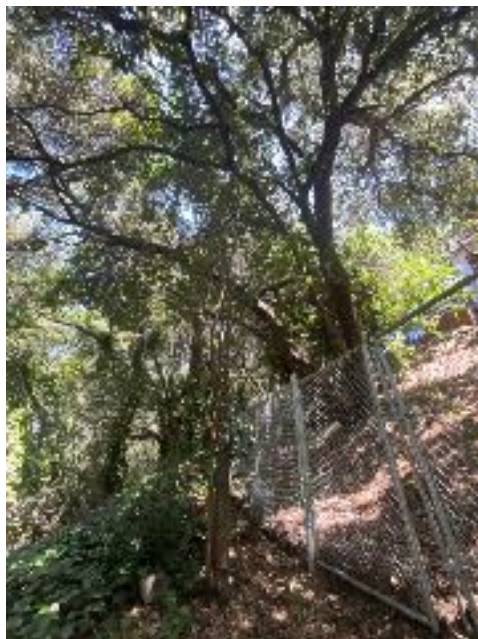
Tag 5483

Canopy of this tree is growing into the neighboring live oak tree.

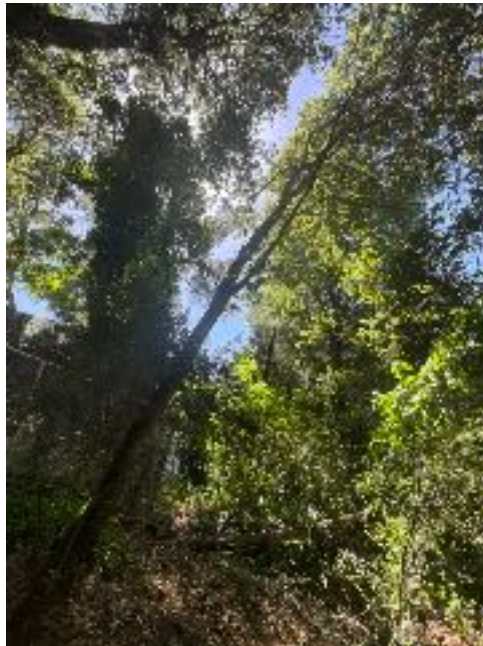
Tag 5484

This tree has a very sparse canopy.

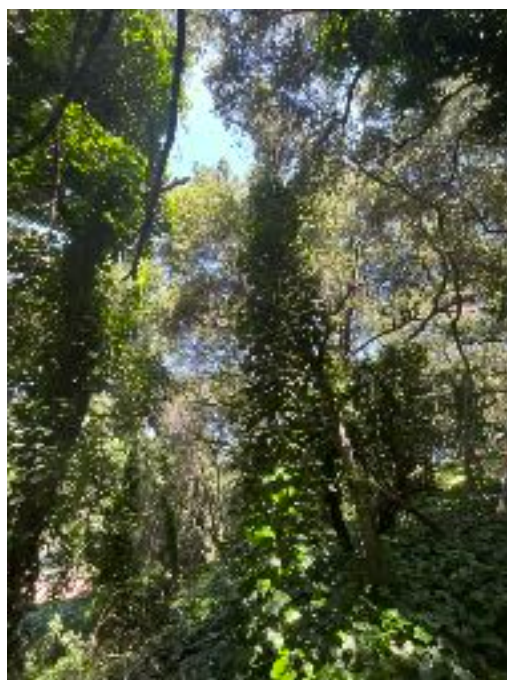
Tag 5485

Canopy of this tree is growing in a northern direction. This tree has very sparse foliage in the canopy.

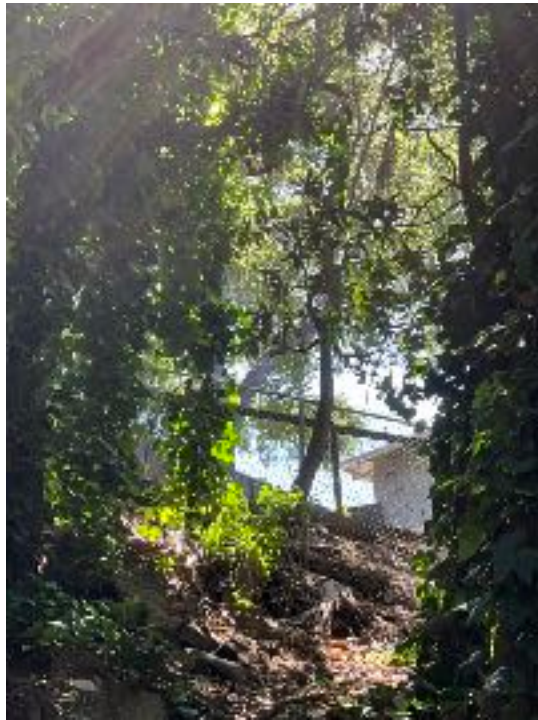
Tag 5486

This tree has a canopy with very sparse foliage growing in a western direction over the neighboring property.
