**MACKINAC ISLAND FERRY COMPANY  
MAIN DOCK EVALUATION**

**CITY OF MACKINAC ISLAND  
MACKINAC ISLAND, MICHIGAN**

**January 2024**

I hereby certify that the structural inspection, conditions study and feasibility report for the above referenced location were prepared by me or under my direct supervision and that I am a duly Licensed Professional Engineer under the laws of the State of Michigan.

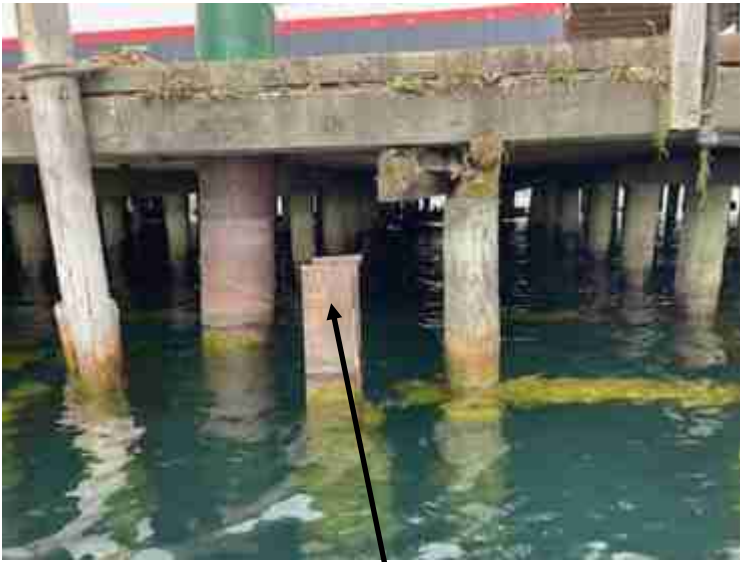
9) Dock (south)

Tops of battered pile removed

1. **Battered Piles:** There are several battered piles that have seen significant damage and have been disconnected from the concrete dock. For better horizontal resistance of the cruise ship loads, these piles should be repaired, extended and reconnected to the concrete deck.

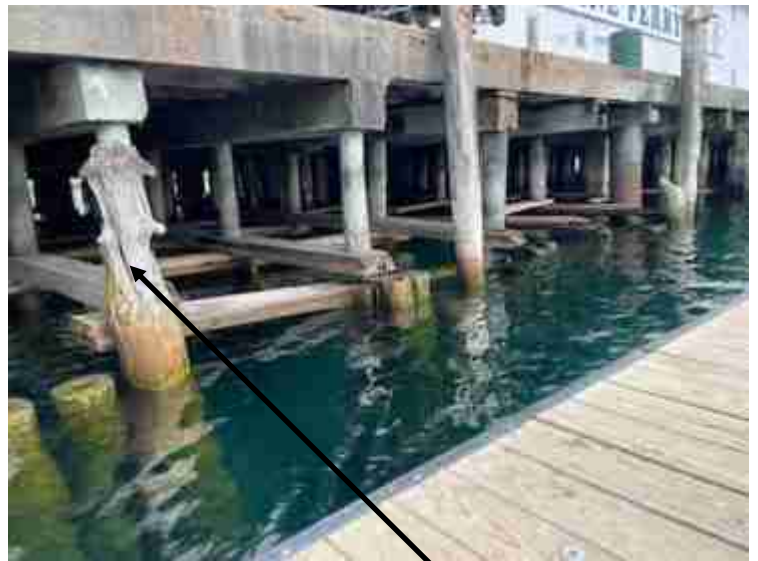
12) Dock (south)

- 3) Pile deterioration appears in several areas at or near the water line. The Lake Huron water level has fluctuated significantly over the past few years which has caused additional deterioration from air/water exposure, ice damage and wave height changes.

Pile deterioration

3. **PILE deterioration:** Several piles are completely deteriorated. These piles should be removed down to the lake bottom and new piles installed as needed.

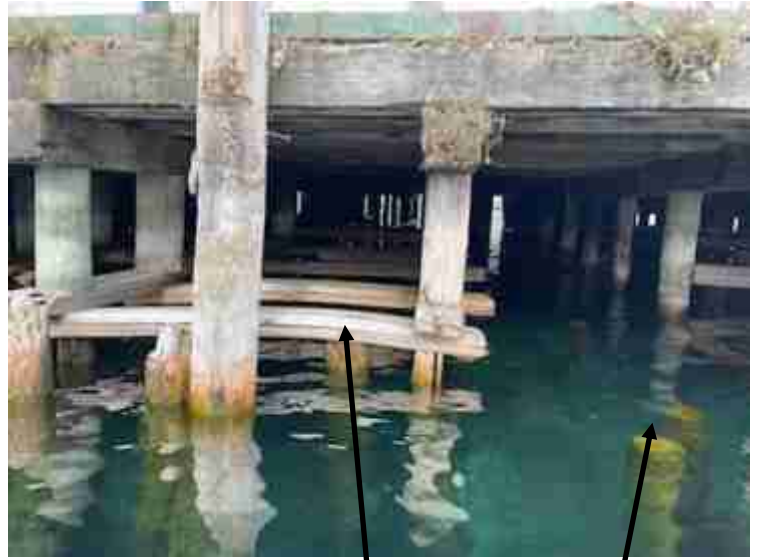
14) Dock (south)

- 2) Several areas along the south edge of the dock from west shoreline out to the east end have missing piles, this would apply to a few areas on the north end and the east end too. The missing piles in some cases have been replaced with shortened piles down to plank benching which is deflecting to the point that support and resistance is not available.

Bowed pile benching

Missing piles

2. **Missing piles:** there are several areas where piles are missing and extension benching has been installed. The benching in these areas should be removed and new piles driven along with new framing and decking.

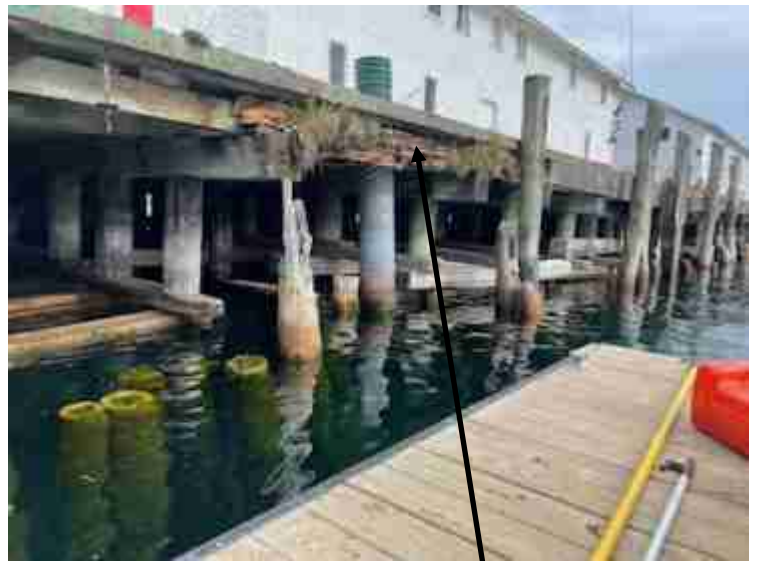
6) Dock (south)

- 6) The secondary edge beams show excessive deterioration along the edge of the dock that supports the concrete deck above.

Secondary edge beam deterioration

6. **Secondary edge beams:** Several edge beams have deteriorated. These beams should be removed and replaced with new edge beams.

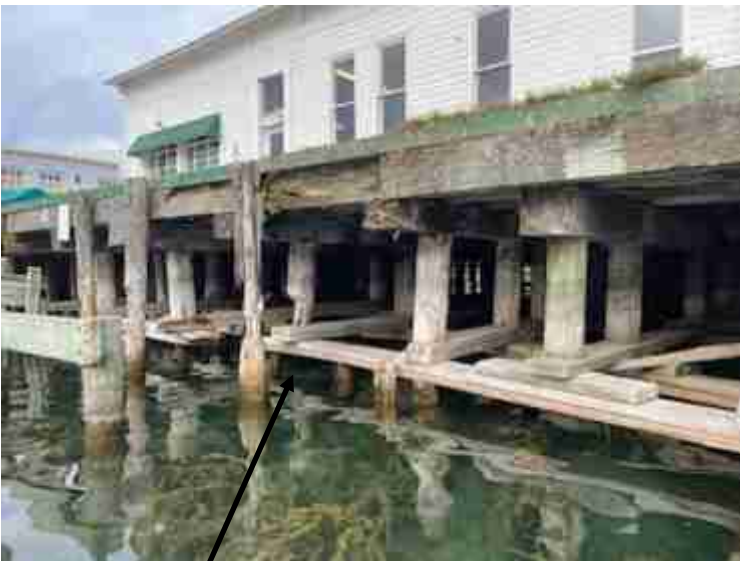
**23) Dock (south) (west end)**

Excessive piles and missing benches

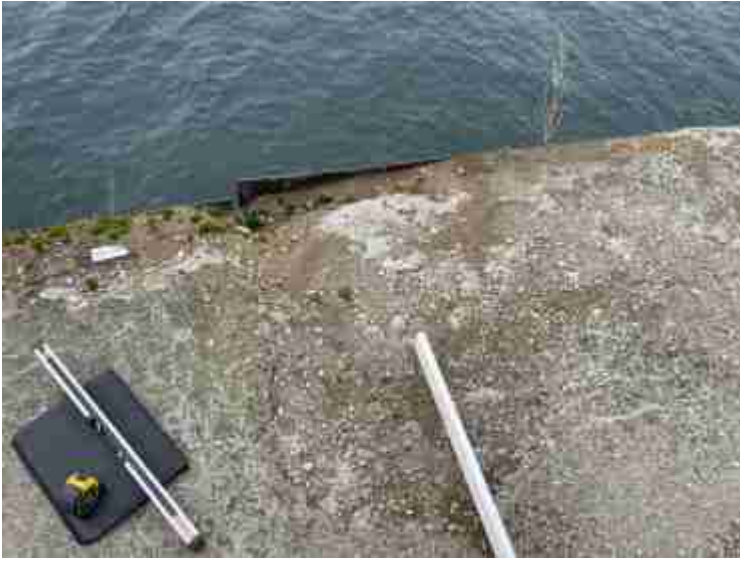
**113) South deck area**  
Apron metal 1 1/2' deck ware

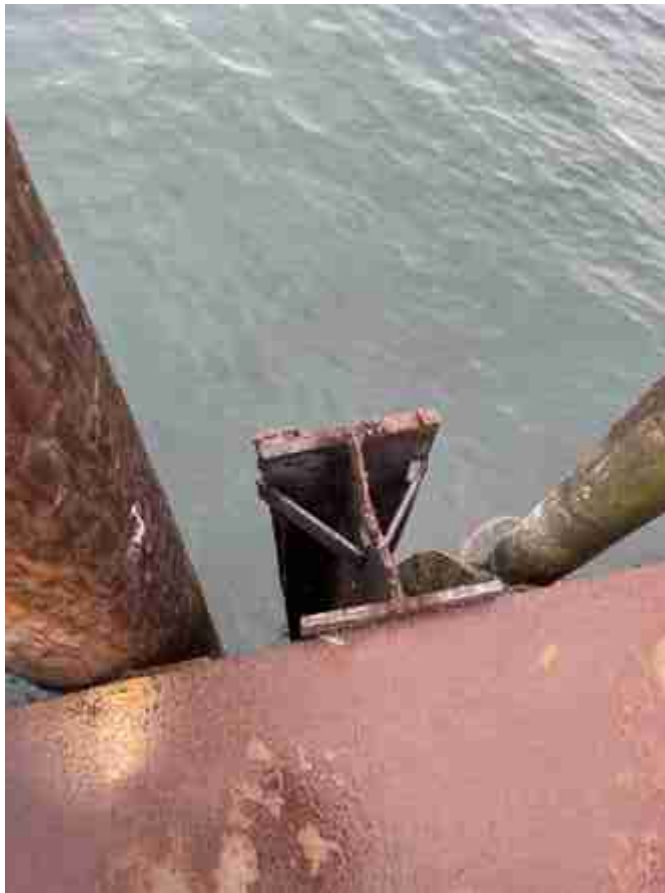
**138)** Reinforce deck and horizontal support (north side)
