March 3, 2025

PROJECT NO. MDBCH24002

RE: LIMITED STORM DAMAGE ASSESSMENT OF "SNACK SHACK" CAFE
15100 GULFVIEW BLVD
MADEIRA BEACH, FL 33708

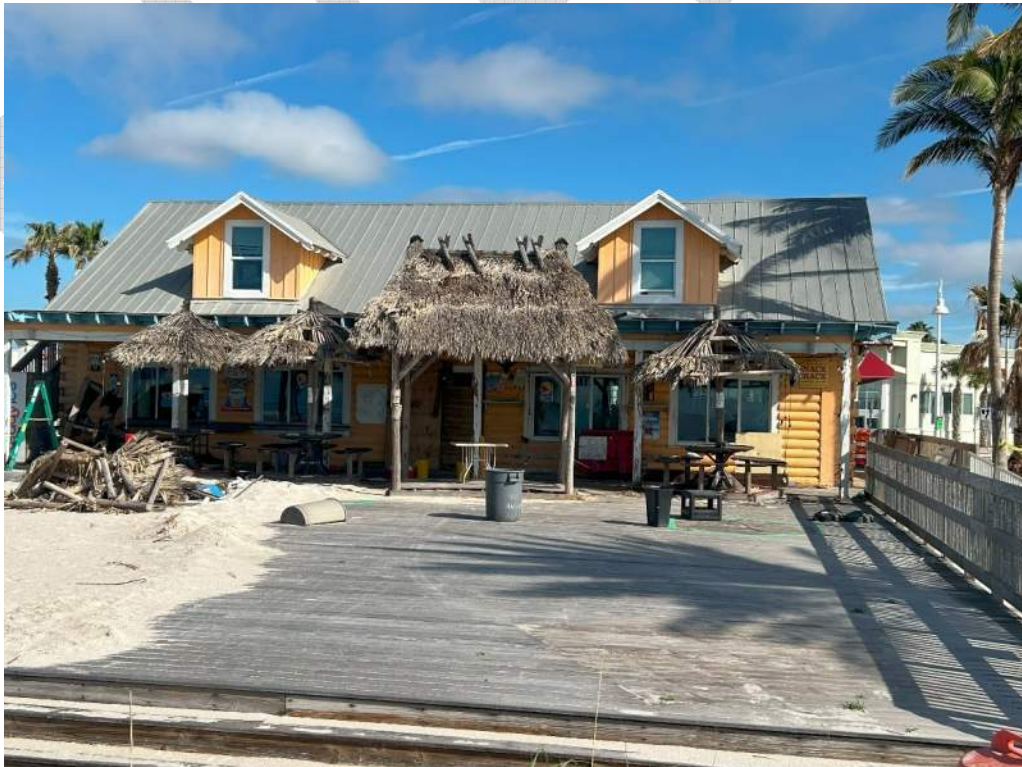
Existing Tiki Huts for sitting on the outside deck were moved for the storm surge from their original location to the building and hit the exterior structure of the back porch. Although no severe damage was seen in the structure, this impact undoubtedly contributed to aggravating the damage to this roof. (See **Photo 2**). Review of the Tiki Huts or the West wood framed deck were not in our scope of work.

Photo 2 – South view of the “Snack Shack” Café (Dec.18, 2024)

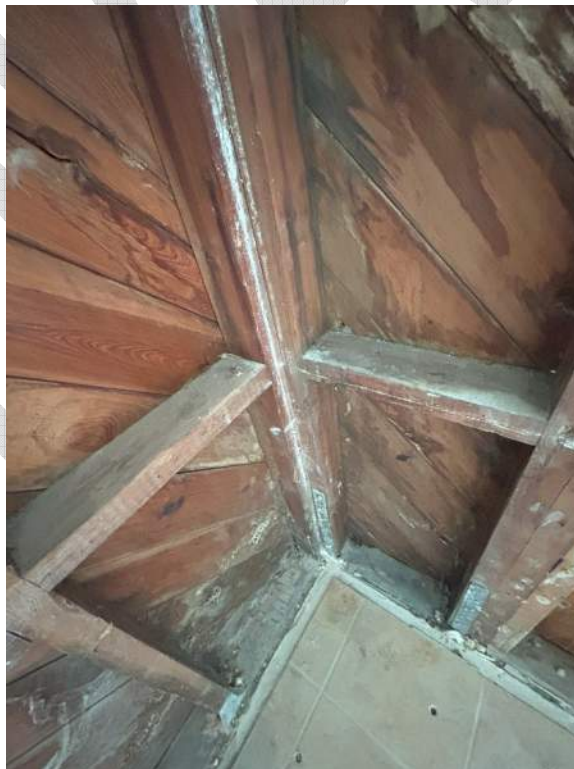
On the central axis of the building, 16 feet from its main side, there are 4 wooden columns spaced each one at 16 feet, the 2 exterior ones have a section of 3" x 7" and the two interior ones are composed of 2 wooden columns of 5" x 5". The exterior and interior walls are made of 2" x 4" wooden studs separated by 16", and of each corner of the building they form a double 2" x 4" wooden column. (See **Photos 6 - 10 and SK-2**)

- The detached wood west deck was not inspected in detail, but was observed to have separated from the North section of porch that extended from the main building. (See **Photos 6 & 7**)
- All the floor and plumbing drains on the first floor were clogged by sea sand (See **Photos 34**) and numerous signs of corrosion were observed on the metal corner beads of the windows, doors, and interior walls and on some pipes and the cover of the electrical panel. (See **Photos 31 & 32**)
- One of the exterior impact glass windows of the south façade was completely broken and another partially broken. (See **Photo 13**)
- The presence of Mold is observed in numerous places on the walls toward the interior of the building, especially at the approximate height that the sea reaches (14" above finish floor level) (See **Photo 33**)

Photo 6 – View of one of the Corner of the Walls Wood Frame Structure.

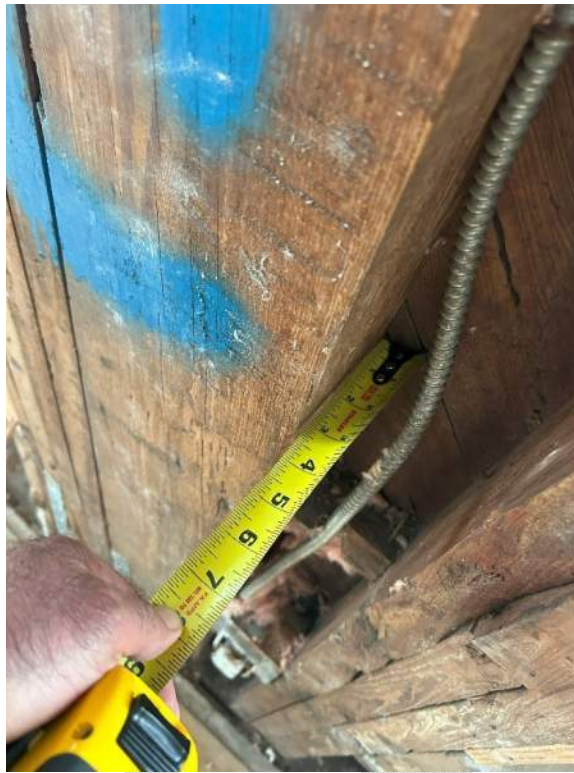
Photo 7 – View of one of the Exterior Intermediate Columns of the Walls Wood Frame Structure.

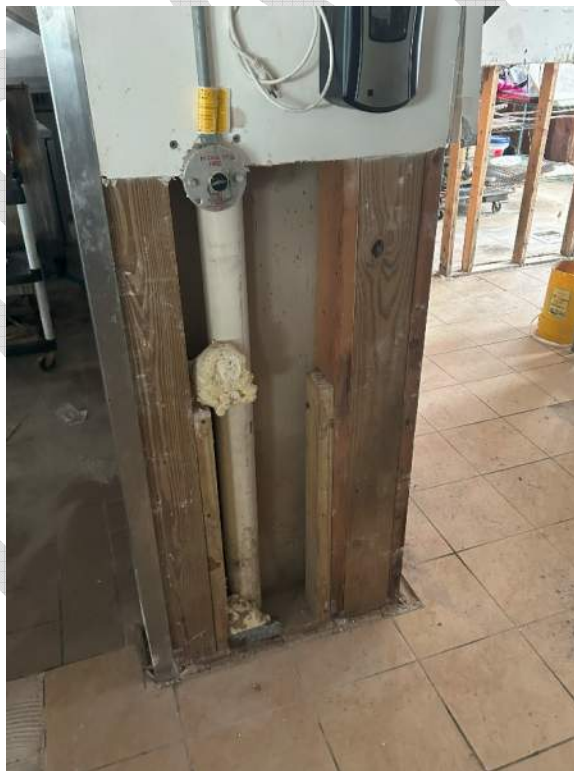
Photo 8 – View of one of the Interior Intermediate Double Columns of the Walls Wood Frame Structure.

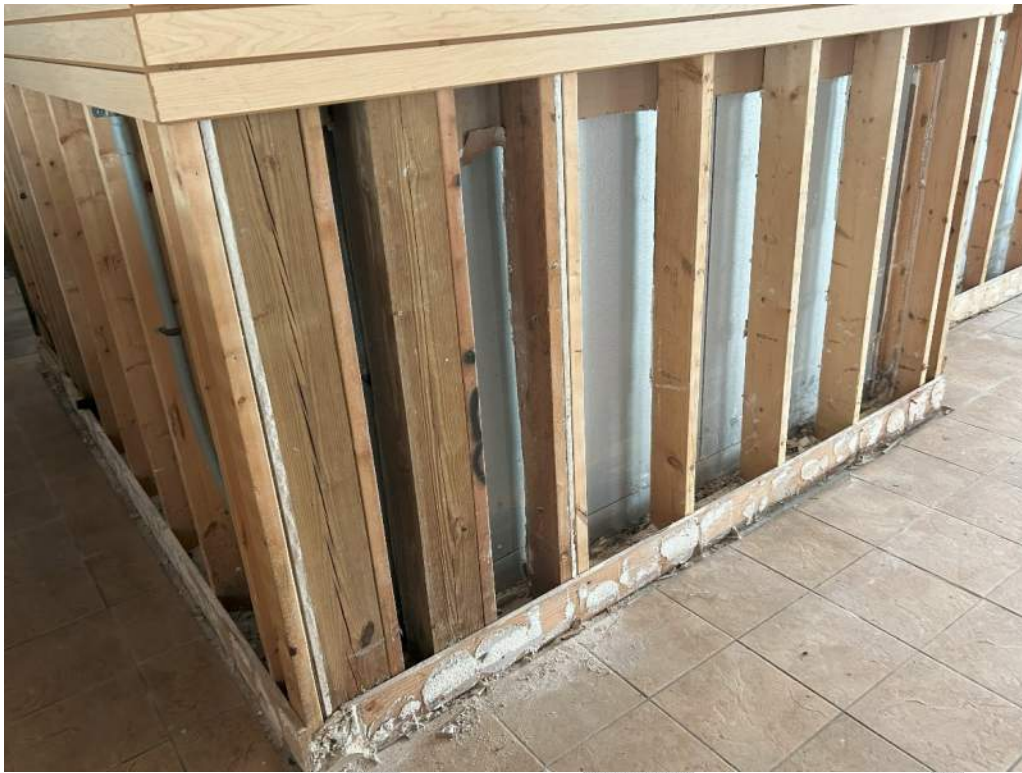
Photo 9 – View of the Interior Walls Wood Frame Structure.

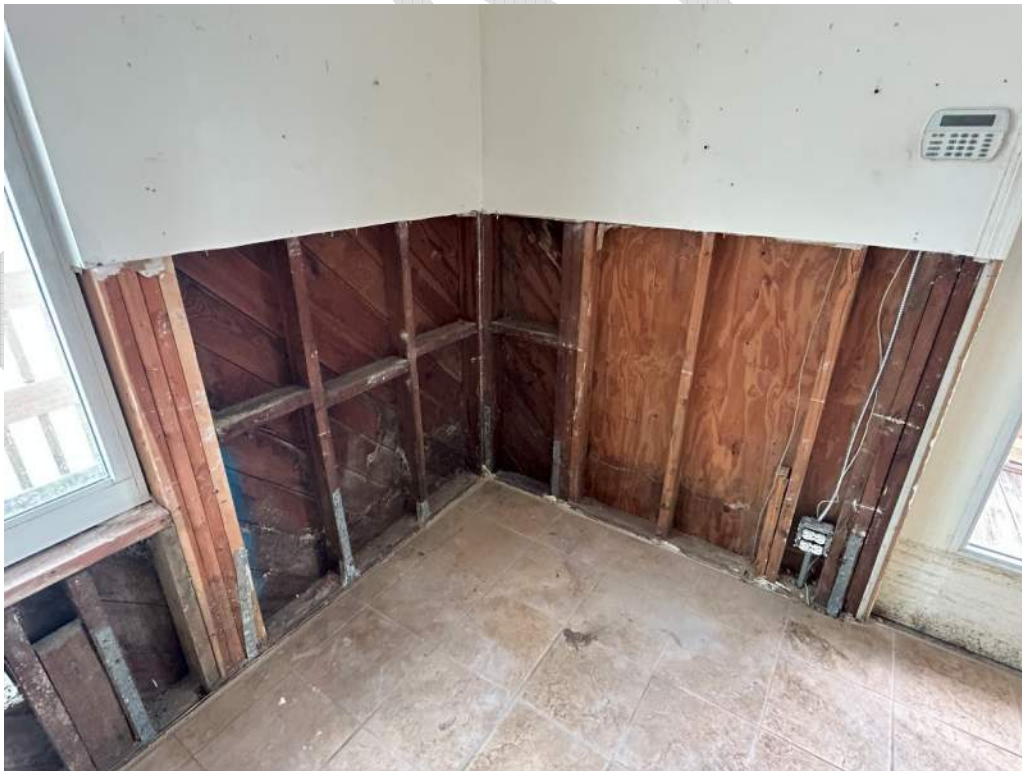
Photo 10 – View of the Exterior Walls Wood Frame Structure.

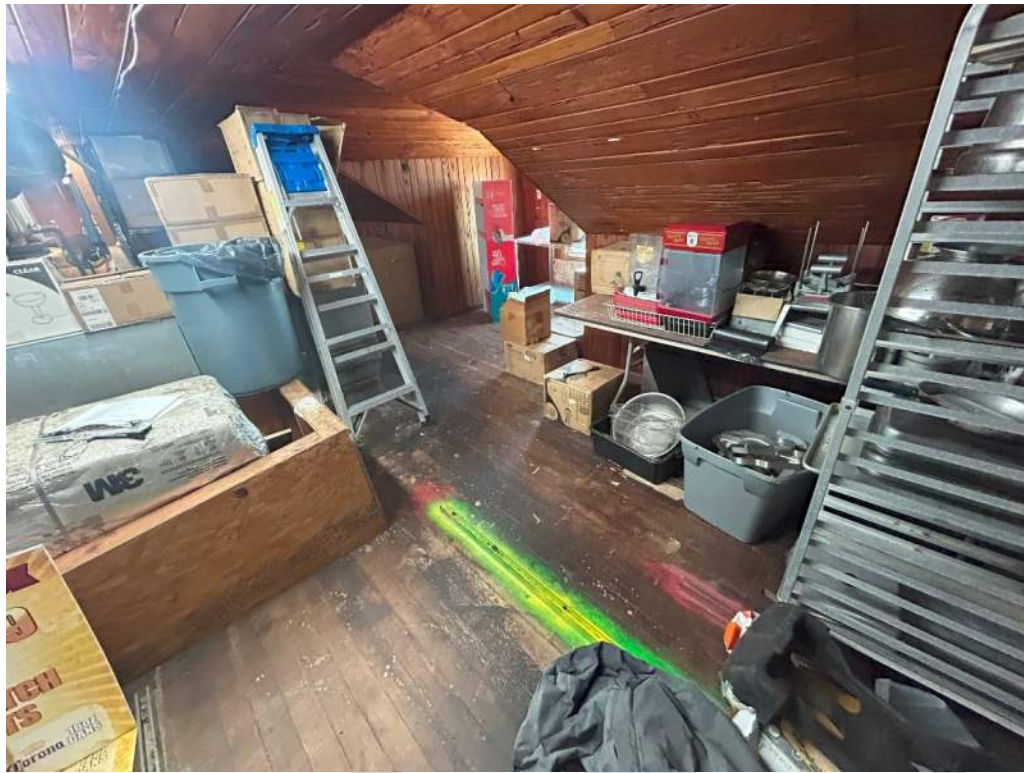
Photo 39 – Inside view of 2nd Floor (Attic).

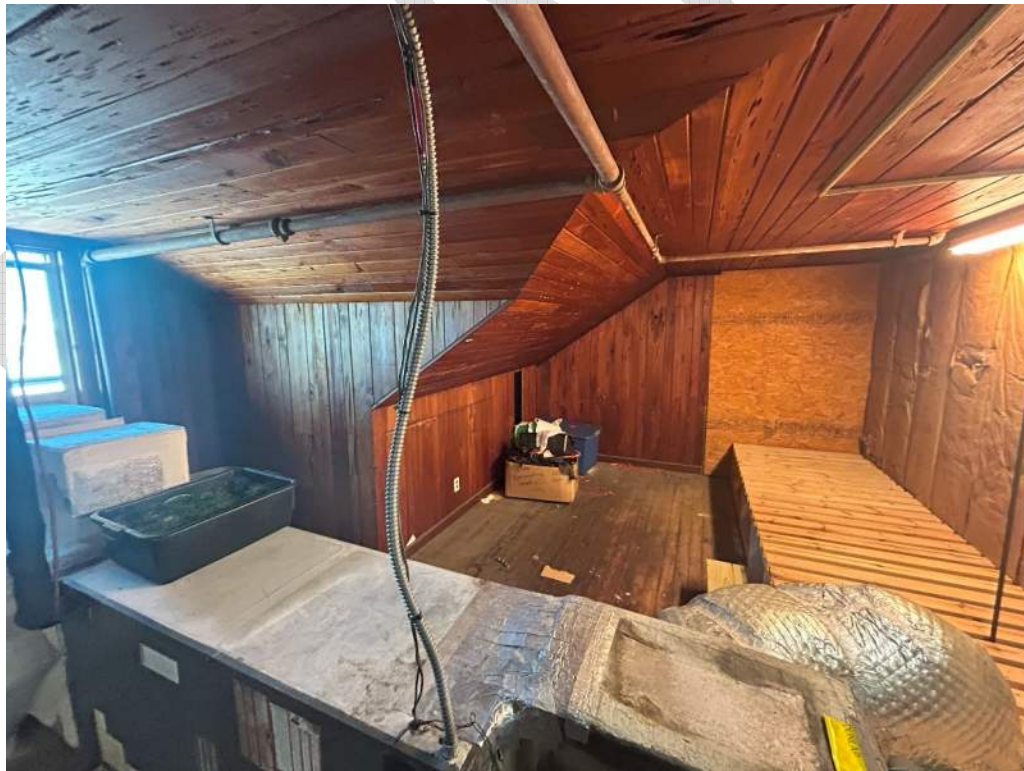
Photo 40 – Inside view of 2nd Floor (Attic).

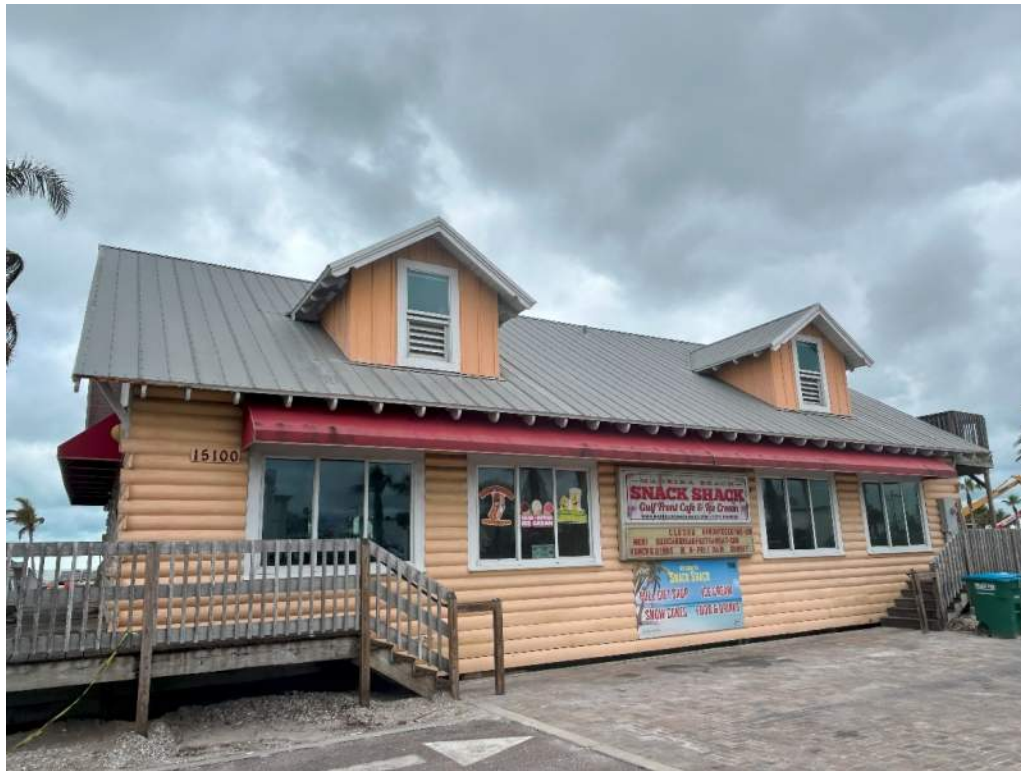
Photo 45 – Outside View of Metal Roofing.

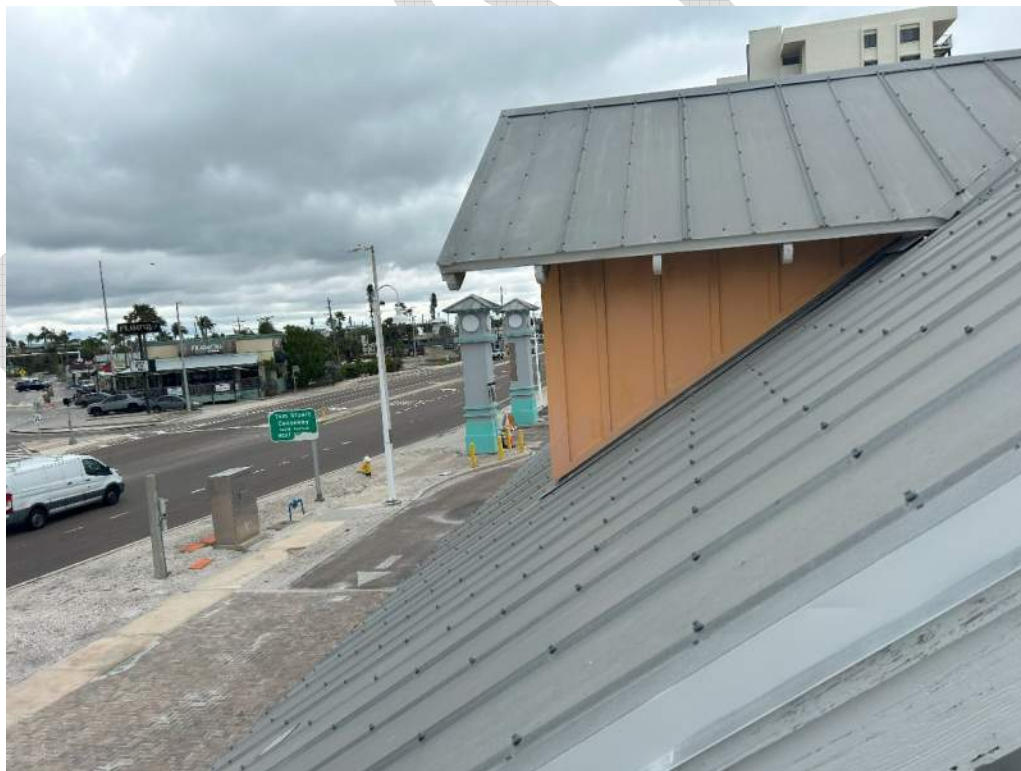
Photo 46 – Outside View of Metal Roofing.

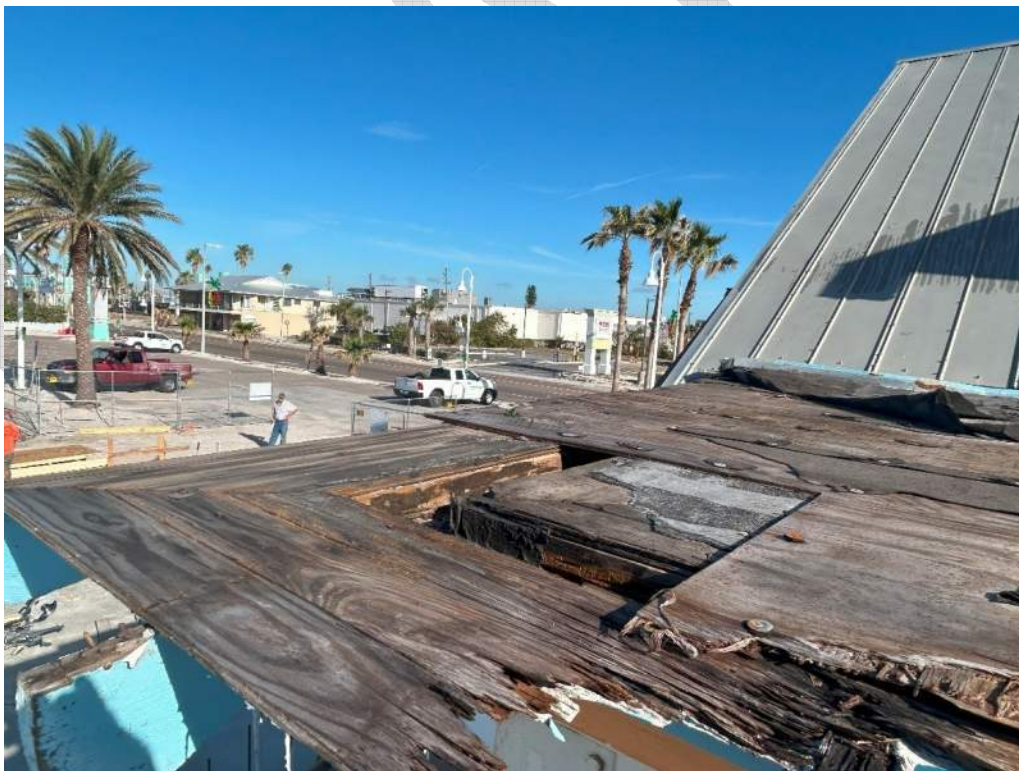
Photo 50 – Back Porch Roof Frame and Sheathing Destroyed.

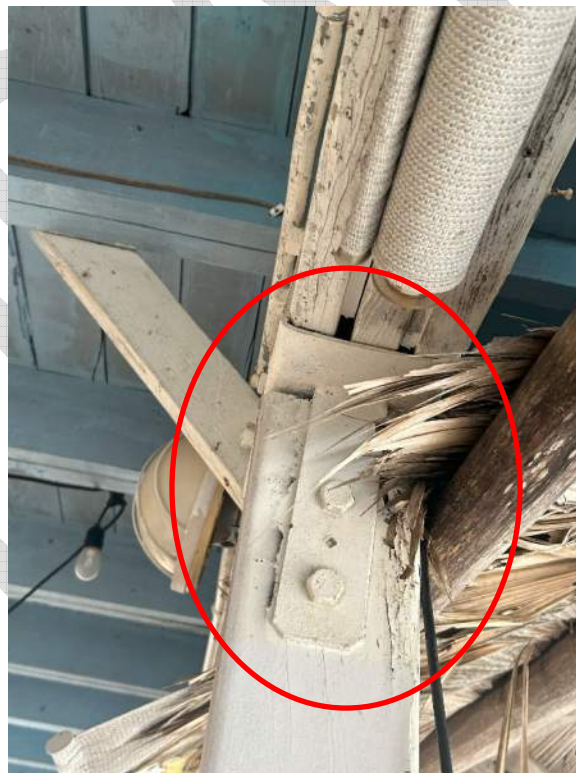
Photo 54 – Top of one of the Wood Column of the Back Porch that was Impacted by Outside Tikis.

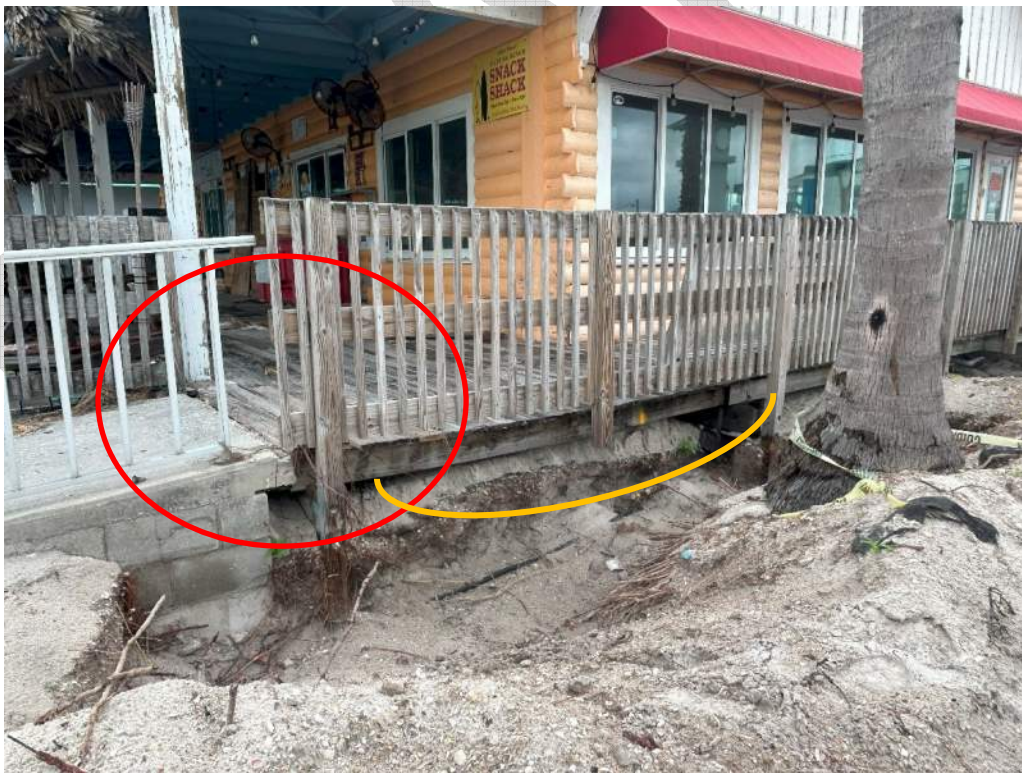
In the northwest corner of the exterior deck the existing **connection failed** due to the impact of the storm surge and on the southeast side of the building, the failure of several of the connections was

detected where the wooden beams that support the side corridor rest on the foundation piles and at these places the floor is in danger of failure.

Photo 56 – Northwest Corner of the Perimetral Corridor at the Top of the Concrete ADA Ramp.

The reparation of this connections and the replacement of the failed or heavy rusted strapping is recommended and the revision of the temporary repair did it bellow the wooden staircase to the 2nd Floor. (See **Photos 11 – 14 and 56 & SK-3**)

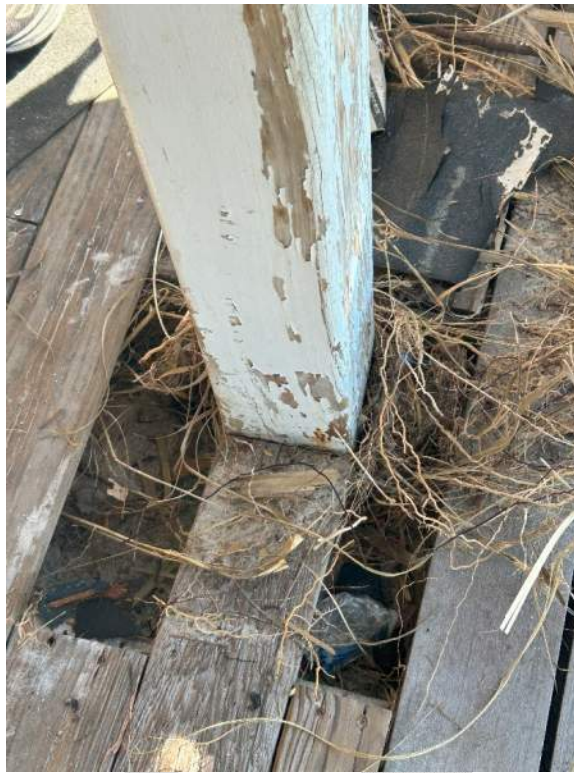
Photo 57 – Bottom Section of the Wooden Columns of the Back Porch.

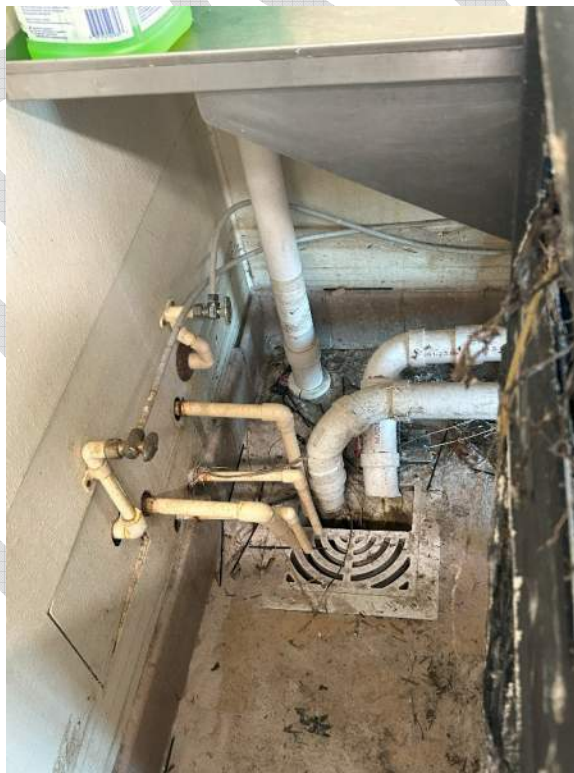
Photo 62 – Floor Drains Clogged.

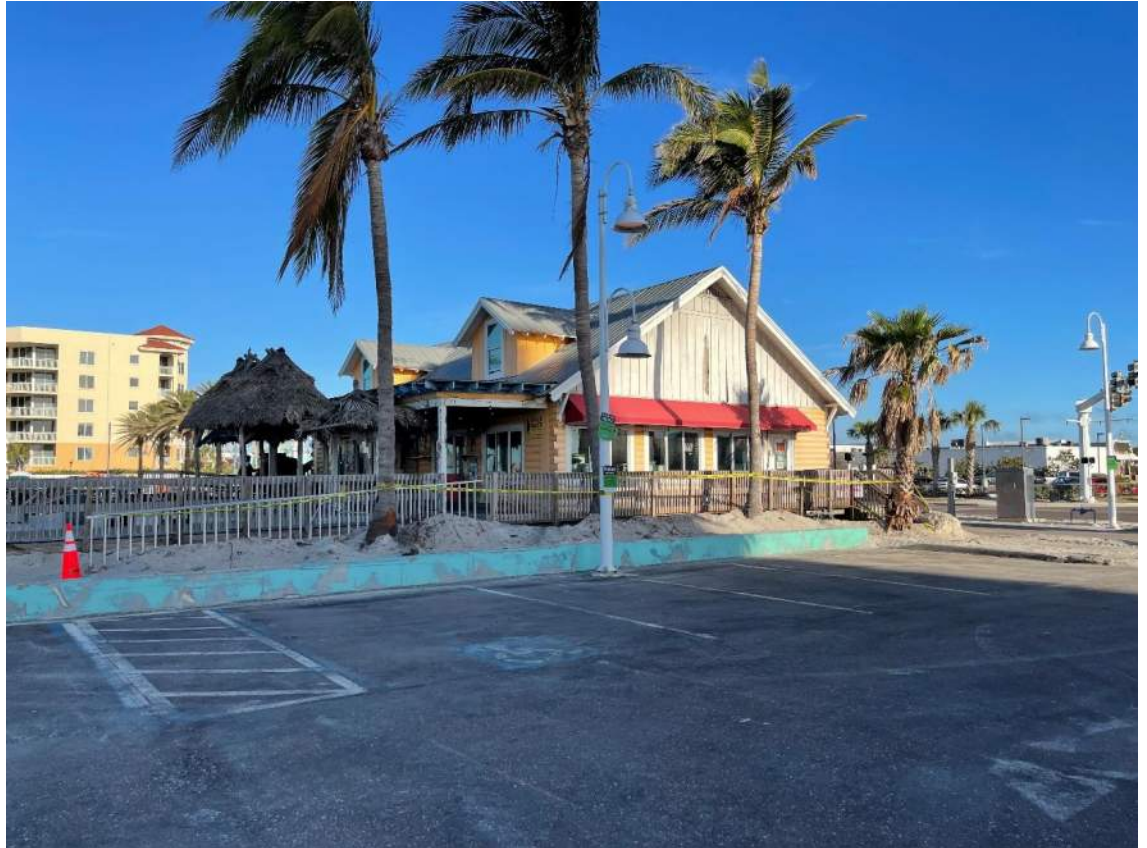
View from parking area.

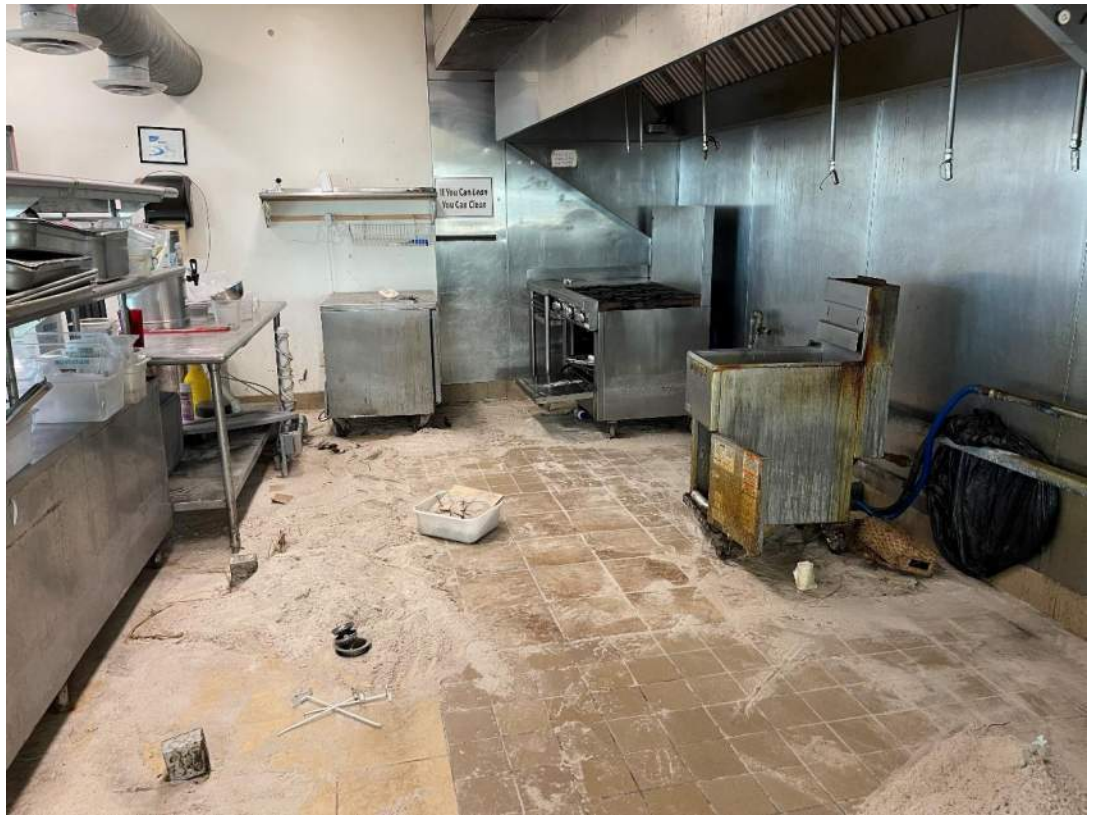
Kitchen area.
