# BELLM BRIDGE MINTURN TEMPORARY SCOUR PROTECTION DESIGN MEMO

DATE: July 13, 2023

RE: Bellm Bridge Design Minturn, CO  
Taylor St Over Eagle River  
Temporary Scour Protection Design  
SEH No. MINTU\_173117

The goal of this memorandum is to describe the temporary scour protection design for the Taylor Street Bridge over Eagle River (Bellm Bridge) in Minturn Colorado.

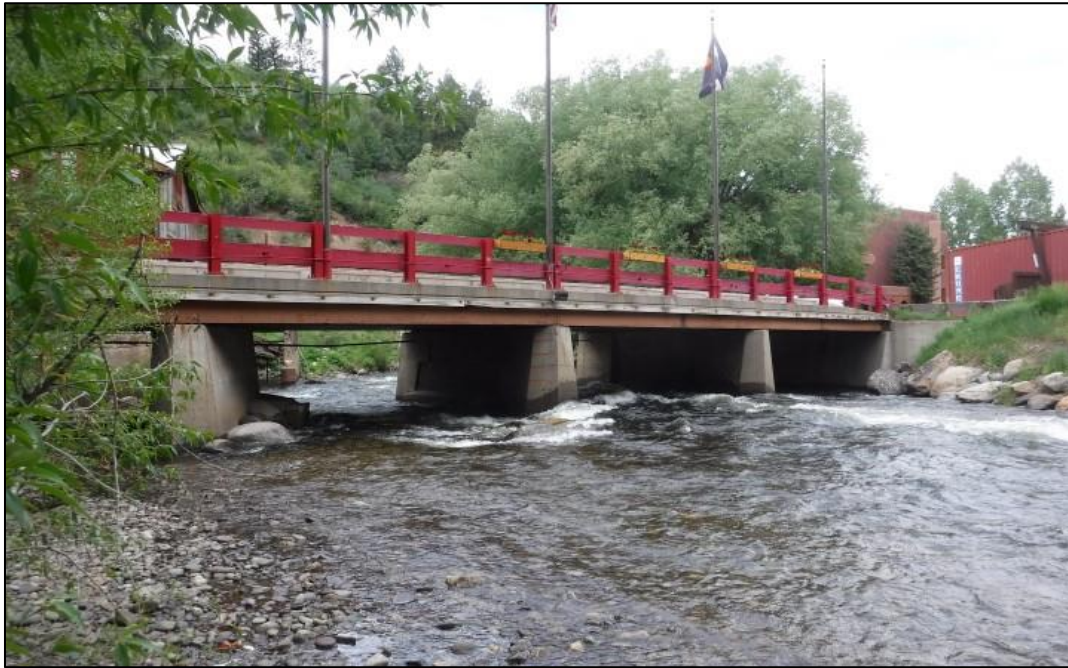
Elevation looking west.

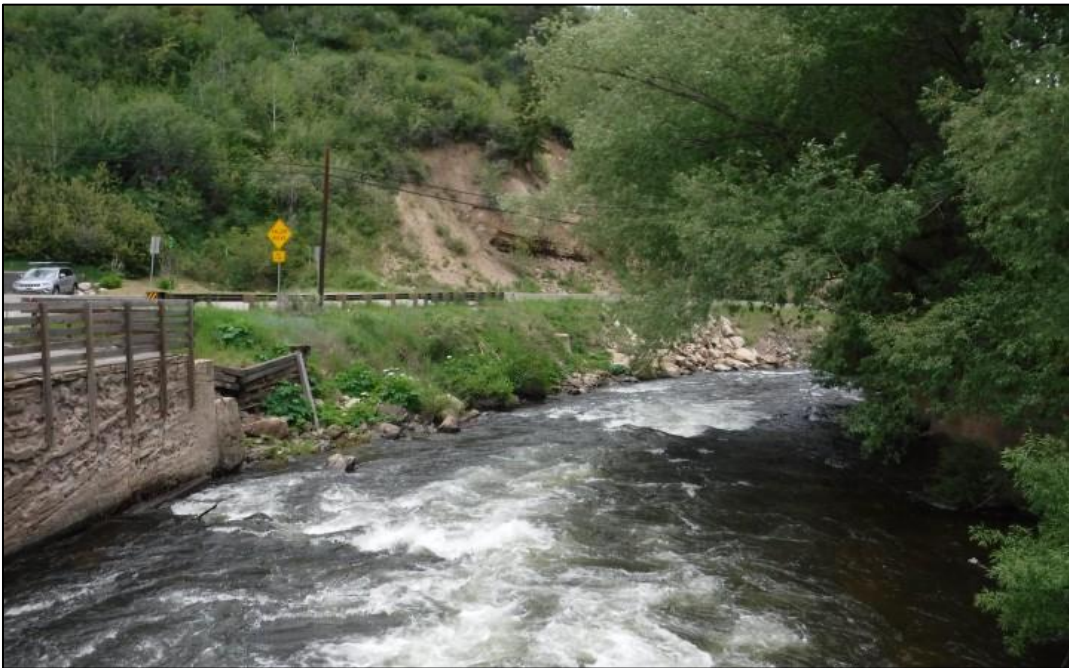
Channel looking west downstream.

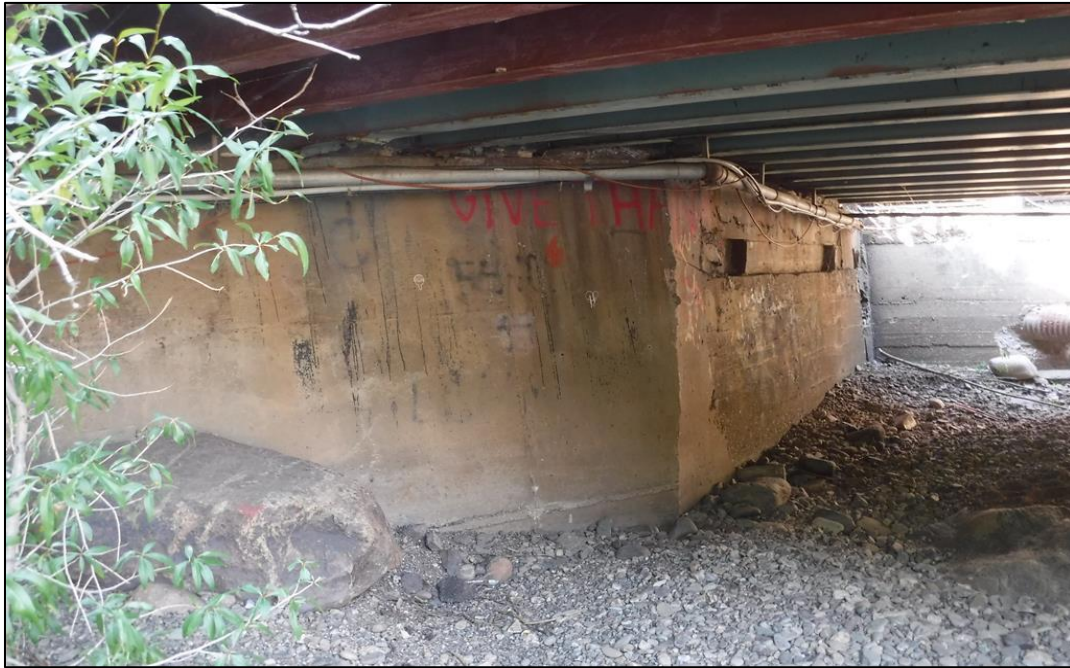
General view of Abutment 1.

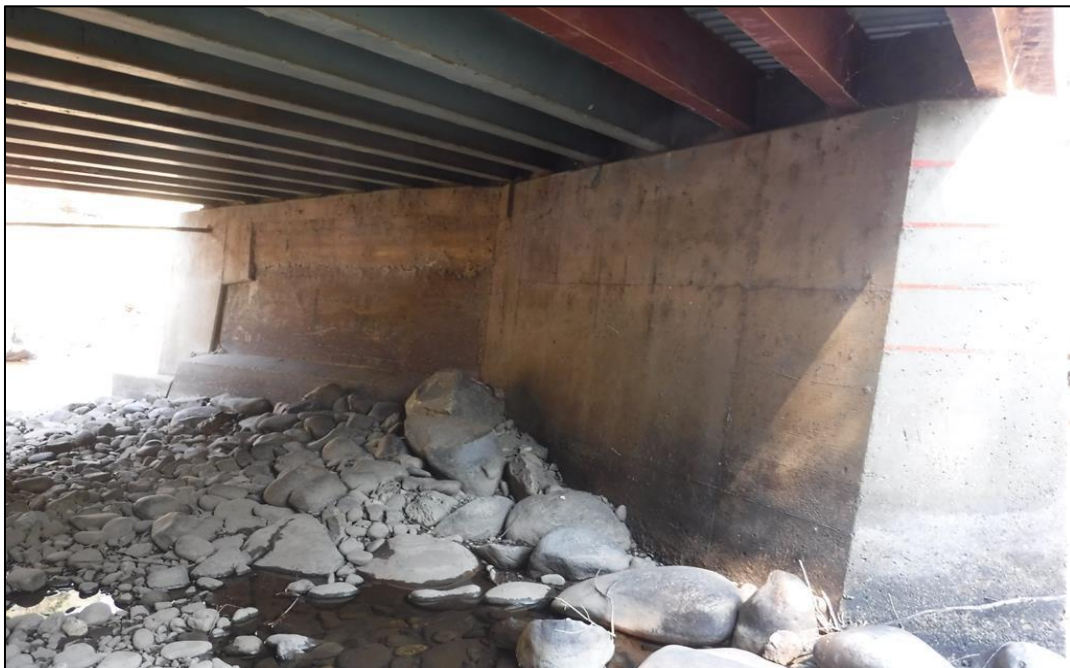
General view of Pier 2.

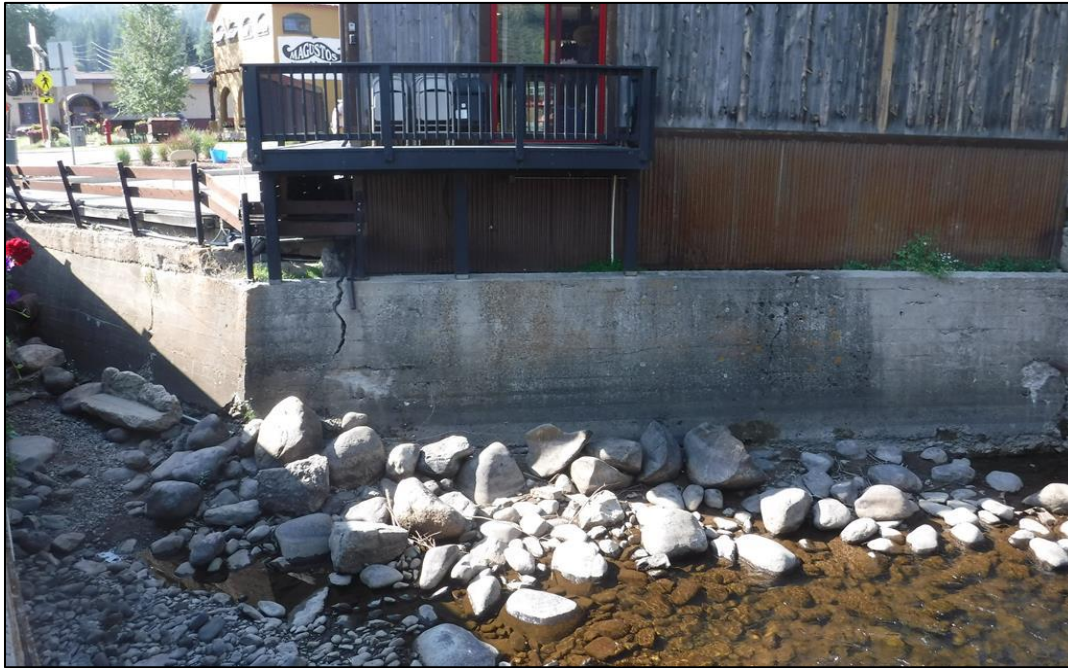
View of SW retention wall.

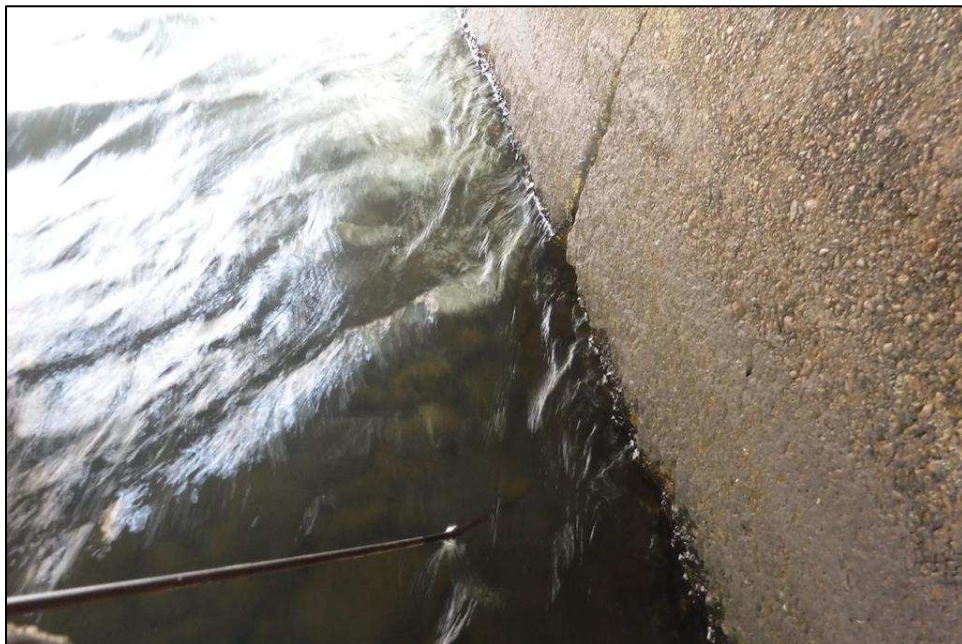
**P3 south side undermined footing at upstream end.**

We recommend that scour countermeasures be installed at the piers and the north abutment footing within 90 days and be installed in accordance with an engineered design. Structure should be monitored after high-flow or flood events until countermeasures are installed. The Essential Repair for this structure has been given a **YELLOW** Priority.

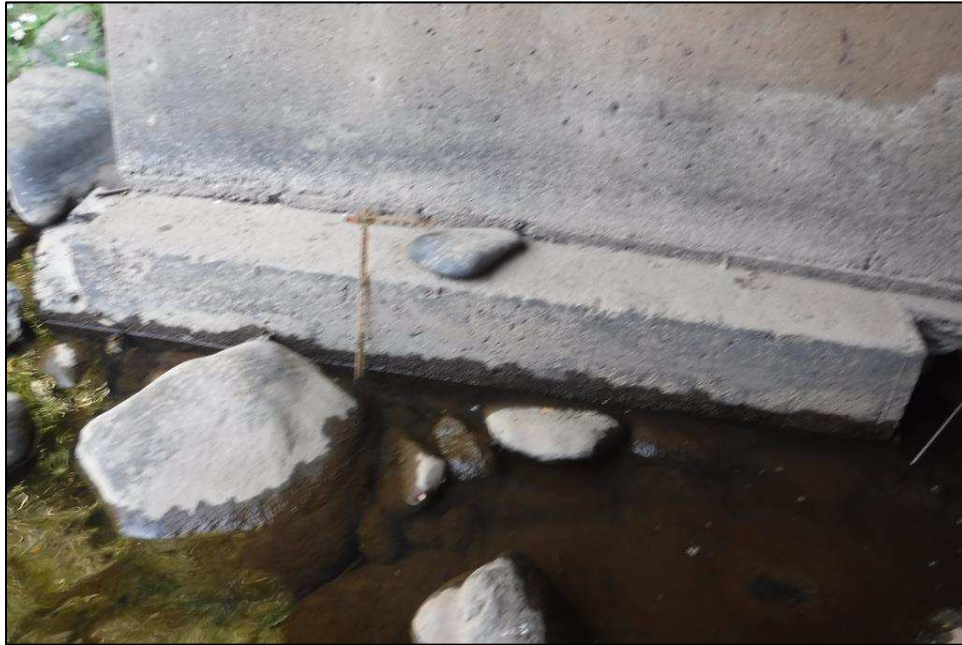
**Abutment 5 exposed footing.**
