INSPECTION REPORT

For the Property at:
203 CHURCH STREET
SWANSBORO, NC 28584

Prepared for: TANK BATES
Inspection Date: Tuesday, October 15, 2024
Prepared by: Kelly Honeycutt, 4741

Report No. 1846

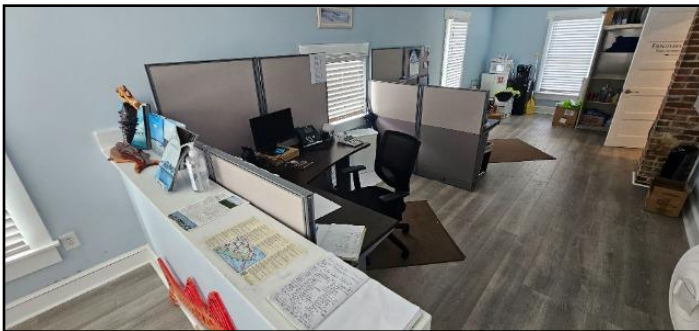
2. Condition: • Areas of air infiltration and visible growth were noted in the left side office areas. The rear wall built around the HVAC plenum was saturated. This is most likely due to condensation and this plenum may not be properly insulated. Condensation from the plenum has wet the drywall. This drywall should be removed so that the HVAC plenum can be evaluated by a licensed mechanical (HVAC) contractor and repaired. Any areas of visible mold growth in the wall cavity should be addressed by removing any wet drywall or drywall showing visible mold growth. As motioned previously, the infiltration of air around the perimeter of the exterior walls should be evaluated by a licensed general contractor. I recommend removing all of the drywall from the exterior walls to inspect the seal around the windows as well. Visible growth and air infiltration were noted at electrical outlets and above and below windows and above baseboards. The concern is that the visible evidence is a sign of more extensive mold growth or moisture issues in the wall cavities. I recommend removing all wet drywall, removing the baseboards, removing drywall and insulation 2 feet up from the floor and removing trim and drywall from around the window casings. If visible mold is discovered, continue to remove drywall and insulation 2 feet past visible mold growth. HEPA vacuum and clean the stud walls with an antimicrobial agent and dry the building materials to industry standards. An areas of air infiltration should be addressed while the wall cavity is open and corrected before remediation begins. If the source of moisture is not corrected, remediation practices and drying may need to be repeated.

7. Left Office Area

Task: Tear our drywall and insulation as described above, correct the sources of moisture, remediated the wall cavities and dry the structure

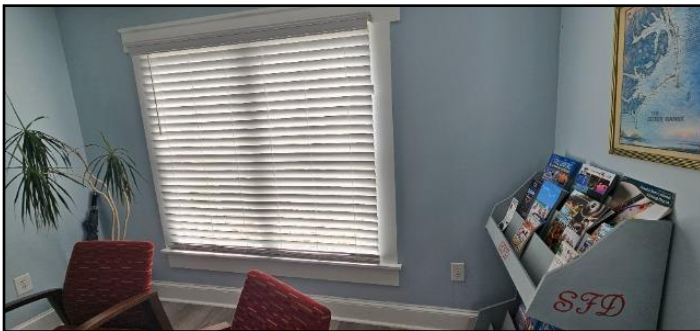
17. Picture for location reference

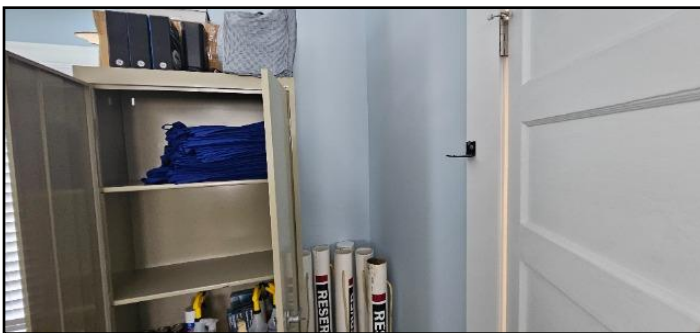
21. Picture for location reference

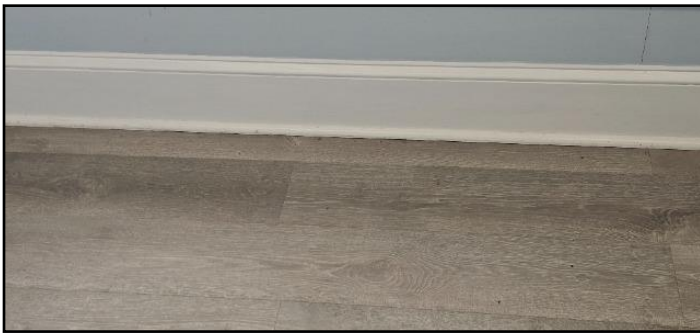
33. Picture for location reference

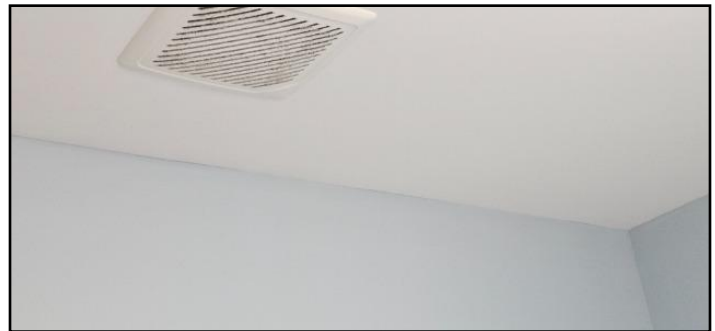
36. Picture for location reference

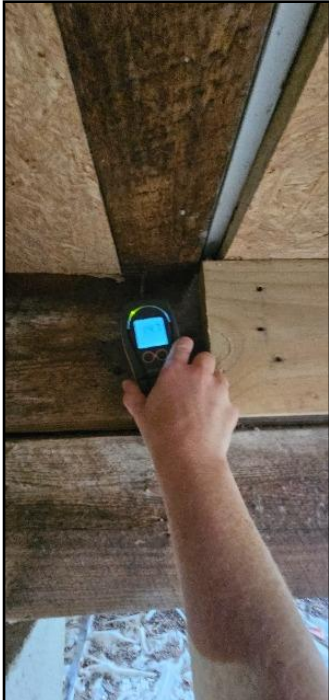
59. Wet Subfloor

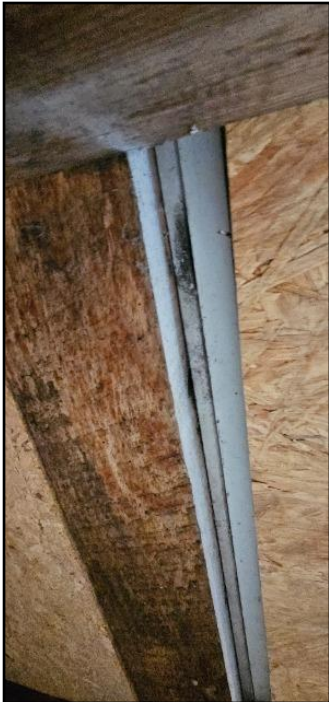
60. Microbial growth on drywall exposed in crawl

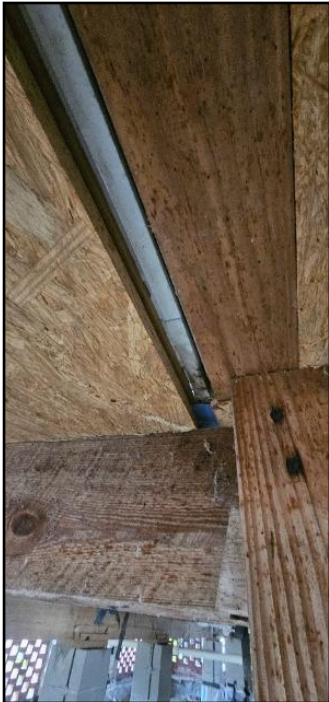
61. Subfloor incomplete

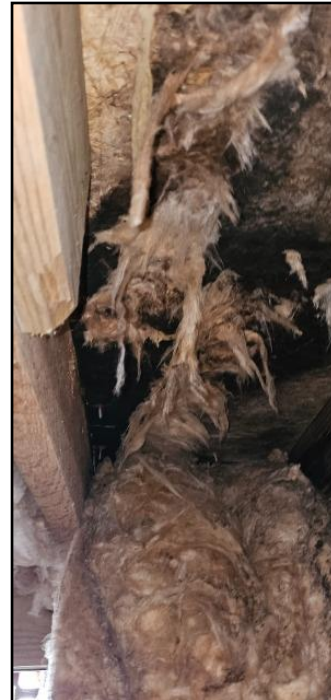
75. Visible mold growth on subfloor
