Todd Prager & Associates
LLC

Tree Risk Assessment for the Davis-Meeker Oak

Date: February 7, 2025

Site Address: 7525 Old Highway 99 SE
Tumwater, Washington 98501

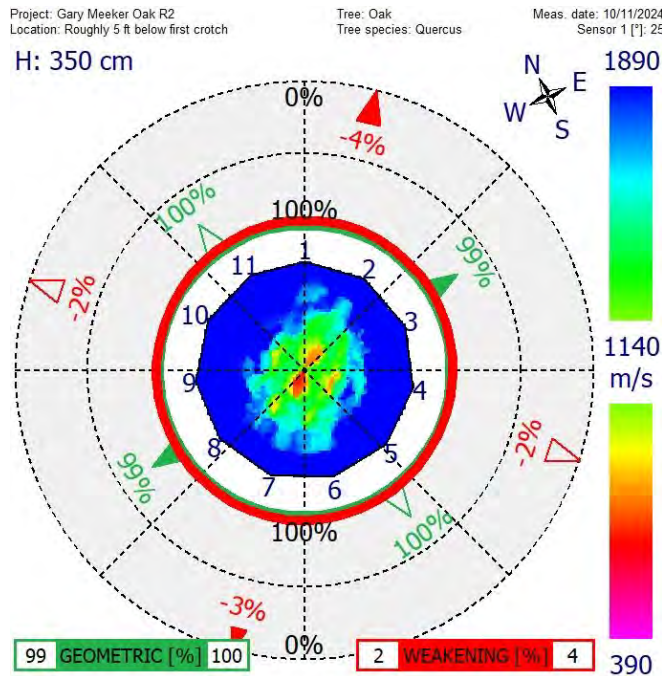
Oak – Reading 2- 350cm

At this level there is a small amount of compromised wood in the center of the stem. The green indicates where the co-dominant inclusion is causing a weak attachment point.

At this level there is between 2% and 4% strength loss. This is low strength loss.

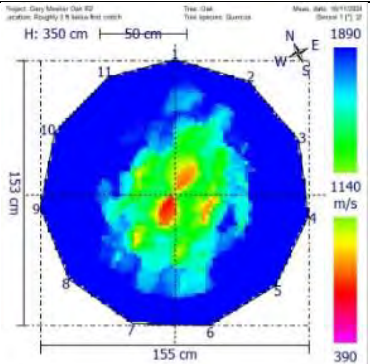
<p>2</p> <p>350 cm/ 11.5 ft</p>	<p>Main stem below codominant union.</p>

<p>At this level there is a small amount of compromised wood in the center of the stem. The green indicates where the co-dominant inclusion is potentially reducing the strength of the attachment point.</p> <p>At this level there is between 2% and 4% strength loss. This is low strength loss.</p>
<p>1</p> <p>50 cm/ 1.6 ft</p>	<p>Main stem near ground level.</p>

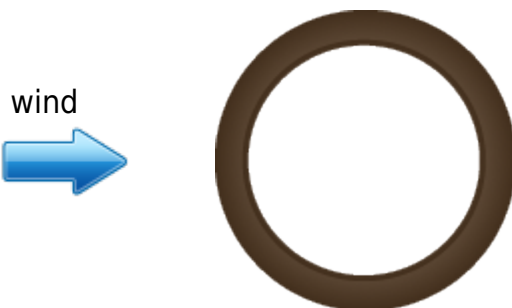
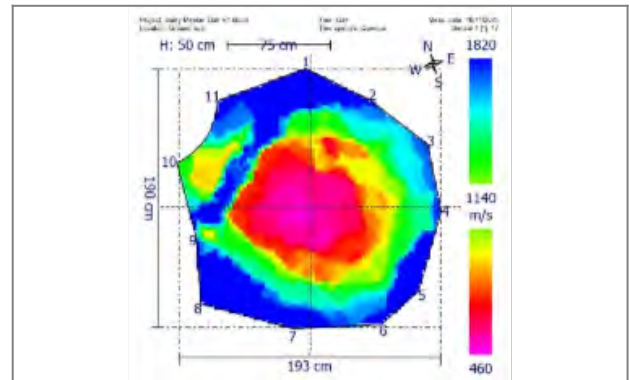
Basic safety: 11.16
Desired factor of safety: 1.5

Stem safety factor: 6.27

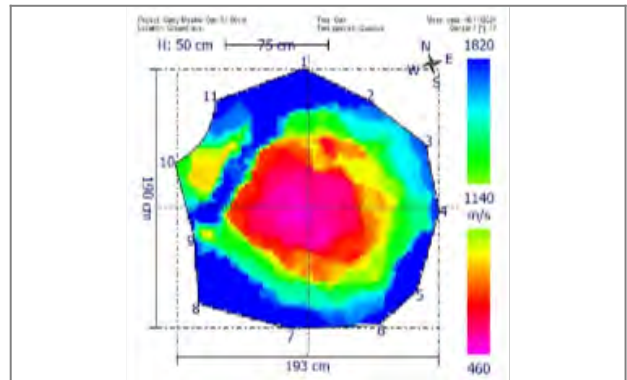
Basic safety: 11.16
Desired factor of safety: 1.5

Stem safety factor: 6.27

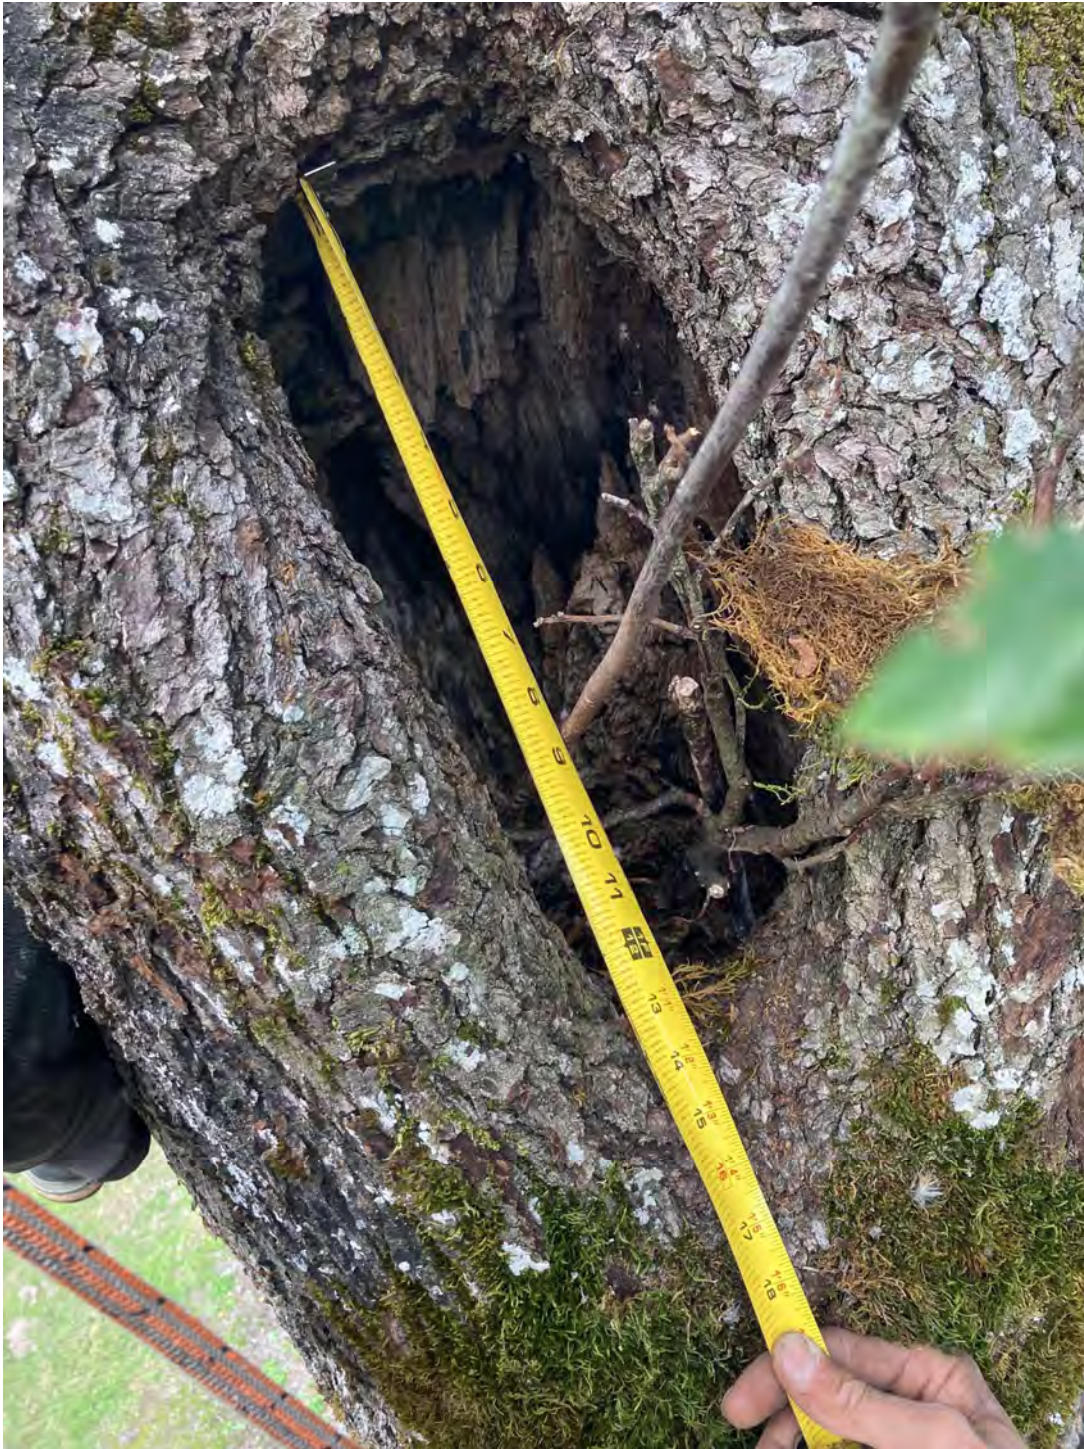
Figure 19 Depth measurement at approximately 24 inches to interior edge of cavity.
